**East Midlands Gateway
Phase 2 (EMG2)**

Geotechnical Preliminary Risk Assessment (EMG2)

East Midlands Gateway Phase 2, Land south of East Midlands Airport, Derby Geo-environmental and Geotechnical Preliminary Risk Assessment

REPORT TITLE: Phase I Geo-environmental and Geotechnical Preliminary Risk Assessment

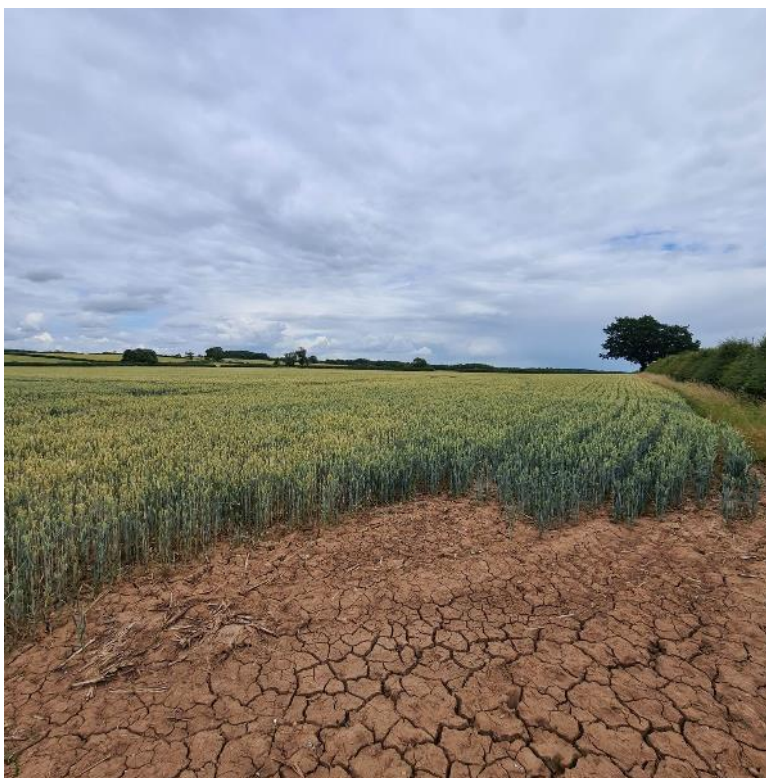
The ground cover north of Hyam's Lane comprises arable land which, at the time of Fairhurst's site visit, was used for wheat growing. Desiccated surface soils were observed across the north of the site.

Photo 2 – View of the central field, to the north of Hyam's Lane, facing eastwards. Desiccated soils can be seen in the foreground.

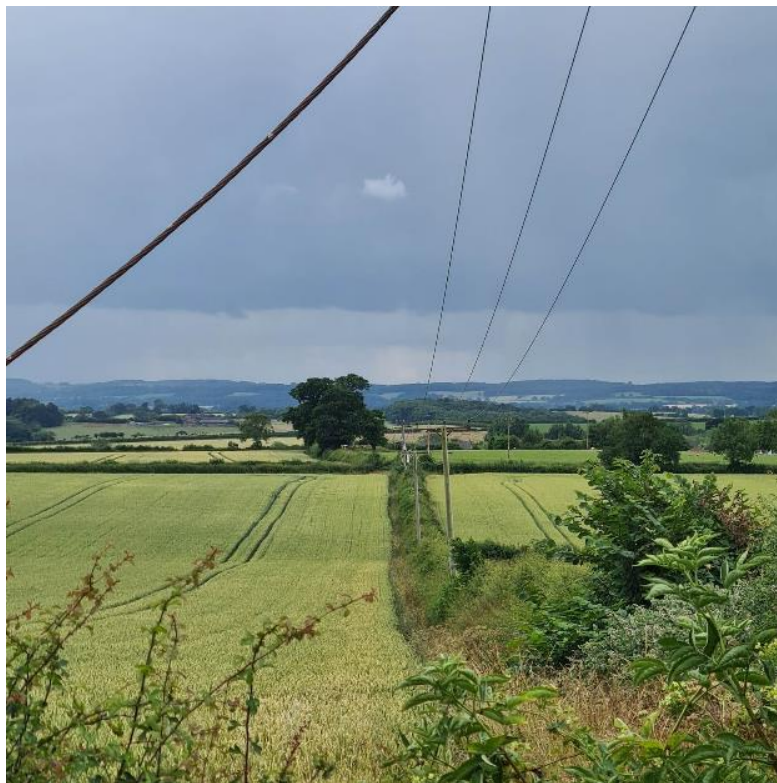
No structures were noted during the walkover in the north east of the site, with exception of the telephone mast. As noted above, overhead cables traverse the western portion of the site. Reference to the Utility Connections Drawing ATS/UC22009, May 2022 indicates that these cables are 11k overhead high voltage cables.

Photo 4 – View of the western fields, north of Hyam's Lane, facing southwards. Overhead power cables, that extend north to south, can be seen at the top of the photo.

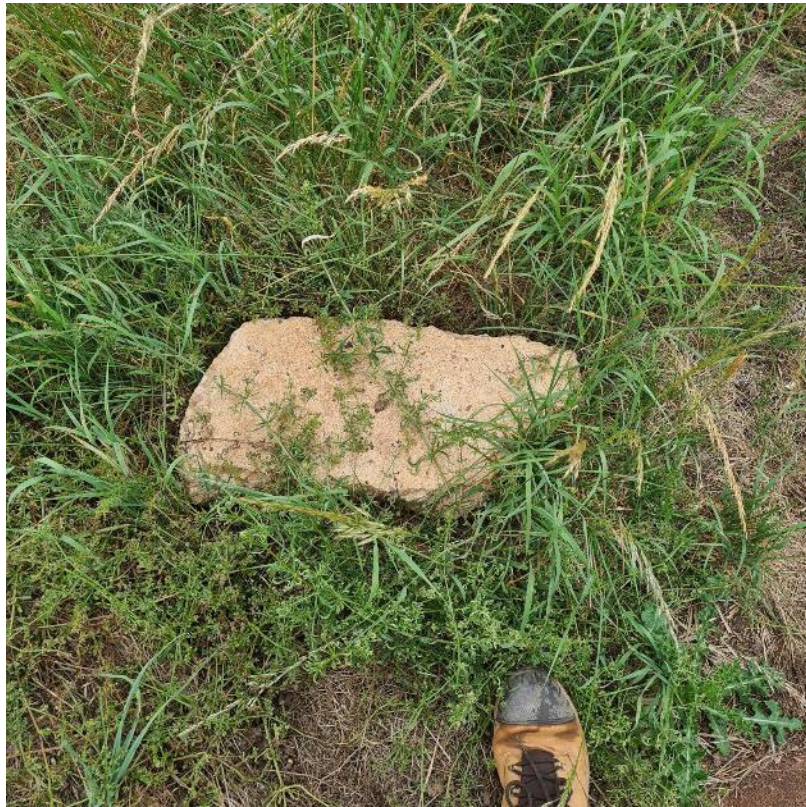
Photo 5 – A cobble of concrete observed in the south-eastern field, south of Hyam's Lane.

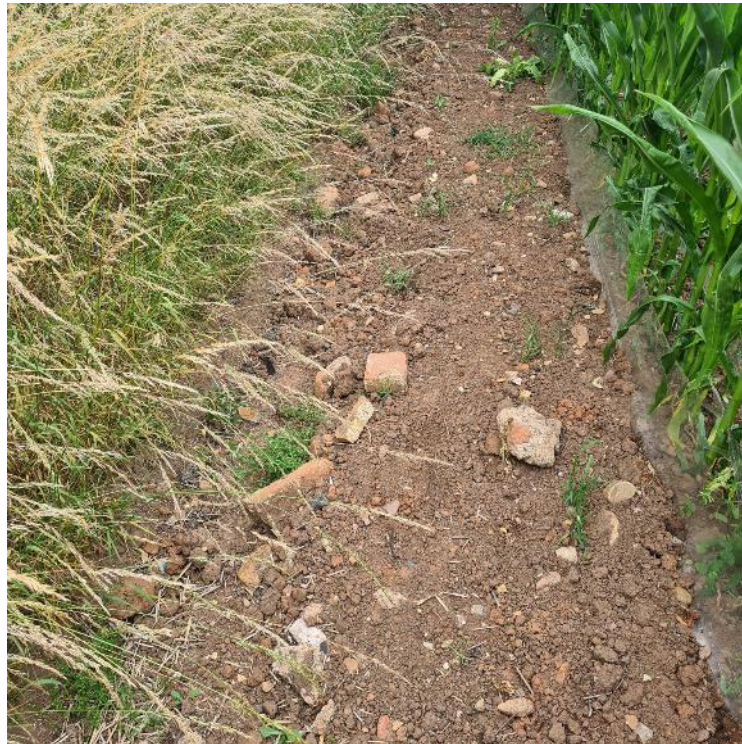
Photo 6 – Brick and concrete observed in the south-eastern field, south of Hyam's Lane.

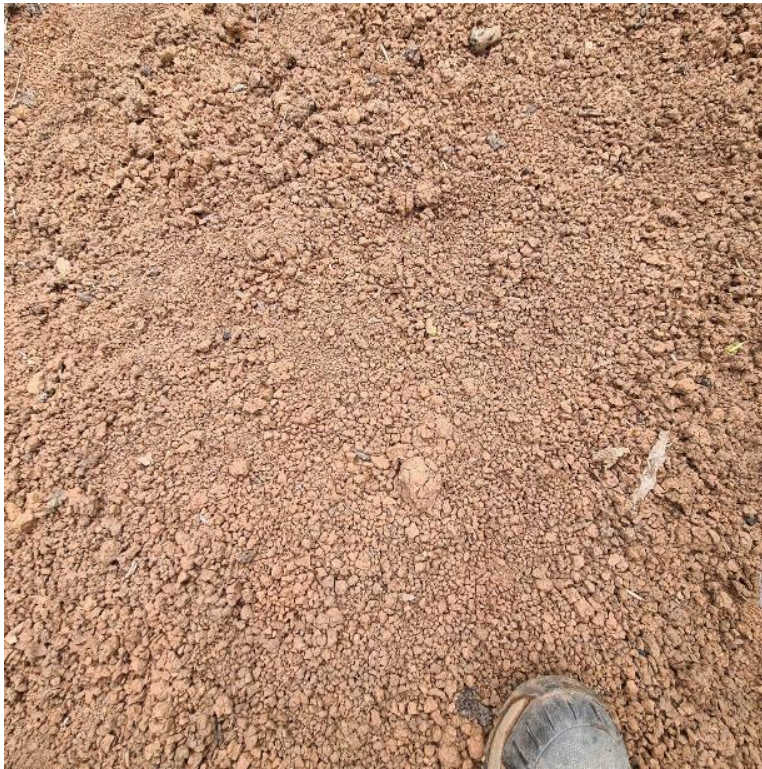
Photo 7 – Dried green manure which had been spread onto the southern fields, south of Hyam's Lane, used for maize growing.

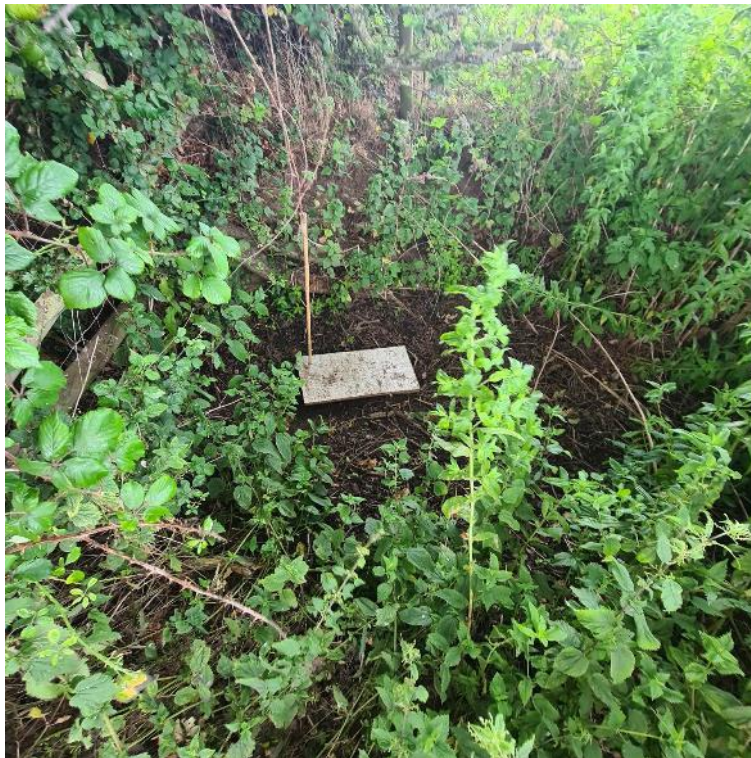
A drainage ditch was observed extending from the central-south-eastern area of the site to the south east corner of the site. At the time of the walkover the drain was observed to be dry in the southern end whilst access could not be made / the drain was obscured by dense foliage in the further north along its extent.

Photo 8 – The drainage ditch in the south-east of the site. The drain was dry at the time of the site visit.

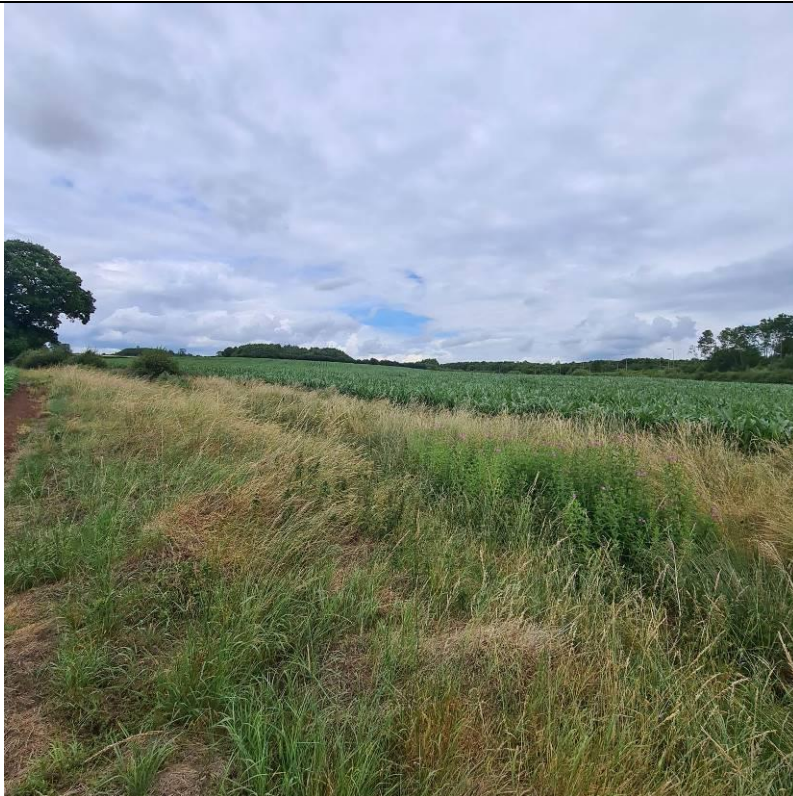
Photo 11 – View of the south-easternmost field, south of Hyam's Lane. The field, where the photo was taken, and the maize field in the background are separated by the drainage ditch, as seen in Photo 8.
