**East Midlands Gateway
Phase 2 (EMG2)**

Fairhurst Ground Investigation Report (EMG2)

Ground Investigation Report

East Midlands Gateway Phase 2,
Land South of East Midlands
Airport, Derby

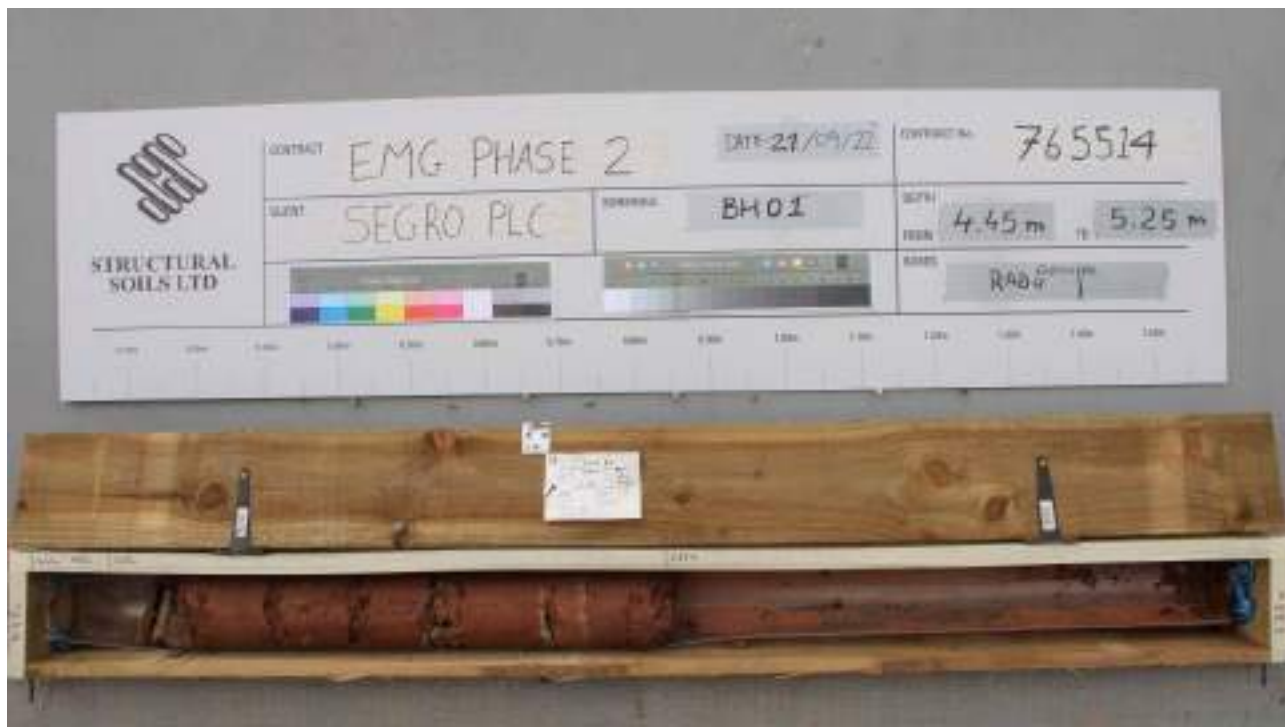
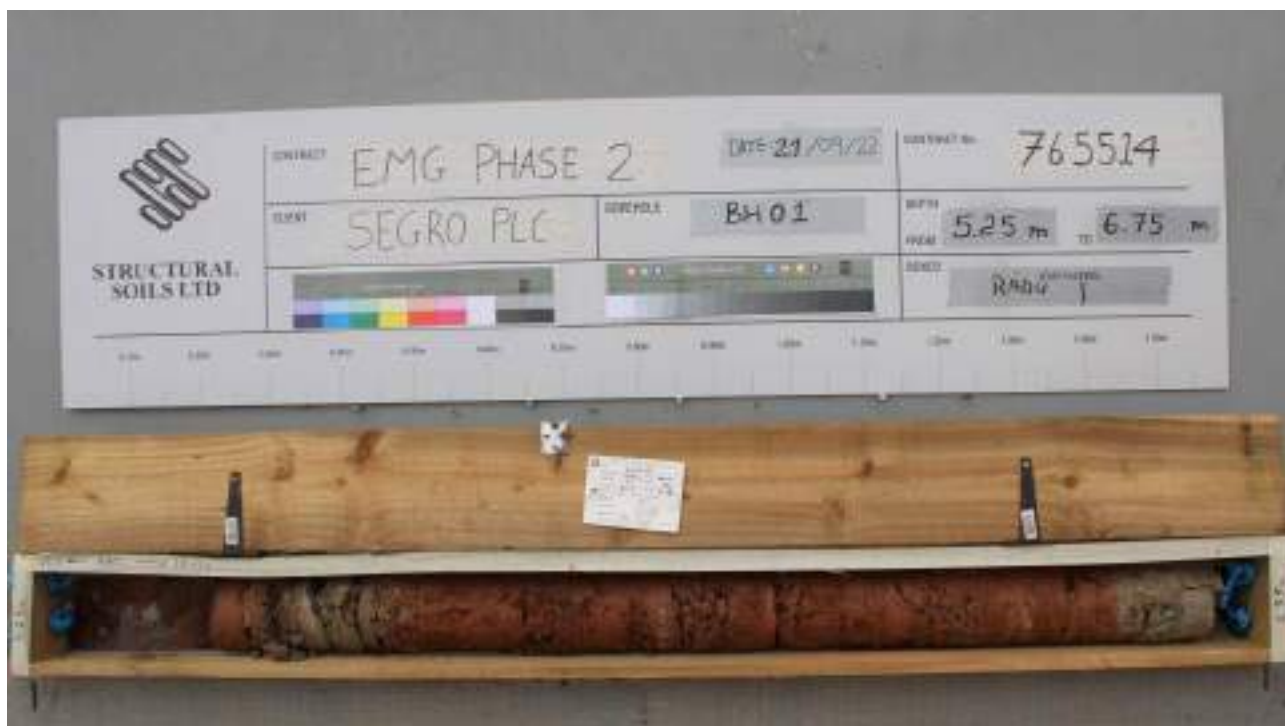
Contract: EMG Phase 2		Client: SEGRO		Borehole: BH01
Contract Ref: 765514	Start: 05.09.22 End: 13.09.22	Ground Level (m AOD): 89.22	National Grid Co-ordinate: E:446551.3 N:325384.8	Sheet: 8 of 16

Method Used: Inspection pit + Cable Percussion + Rotary Cored	Plant Used: Dando 3000 Mark 2 + Comacchio GEO 601	Drilled By: Jonny Hutt + Sam Carter	Logged By: JAlton + RStan	Checked By: AS	AGS
---	---	-------------------------------------	---------------------------	----------------	-----

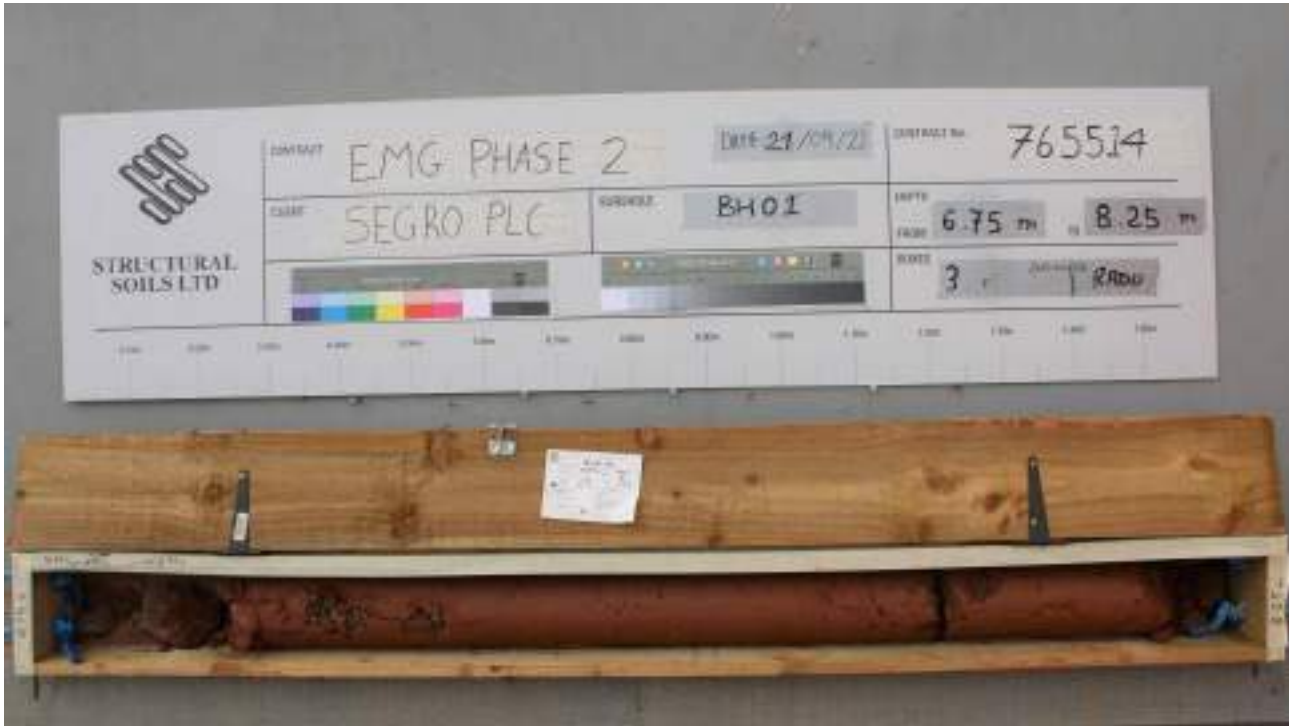
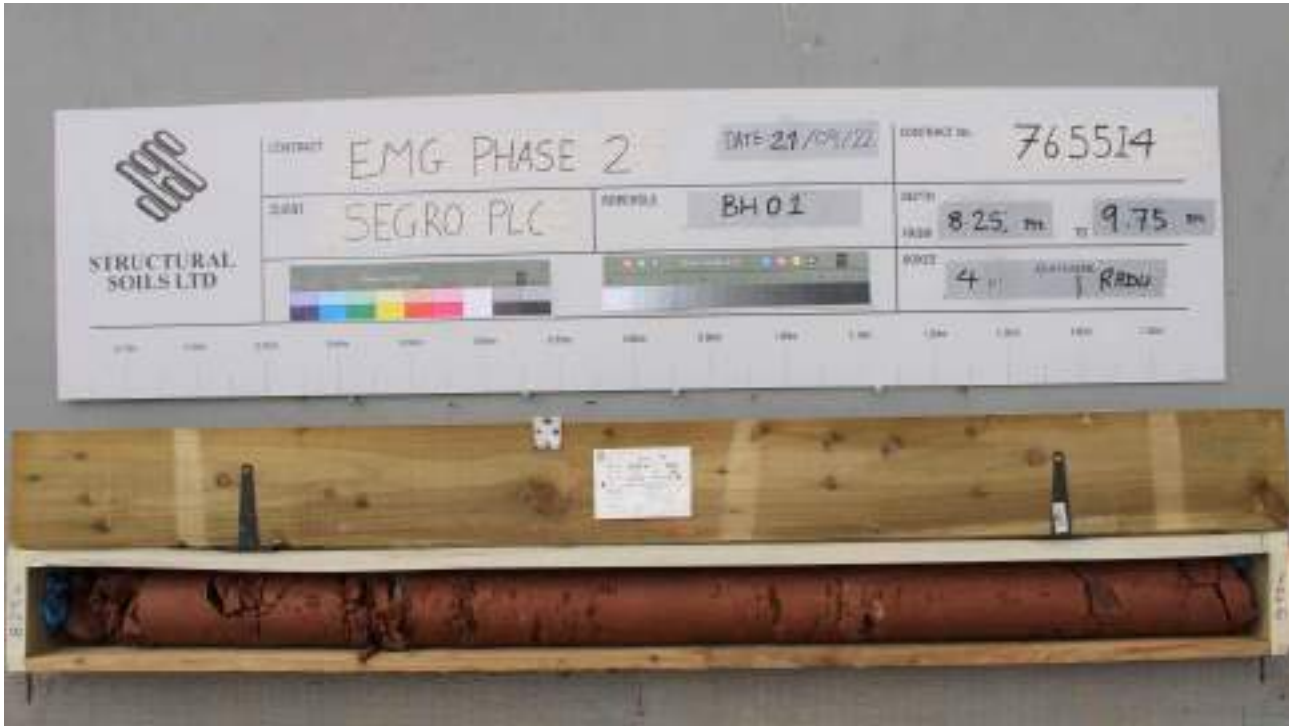
Contract: EMG Phase 2			Client: SEGRO	Borehole: BH01
Contract Ref: 765514	Start: 05.09.22 End: 13.09.22	Ground Level (m AOD): 89.22	National Grid Co-ordinate: E:446551.3 N:325384.8	Sheet: 9 of 16

Method Used: Inspection pit + Cable Percussion + Rotary Cored	Plant Used: Dando 3000 Mark 2 + Cornacchio GEO 601	Drilled By: Jonny Hutt + Sam Carter	Logged By: JAlton + RStan	Checked By: AS	AGS
---	--	-------------------------------------	---------------------------	----------------	-----

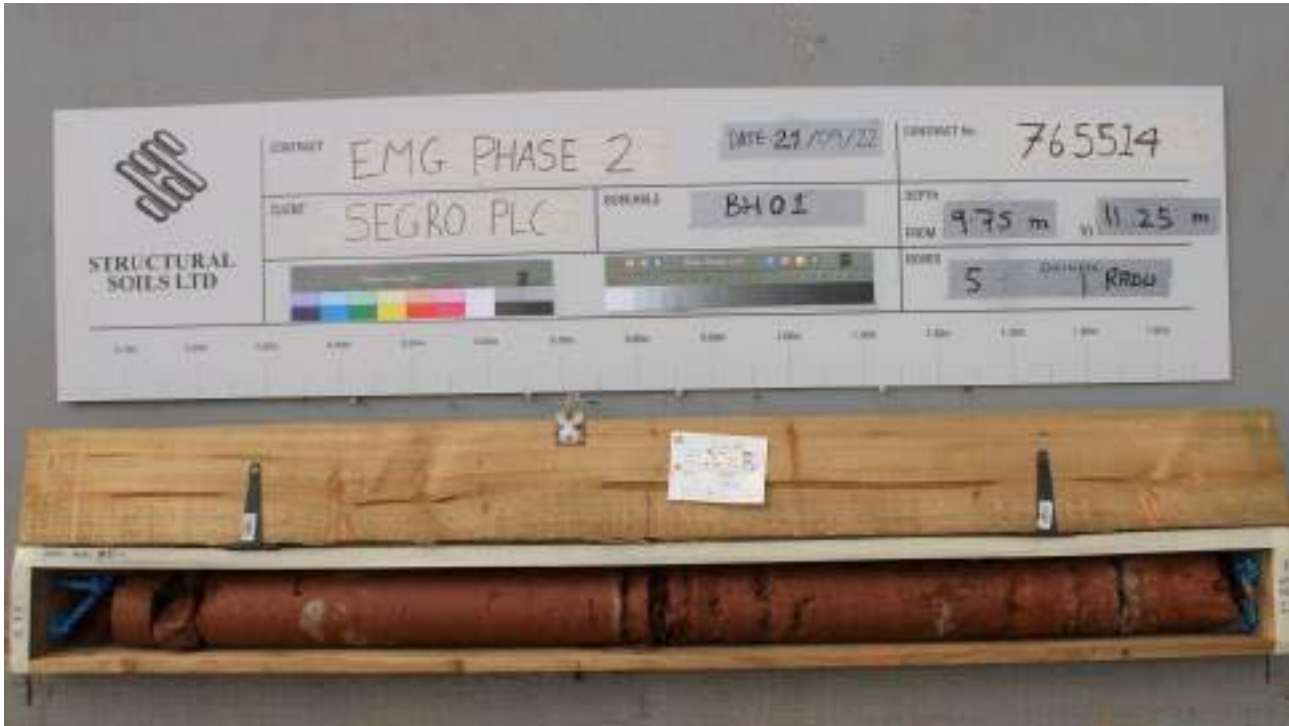
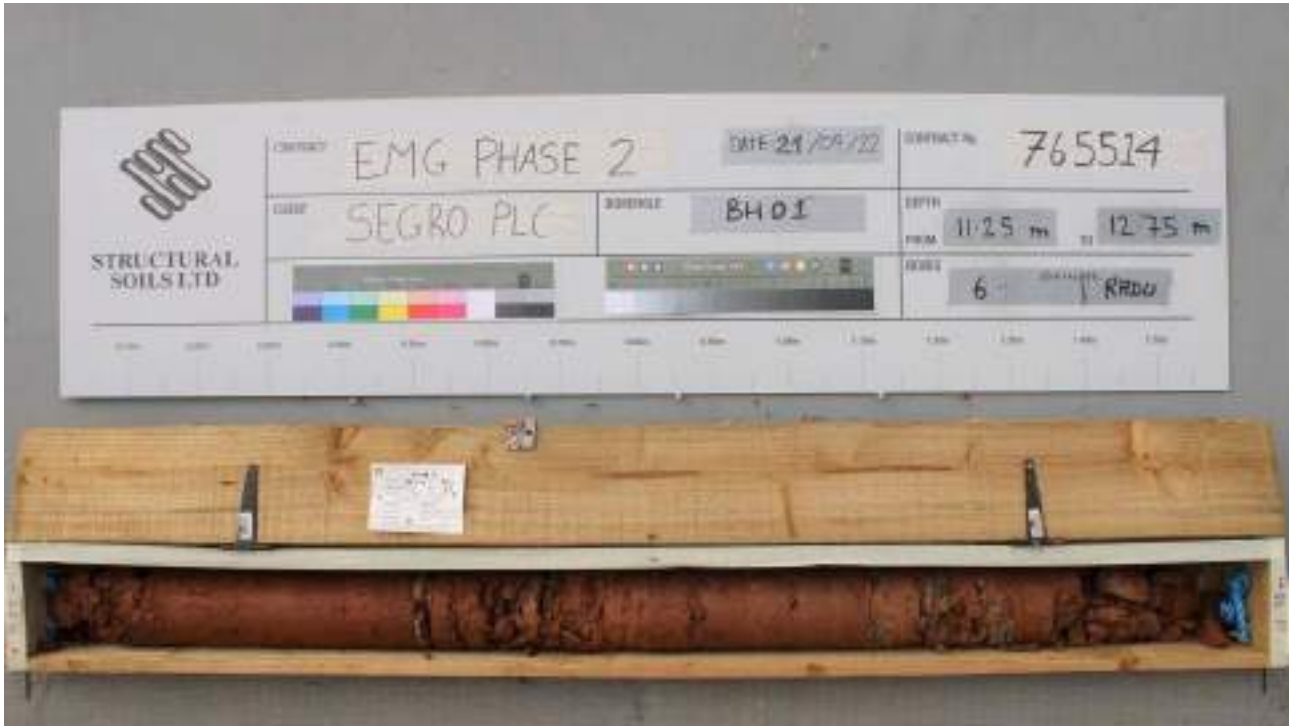
Contract: EMG Phase 2			Client: SEGRO	Borehole: BH01
Contract Ref: 765514	Start: 05.09.22 End: 13.09.22	Ground Level (m AOD): 89.22	National Grid Co-ordinate: E:446551.3 N:325384.8	Sheet: 10 of 16

Method Used: Inspection pit + Cable Percussion + Rotary Cored	Plant Used: Dando 3000 Mark 2 + Cornacchio GEO 601	Drilled By: Jonny Hutt + Sam Carter	Logged By: JAlton + RStan	Checked By: AS	
---	--	-------------------------------------	---------------------------	----------------	--

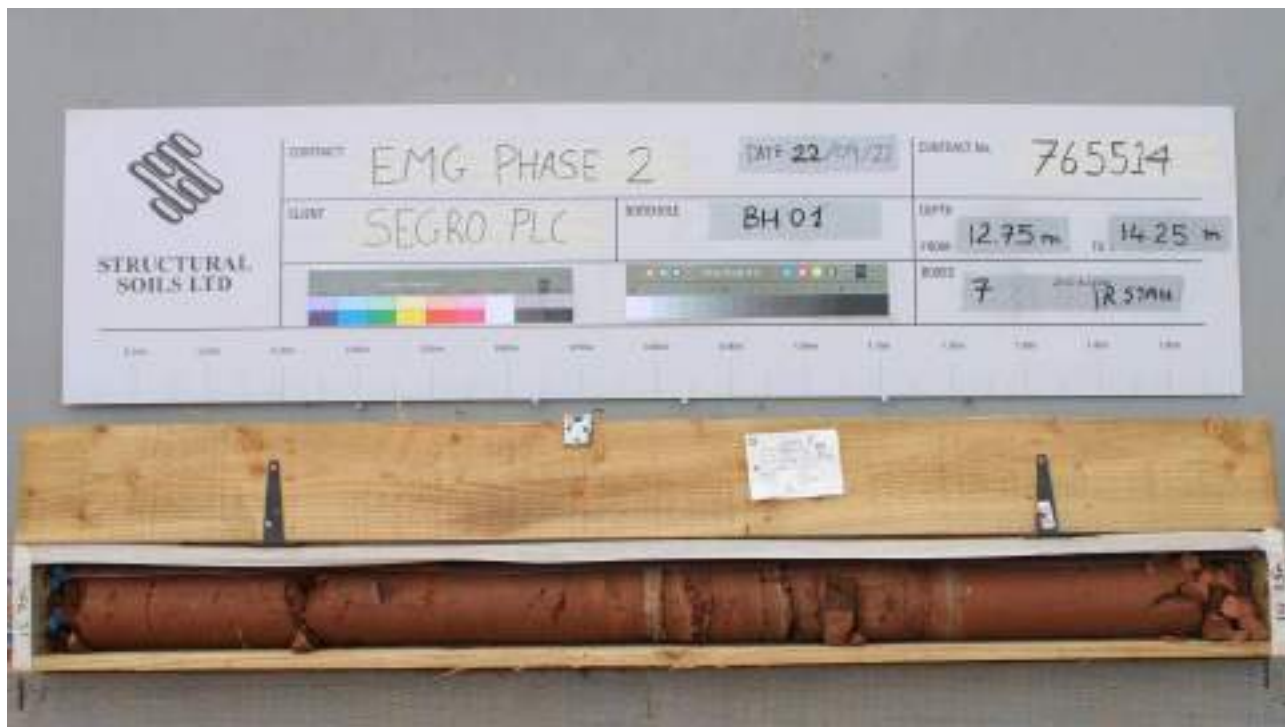
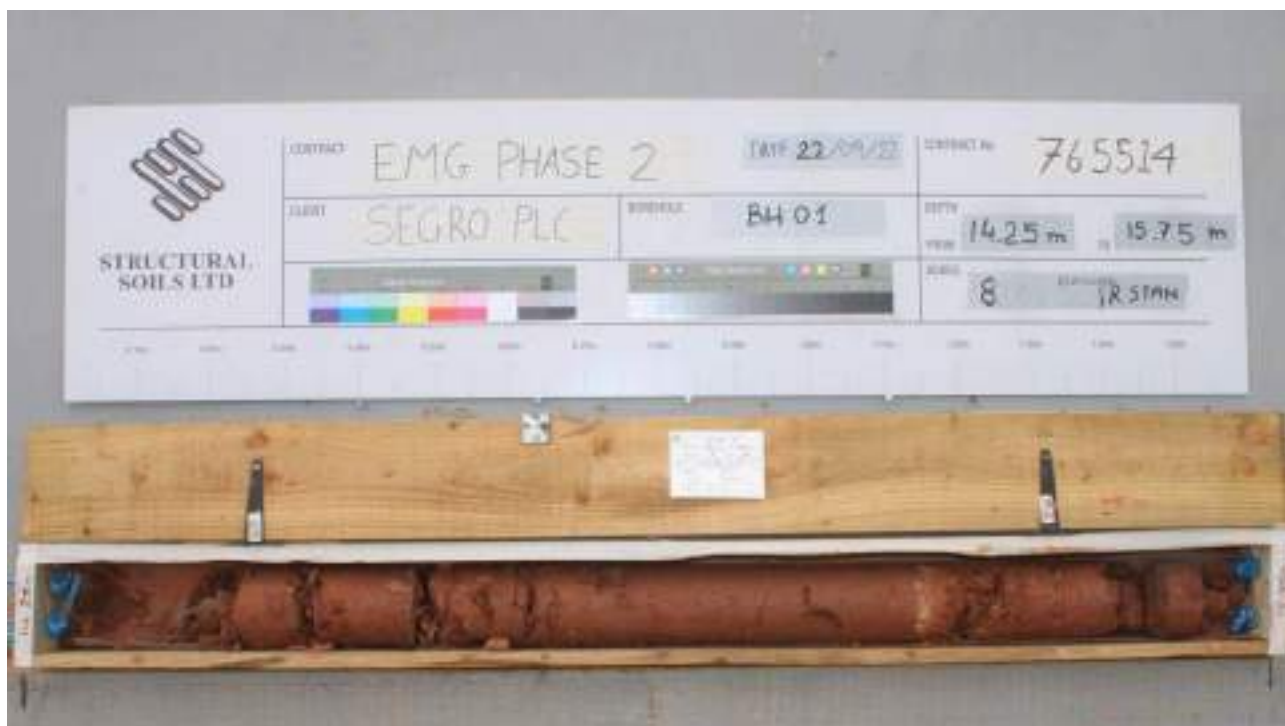
Contract: EMG Phase 2		Client: SEGRO		Borehole: BH01
Contract Ref: 765514	Start: 05.09.22 End: 13.09.22	Ground Level (m AOD): 89.22	National Grid Co-ordinate: E:446551.3 N:325384.8	Sheet: 11 of 16

Method Used: Inspection pit + Cable Percussion + Rotary Cored	Plant Used: Dando 3000 Mark 2 + Comacchio GEO 601	Drilled By: Jonny Hutt + Sam Carter	Logged By: JAlton + RStan	Checked By: AS	AGS
---	---	-------------------------------------	---------------------------	----------------	-----

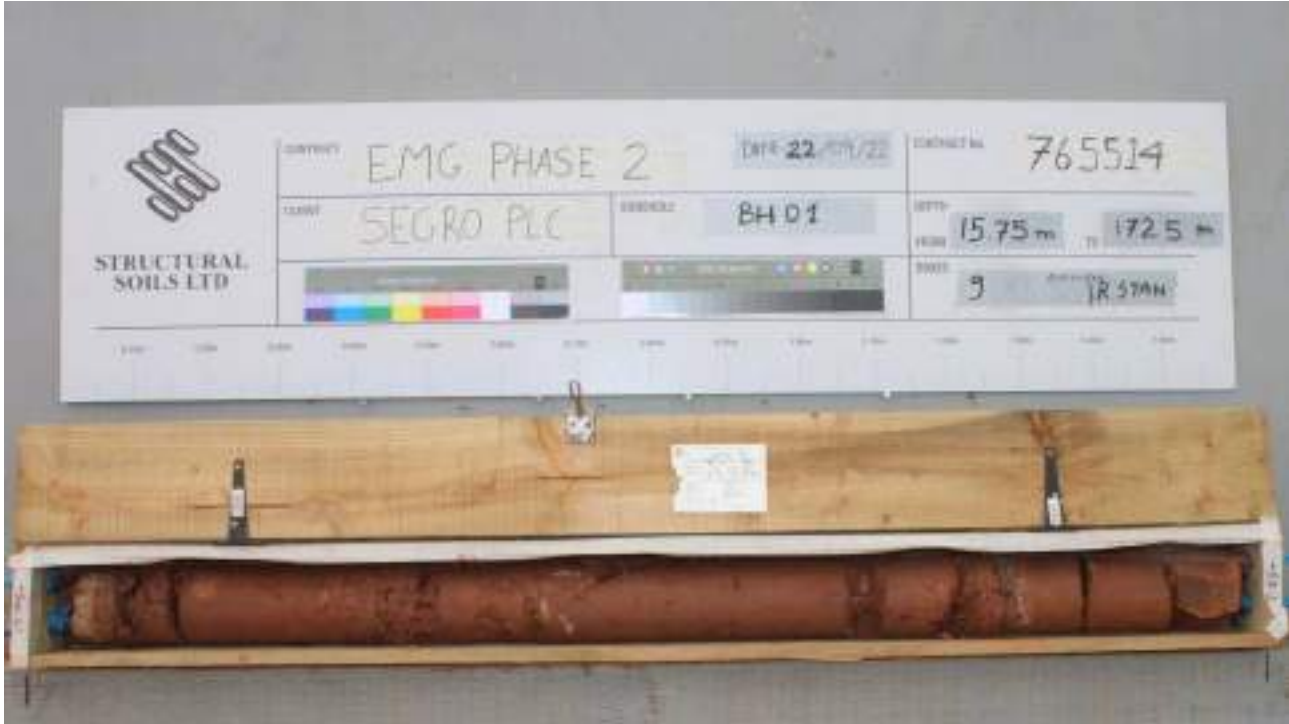
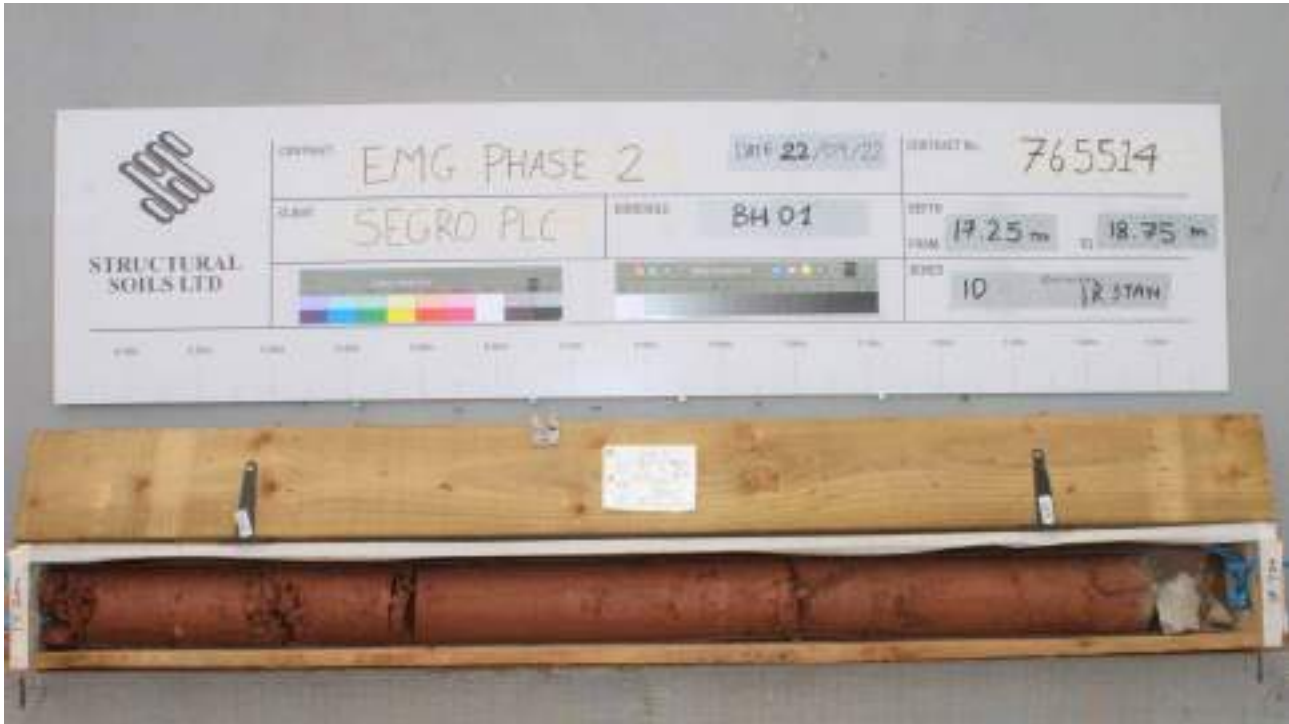
Contract: EMG Phase 2			Client: SEGRO	Borehole: BH01
Contract Ref: 765514	Start: 05.09.22 End: 13.09.22	Ground Level (m AOD): 89.22	National Grid Co-ordinate: E:446551.3 N:325384.8	Sheet: 12 of 16

Method Used: Inspection pit + Cable Percussion + Rotary Cored	Plant Used: Dando 3000 Mark 2 + Comacchio GEO 601	Drilled By: Jonny Hutt + Sam Carter	Logged By: JAlton + RStan	Checked By: AS	AGS
---	---	-------------------------------------	---------------------------	----------------	-----

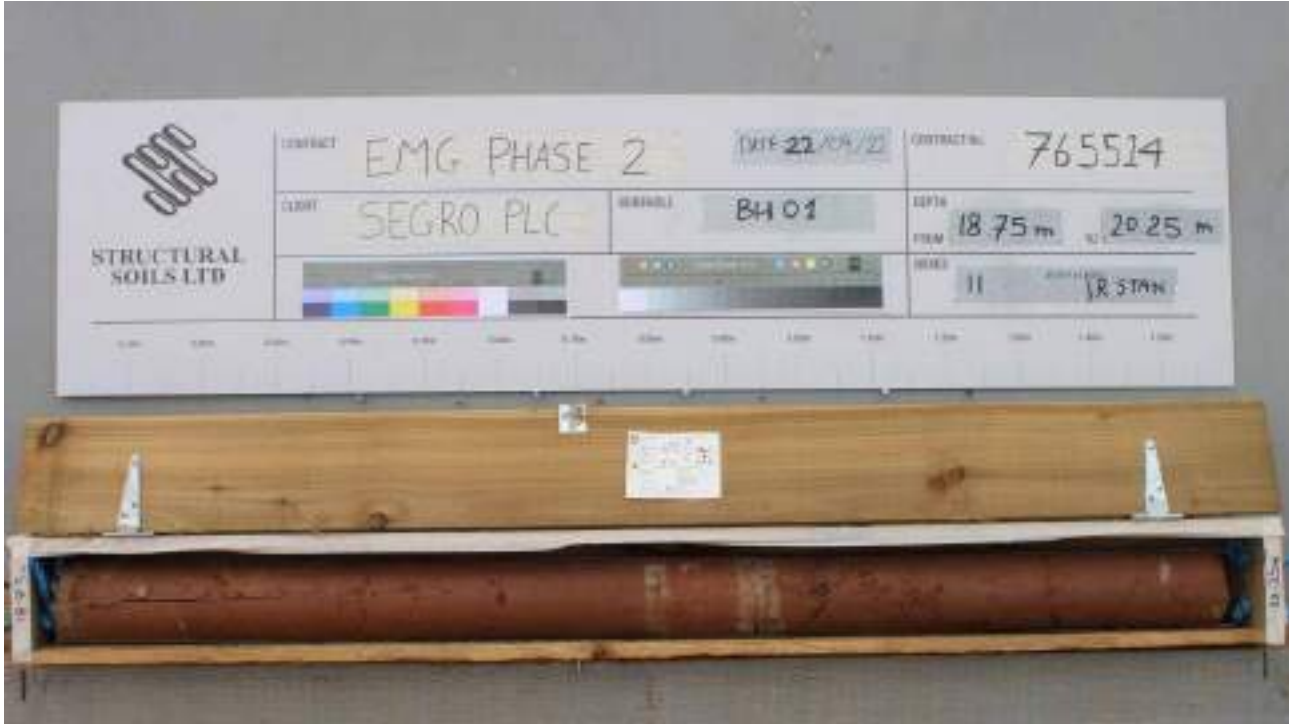
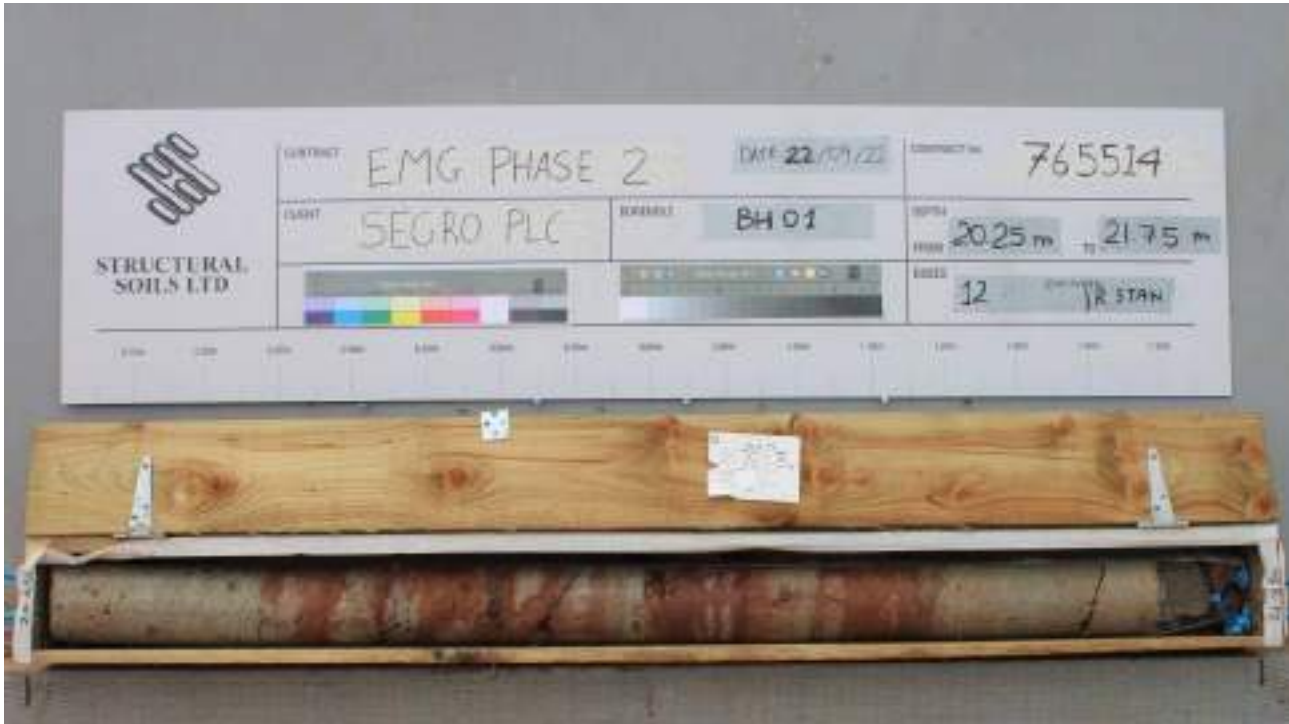
Contract: EMG Phase 2			Client: SEGRO	Borehole: BH01
Contract Ref: 765514	Start: 05.09.22 End: 13.09.22	Ground Level (m AOD): 89.22	National Grid Co-ordinate: E:446551.3 N:325384.8	Sheet: 13 of 16

Method Used: Inspection pit + Cable Percussion + Rotary Cored	Plant Used: Dando 3000 Mark 2 + Cornacchio GEO 601	Drilled By: Jonny Hutt + Sam Carter	Logged By: JAlton + RStan	Checked By: AS	AGS
---	--	-------------------------------------	---------------------------	----------------	-----

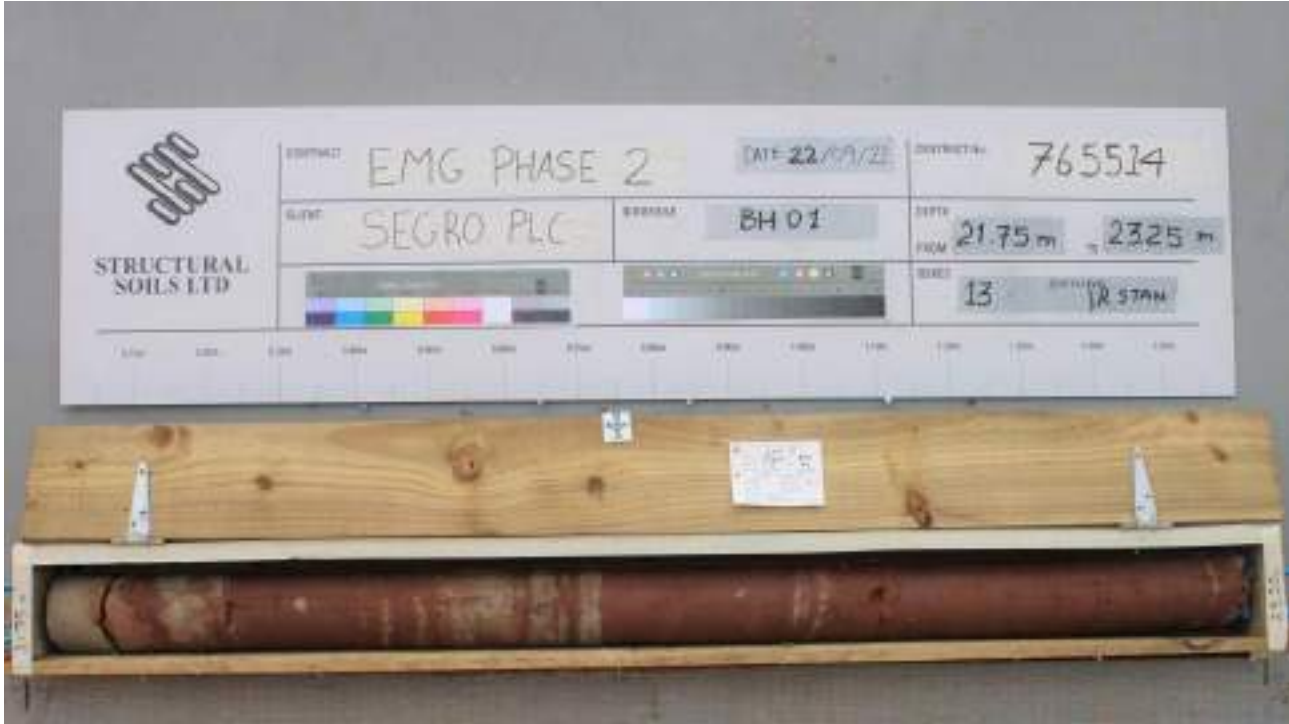
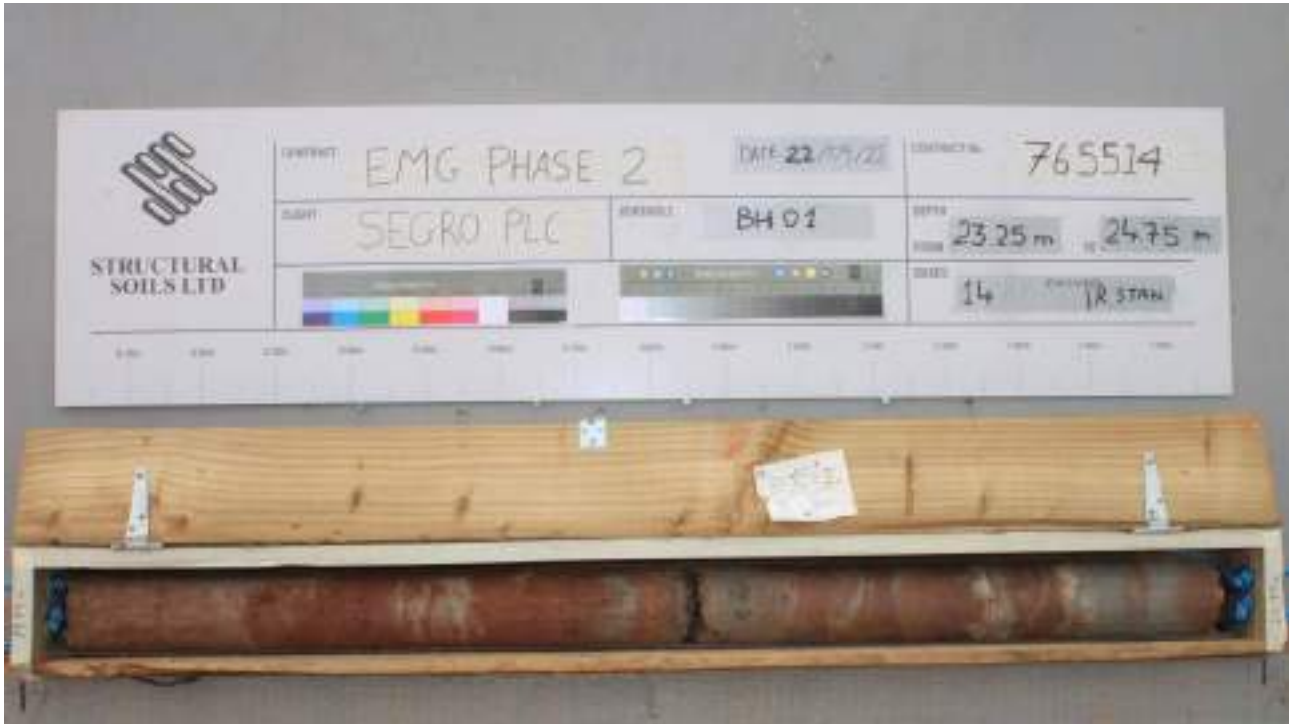
Contract: EMG Phase 2		Client: SEGRO		Borehole: BH01
Contract Ref: 765514	Start: 05.09.22 End: 13.09.22	Ground Level (m AOD): 89.22	National Grid Co-ordinate: E:446551.3 N:325384.8	Sheet: 14 of 16

Method Used: Inspection pit + Cable Percussion + Rotary Cored	Plant Used: Dando 3000 Mark 2 + Cornacchio GEO 601	Drilled By: Jonny Hutt + Sam Carter	Logged By: JAlton + RStan	Checked By: AS	AGS
---	--	-------------------------------------	---------------------------	----------------	-----

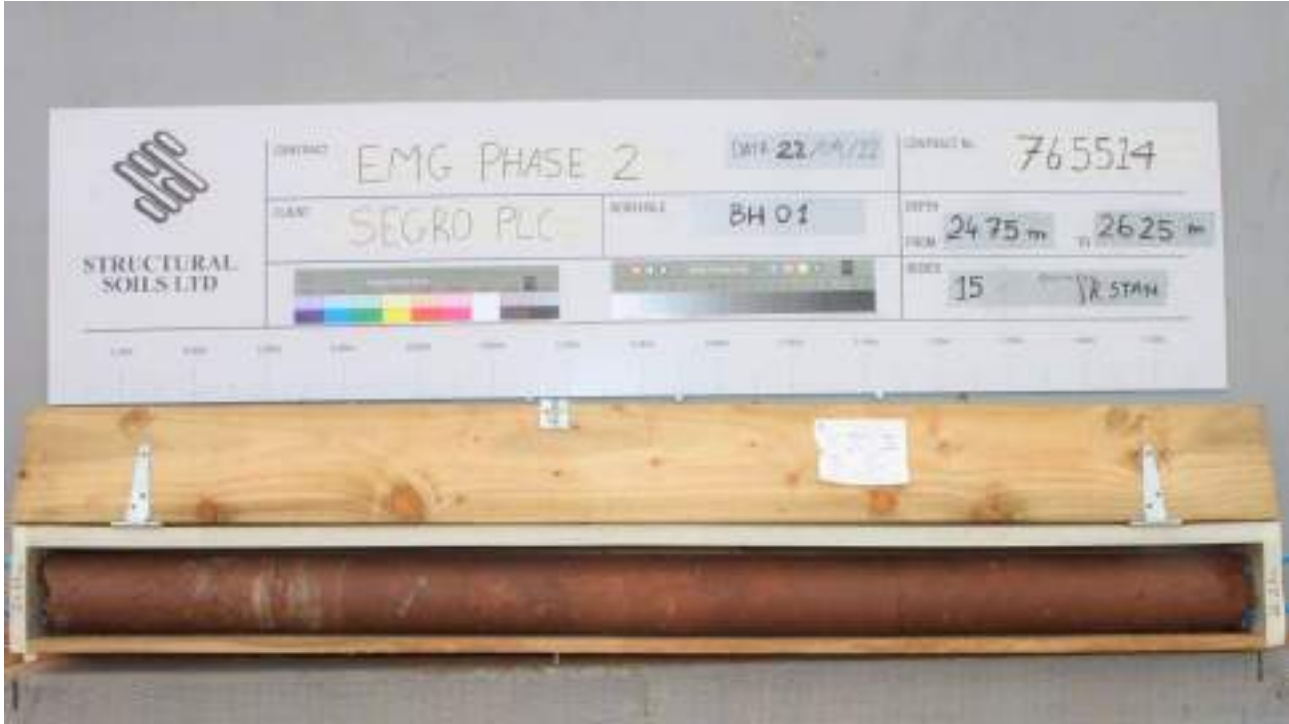
Contract: EMG Phase 2			Client: SEGRO	Borehole: BH01
Contract Ref: 765514	Start: 05.09.22 End: 13.09.22	Ground Level (m AOD): 89.22	National Grid Co-ordinate: E:446551.3 N:325384.8	Sheet: 15 of 16

Method Used: Inspection pit + Cable Percussion + Rotary Cored	Plant Used: Dando 3000 Mark 2 + Comacchio GEO 601	Drilled By: Jonny Hutt + Sam Carter	Logged By: JAlton + RStan	Checked By: AS	AGS
---	---	-------------------------------------	---------------------------	----------------	-----

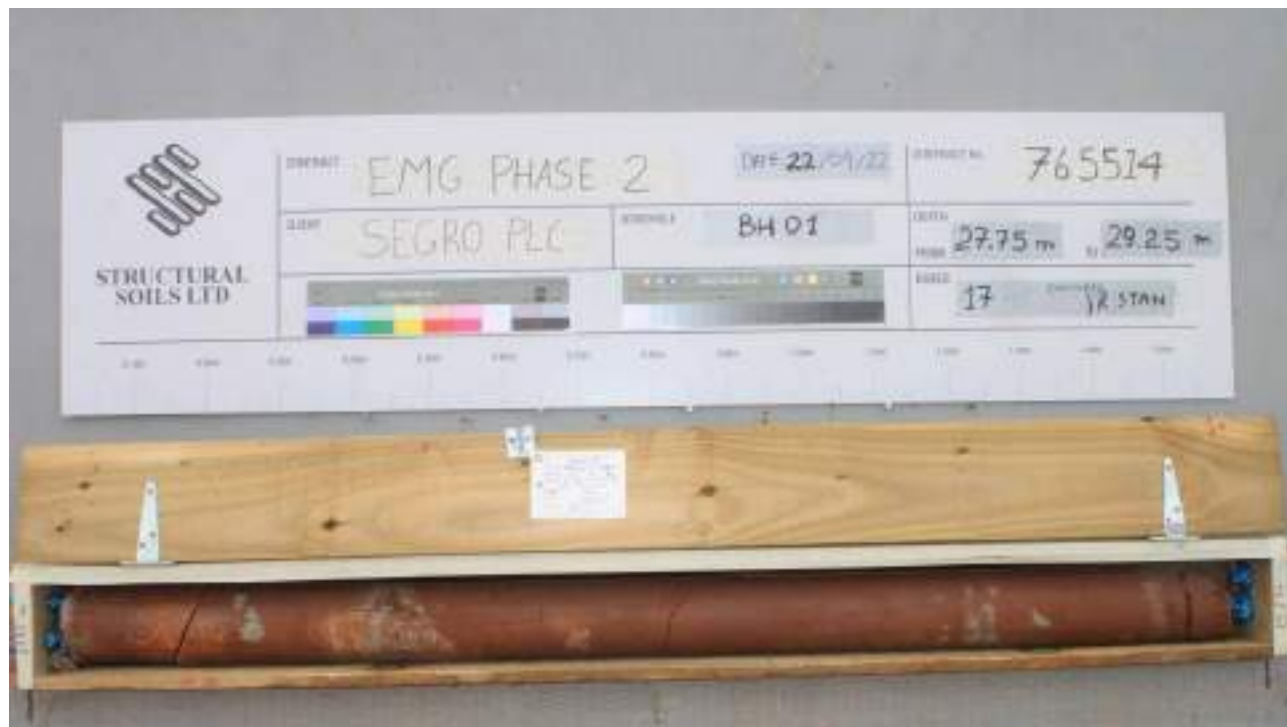
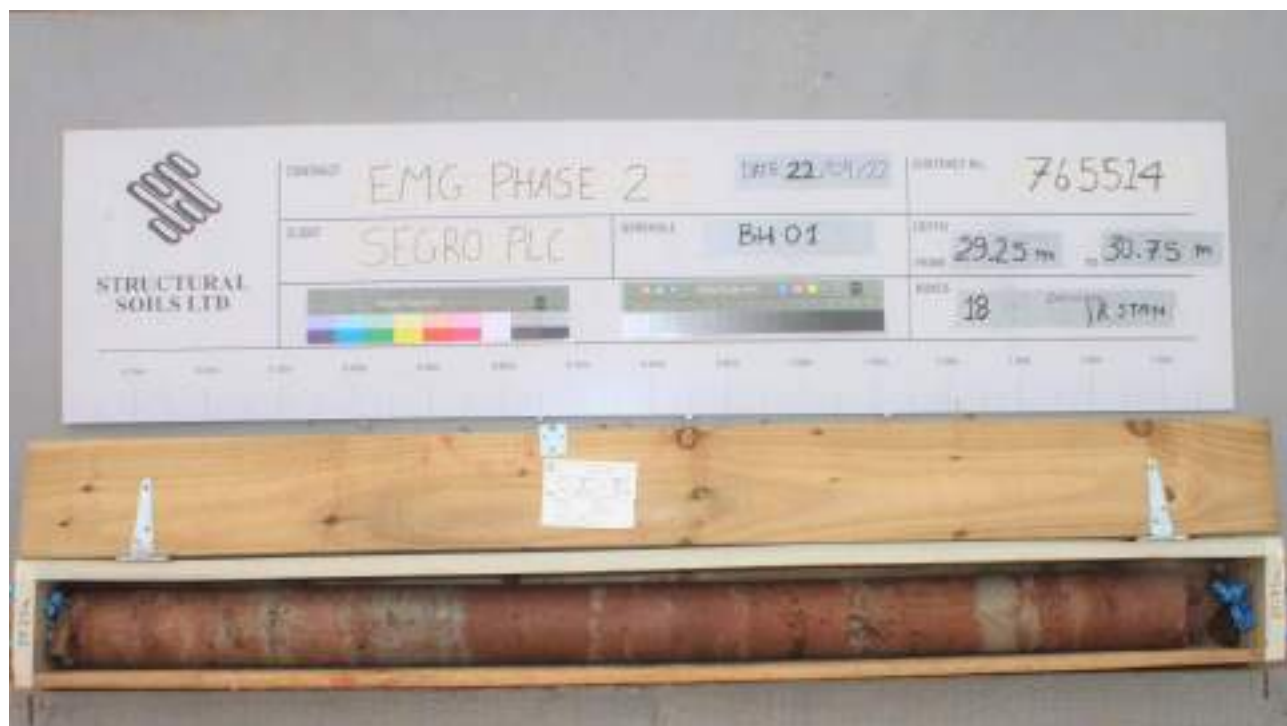
Contract: EMG Phase 2		Client: SEGRO		Borehole: BH01
Contract Ref: 765514	Start: 05.09.22 End: 13.09.22	Ground Level (m AOD): 89.22	National Grid Co-ordinate: E:446551.3 N:325384.8	Sheet: 16 of 16

Method Used: Inspection pit + Cable Percussion + Rotary Cored	Plant Used: Dando 3000 Mark 2 + Comacchio GEO 601	Drilled By: Jonny Hutt + Sam Carter	Logged By: JAlton + RStan	Checked By: AS	AGS
---	---	-------------------------------------	---------------------------	----------------	-----

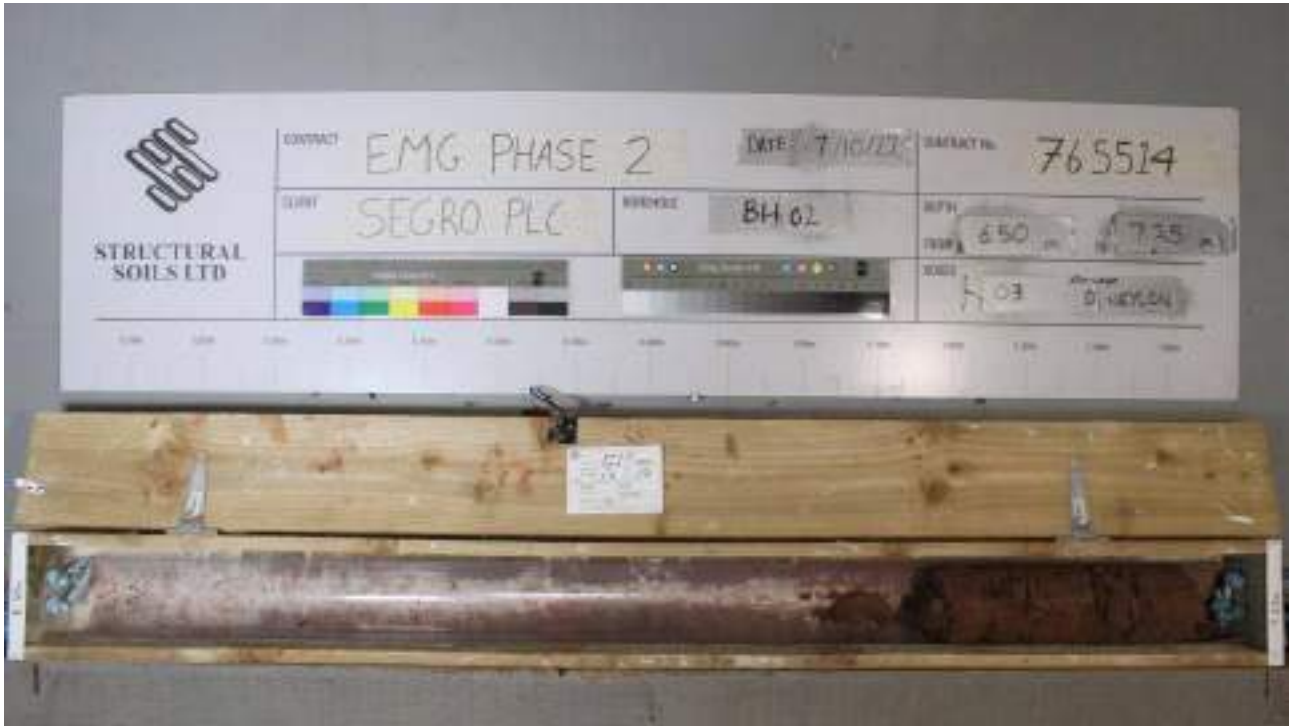
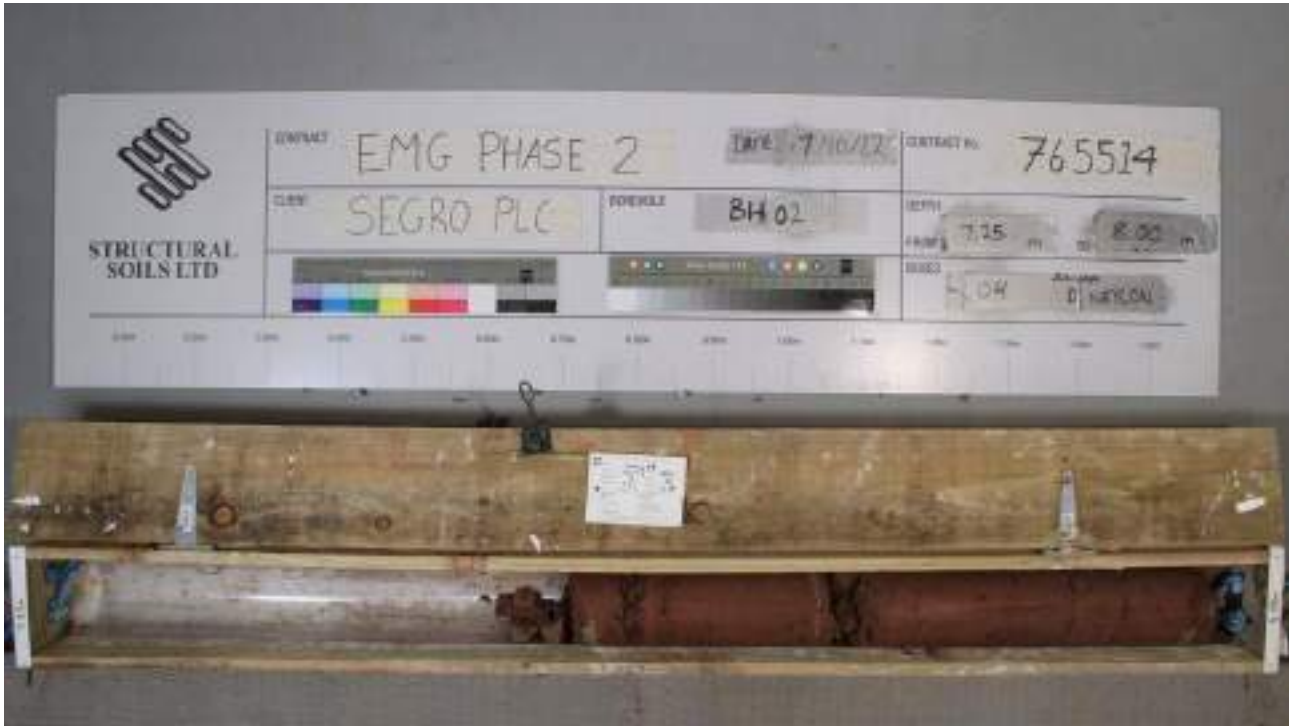
Contract: EMG Phase 2			Client: SEGRO	Borehole: BH02
Contract Ref: 765514	Start: 06.09.22 End: 15.09.22	Ground Level (m AOD): 90.55	National Grid Co-ordinate: E:446375.9 N:325257.4	Sheet: 7 of 12

Method Used: Inspection pit + Cable Percussion + Rotary Cored	Plant Used: Dando 3000 + Comacchio GEO 601	Drilled By: Jonny Hutt + Sam Carter	Logged By: D.Neylon + J.Aiton	Checked By: AS	AGS
---	--	-------------------------------------	-------------------------------	----------------	-----

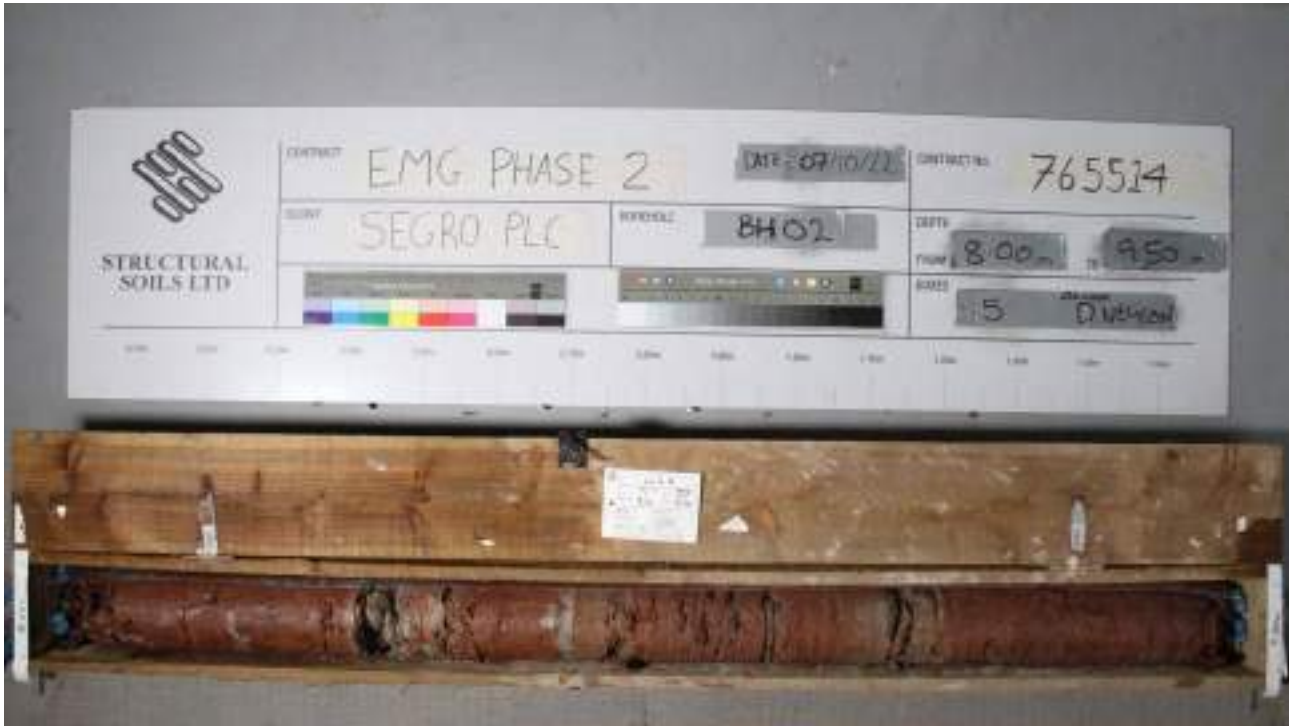
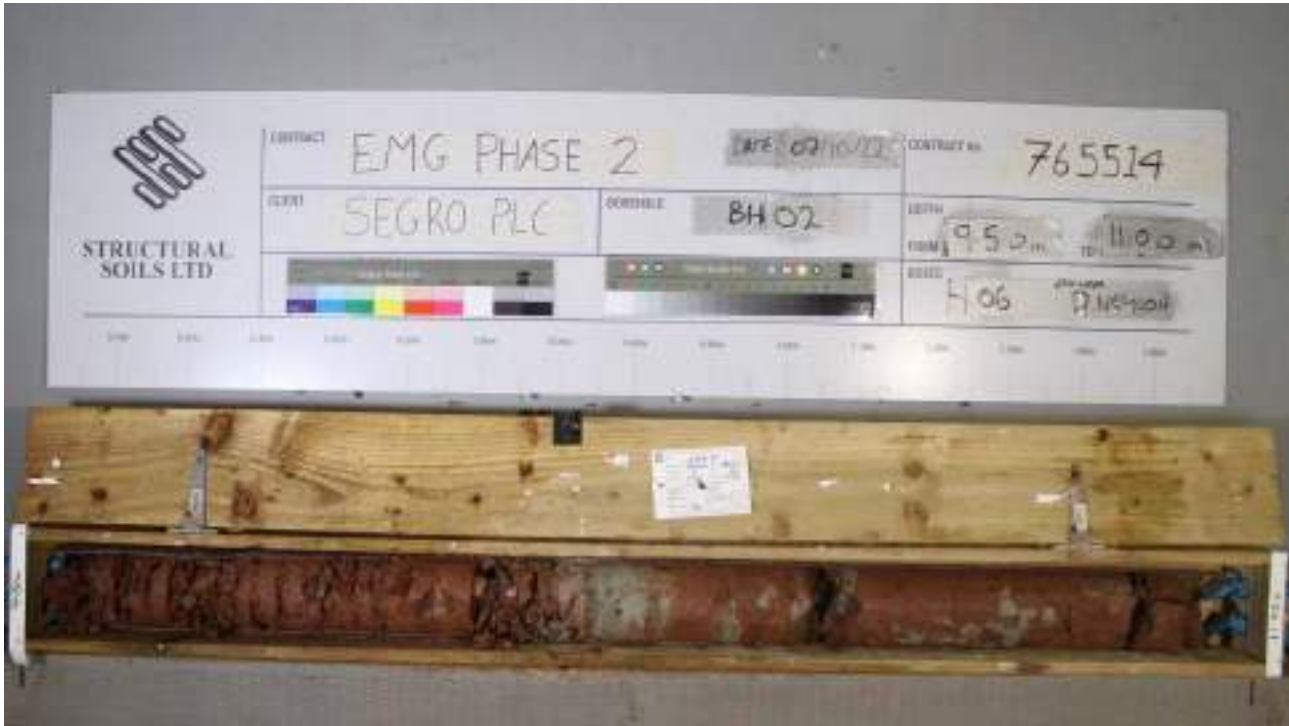
Contract: EMG Phase 2			Client: SEGRO	Borehole: BH02
Contract Ref: 765514	Start: 06.09.22 End: 15.09.22	Ground Level (m AOD): 90.55	National Grid Co-ordinate: E:446375.9 N:325257.4	Sheet: 8 of 12

Method Used: Inspection pit + Cable Percussion + Rotary Cored	Plant Used: Dando 3000 + Comacchio GEO 601	Drilled By: Jonny Hutt + Sam Carter	Logged By: DNeylon + JAlton	Checked By: AS	AGS
---	--	-------------------------------------	-----------------------------	----------------	-----

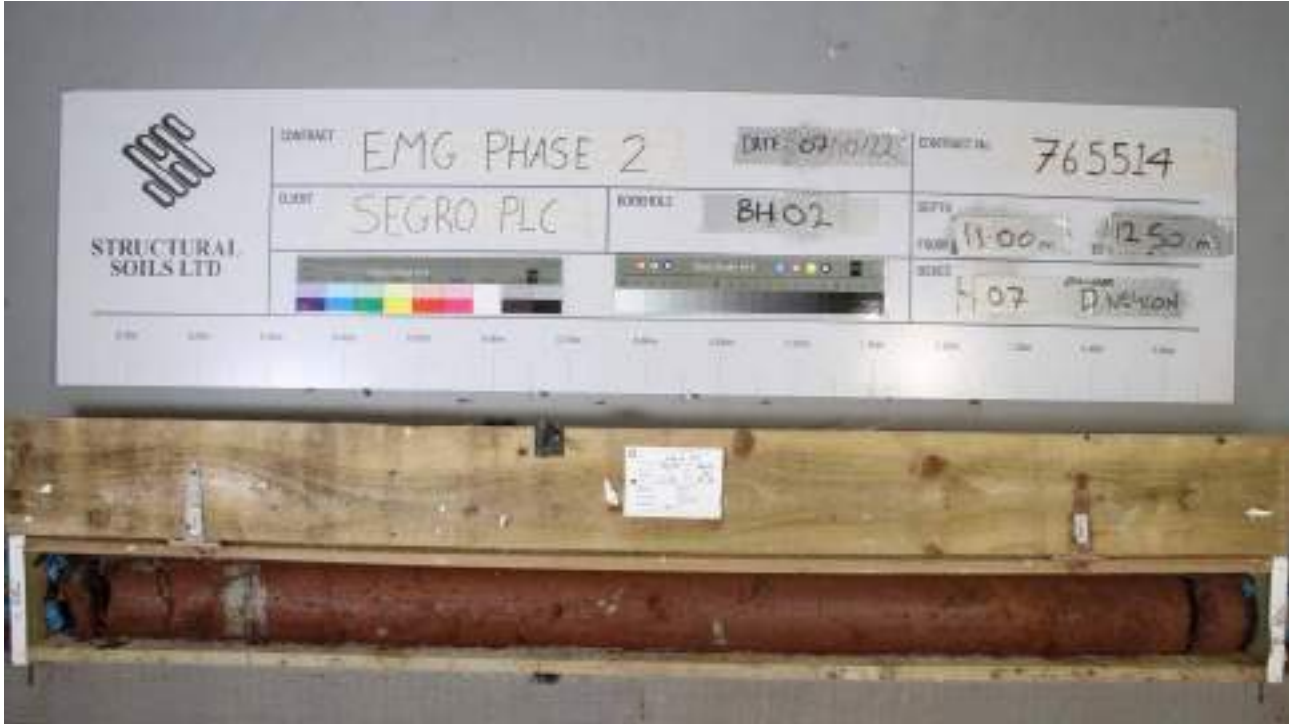
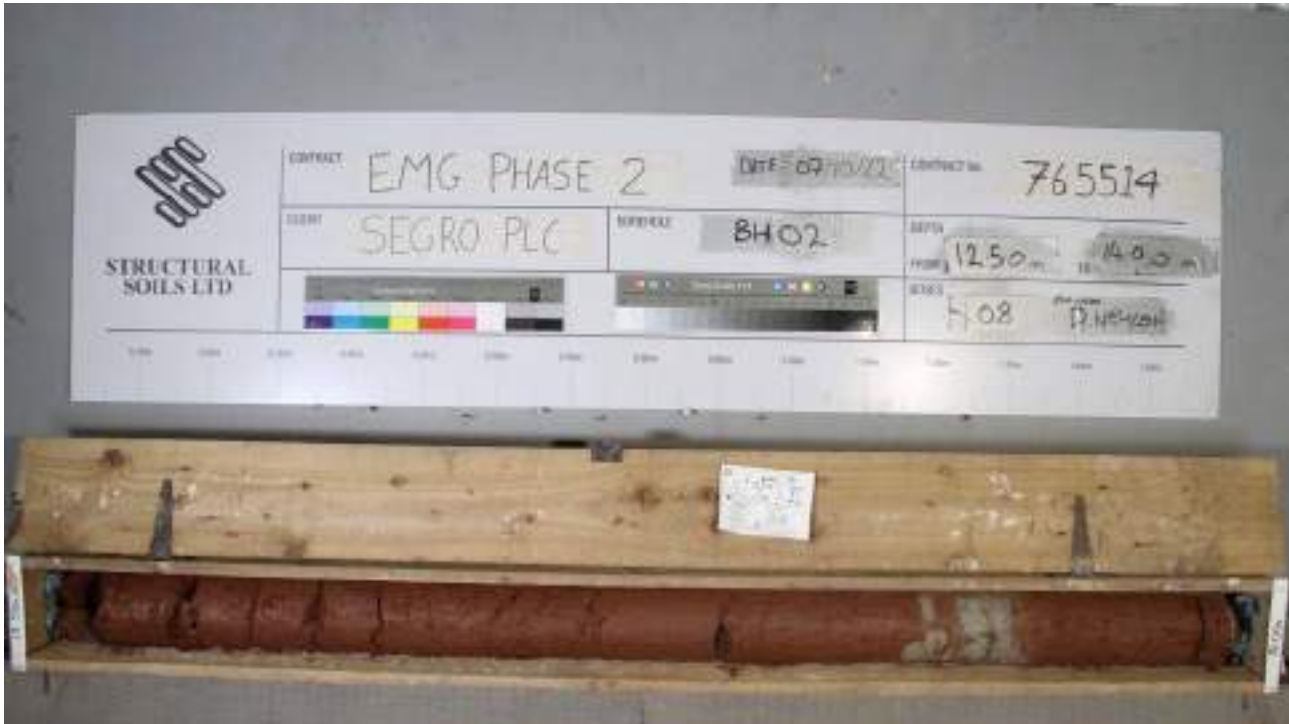
Contract: EMG Phase 2		Client: SEGRO		Borehole: BH02
Contract Ref: 765514	Start: 06.09.22 End: 15.09.22	Ground Level (m AOD): 90.55	National Grid Co-ordinate: E:446375.9 N:325257.4	Sheet: 9 of 12

Method Used: Inspection pit + Cable Percussion + Rotary Cored	Plant Used: Dando 3000 + Comacchio GEO 601	Drilled By: Jonny Hutt + Sam Carter	Logged By: DNeylon + JAlton	Checked By: AS	AGS
--	---	--	--------------------------------	-------------------	-----
