**East Midlands Gateway
Phase 2 (EMG2)**

Fairhurst Ground Investigation Report (EMG2)

Ground Investigation Report

East Midlands Gateway Phase 2,
Land South of East Midlands
Airport, Derby

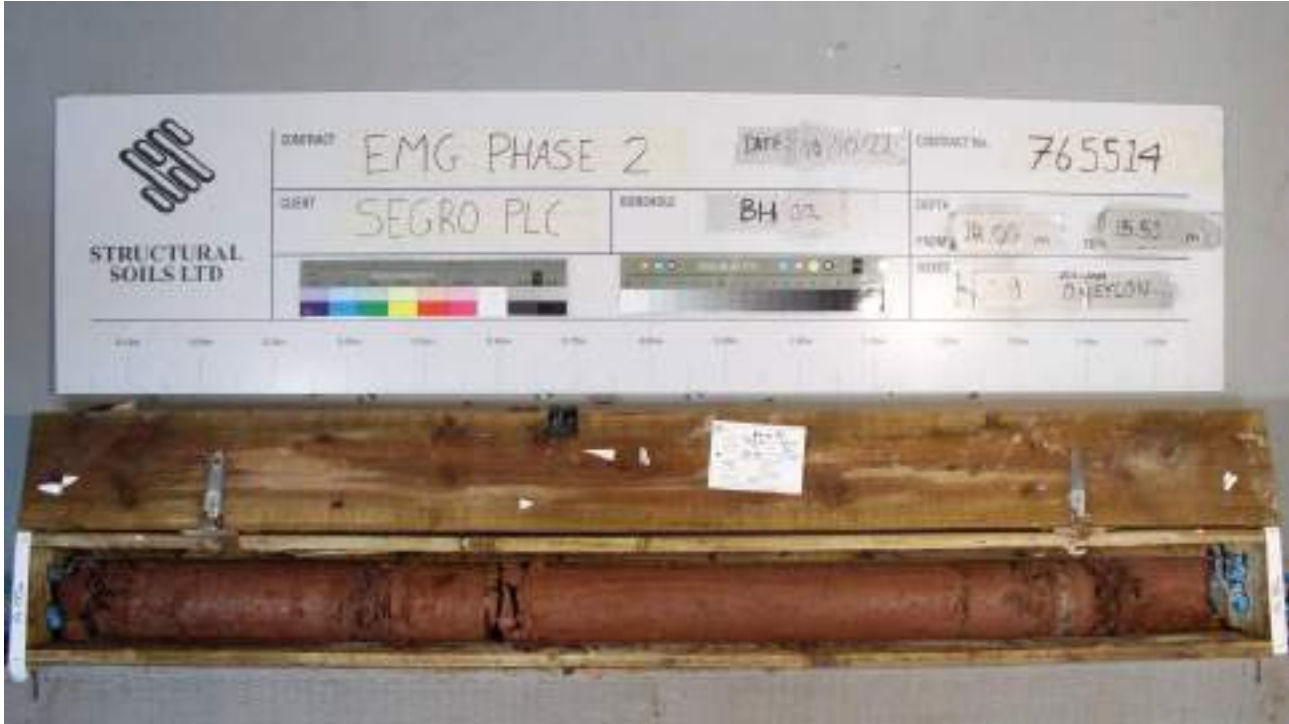
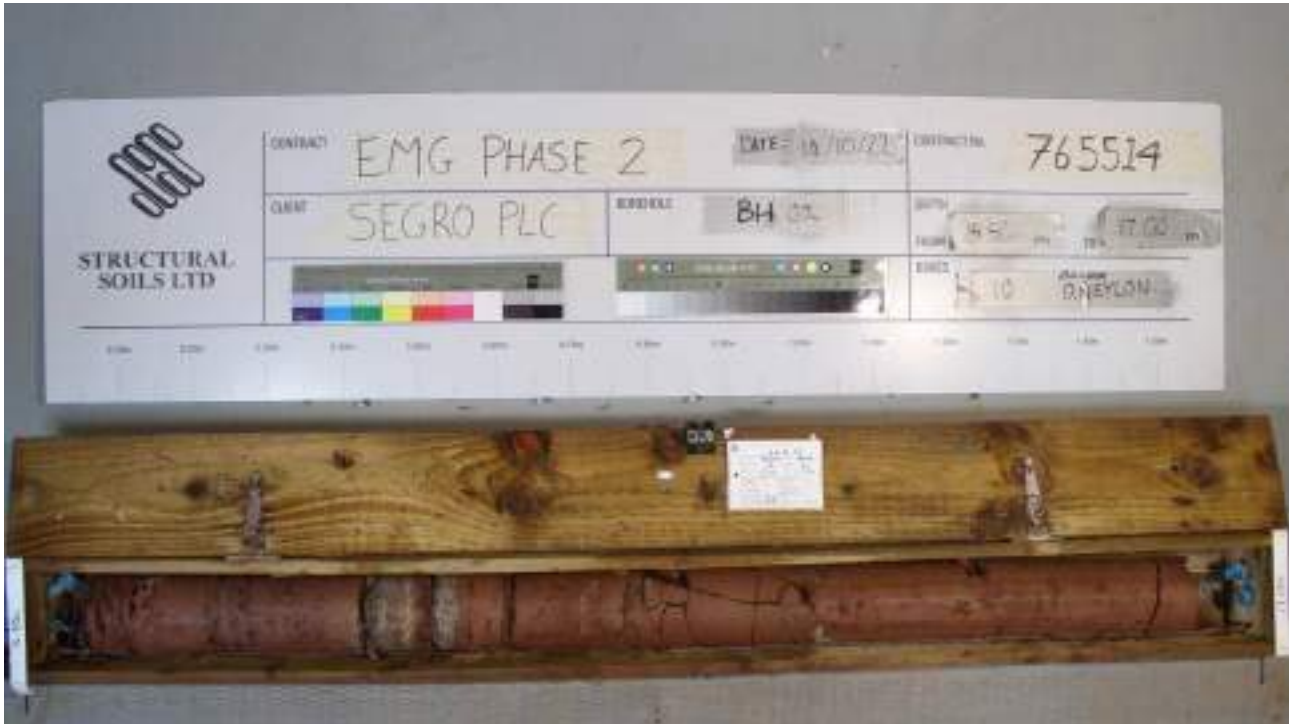
Contract: EMG Phase 2			Client: SEGRO	Borehole: BH02
Contract Ref: 765514	Start: 06.09.22 End: 15.09.22	Ground Level (m AOD): 90.55	National Grid Co-ordinate: E:446375.9 N:325257.4	Sheet: 10 of 12

Method Used: Inspection pit + Cable Percussion + Rotary Cored	Plant Used: Dando 3000 + Comacchio GEO 601	Drilled By: Jonny Hutt + Sam Carter	Logged By: D.Neylon + J.Aiton	Checked By: AS	AGS
---	--	-------------------------------------	-------------------------------	----------------	-----

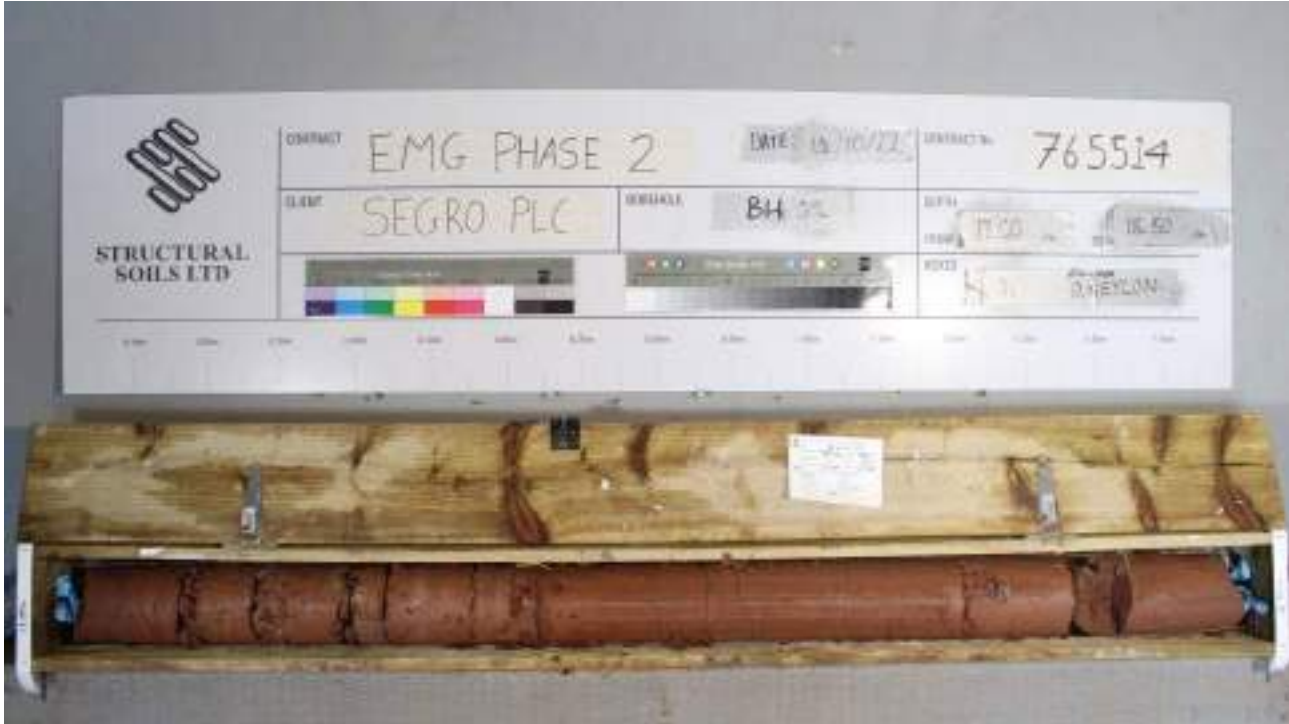
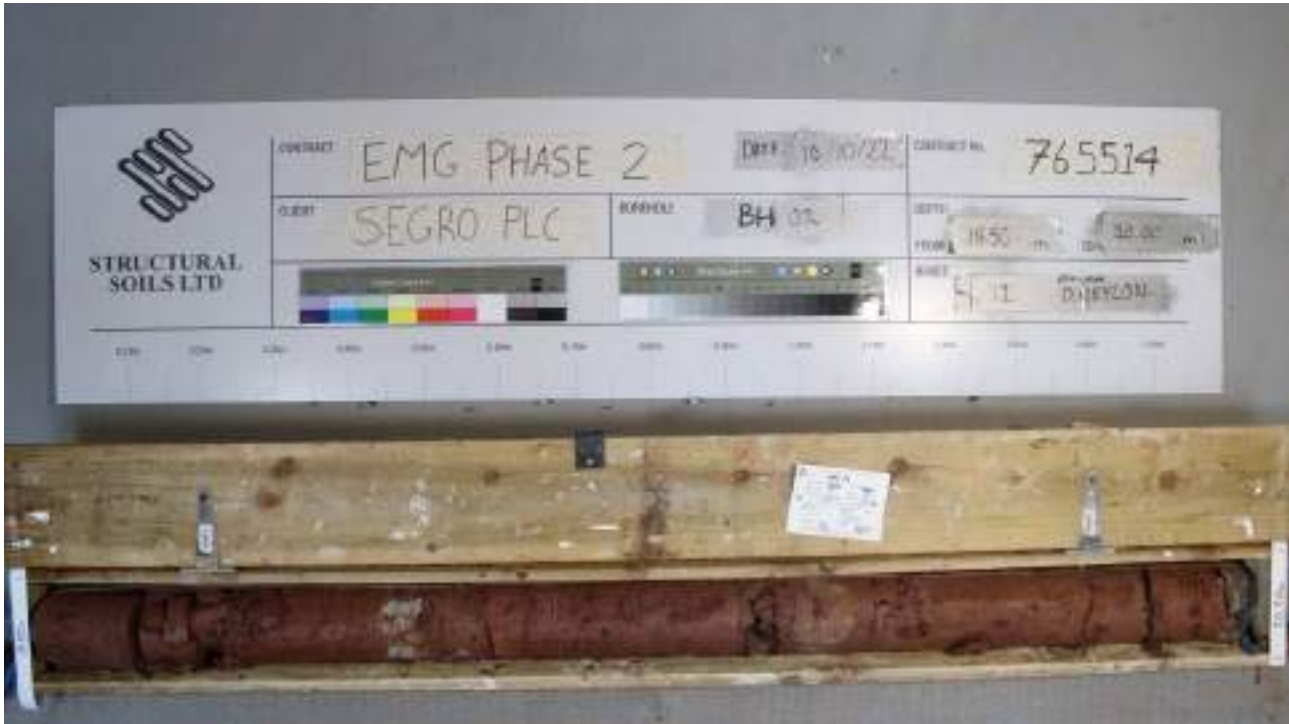
Contract: EMG Phase 2			Client: SEGRO	Borehole: BH02
Contract Ref: 765514	Start: 06.09.22 End: 15.09.22	Ground Level (m AOD): 90.55	National Grid Co-ordinate: E:446375.9 N:325257.4	Sheet: 11 of 12

Method Used: Inspection pit + Cable Percussion + Rotary Cored	Plant Used: Dando 3000 + Comacchio GEO 601	Drilled By: Jonny Hutt + Sam Carter	Logged By: DNeylon + JAlton	Checked By: AS	AGS
---	--	-------------------------------------	-----------------------------	----------------	-----

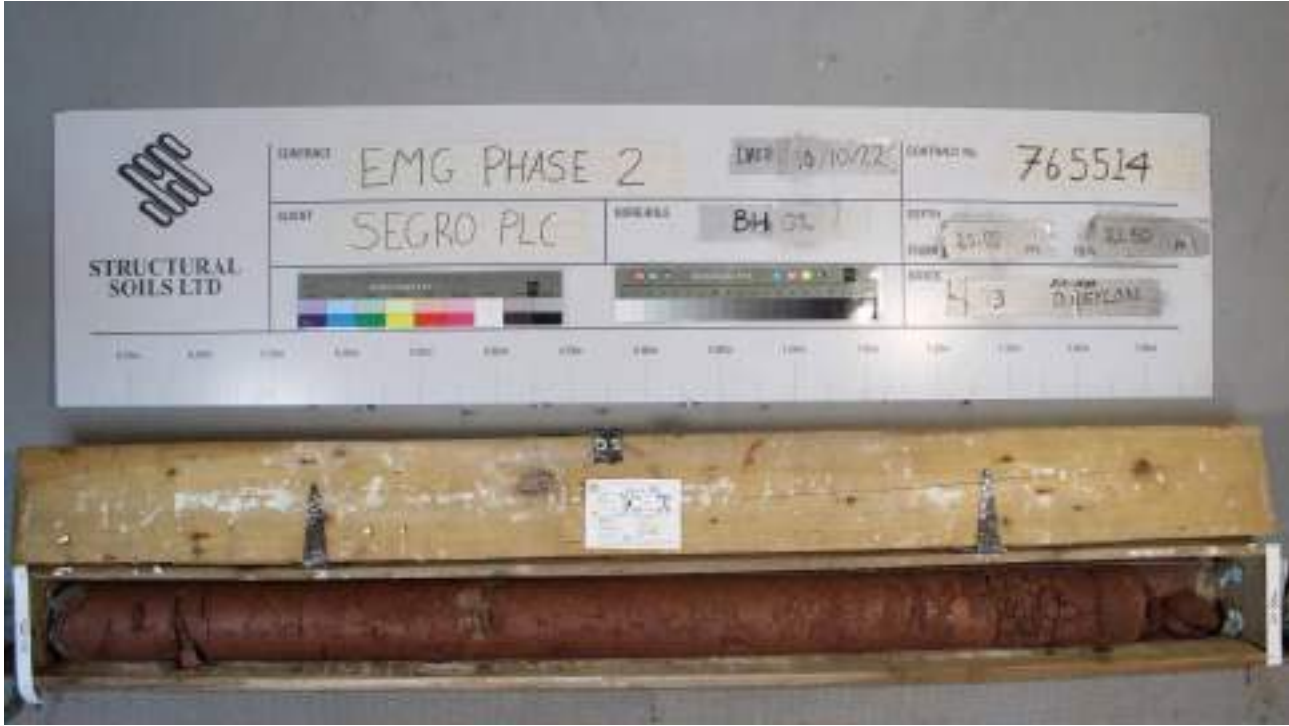
Contract: EMG Phase 2			Client: SEGRO		Borehole: BH02
Contract Ref: 765514	Start: 06.09.22 End: 15.09.22	Ground Level (m AOD): 90.55	National Grid Co-ordinate: E:446375.9 N:325257.4		Sheet: 12 of 12

Method Used: Inspection pit + Cable Percussion + Rotary Cored	Plant Used: Dando 3000 + Comacchio GEO 601	Drilled By: Jonny Hutt + Sam Carter	Logged By: DNeylon + JAlton	Checked By: AS	AGS
---	--	-------------------------------------	-----------------------------	----------------	-----

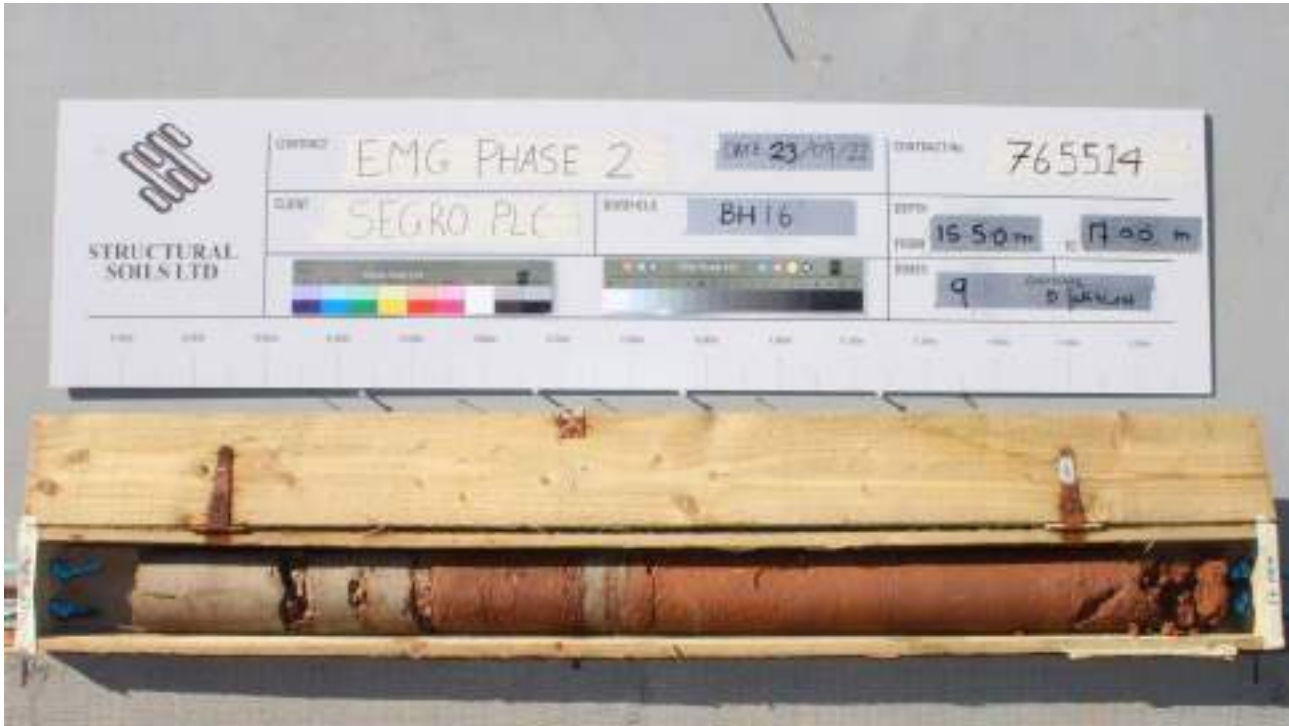
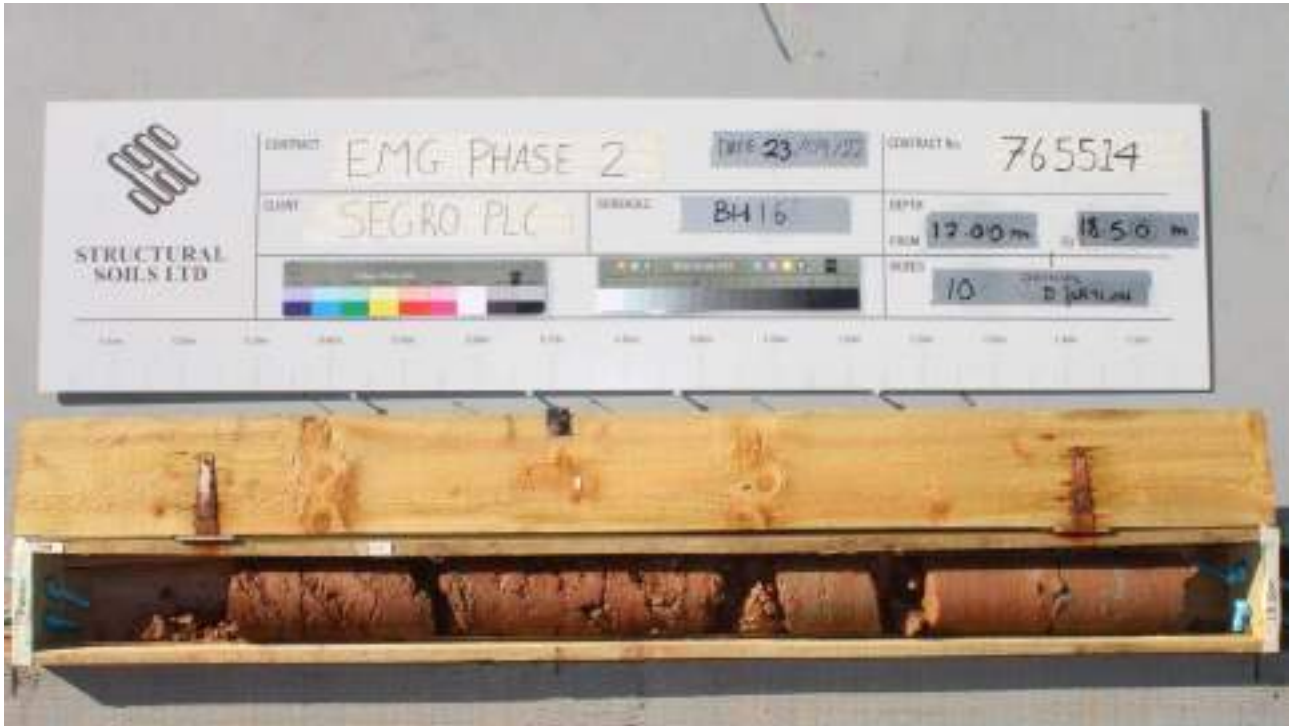
Contract: EMG Phase 2			Client: SEGRO	Borehole: BH16
Contract Ref: 765514	Start: 15.09.22 End: 15.09.22	Ground Level (m AOD): 73.98	National Grid Co-ordinate: E:446488.6 N:324866.7	Sheet: 10 of 11

Method Used: Inspection pit + Cable Percussion + Rotary Cored	Plant Used: Dando 3000 + Comacchio GEO 205	Drilled By: Jonny Hutt + Luke Bamford	Logged By: DNartey + DNeylon	Checked By: AS	AGS
---	--	---------------------------------------	------------------------------	----------------	-----

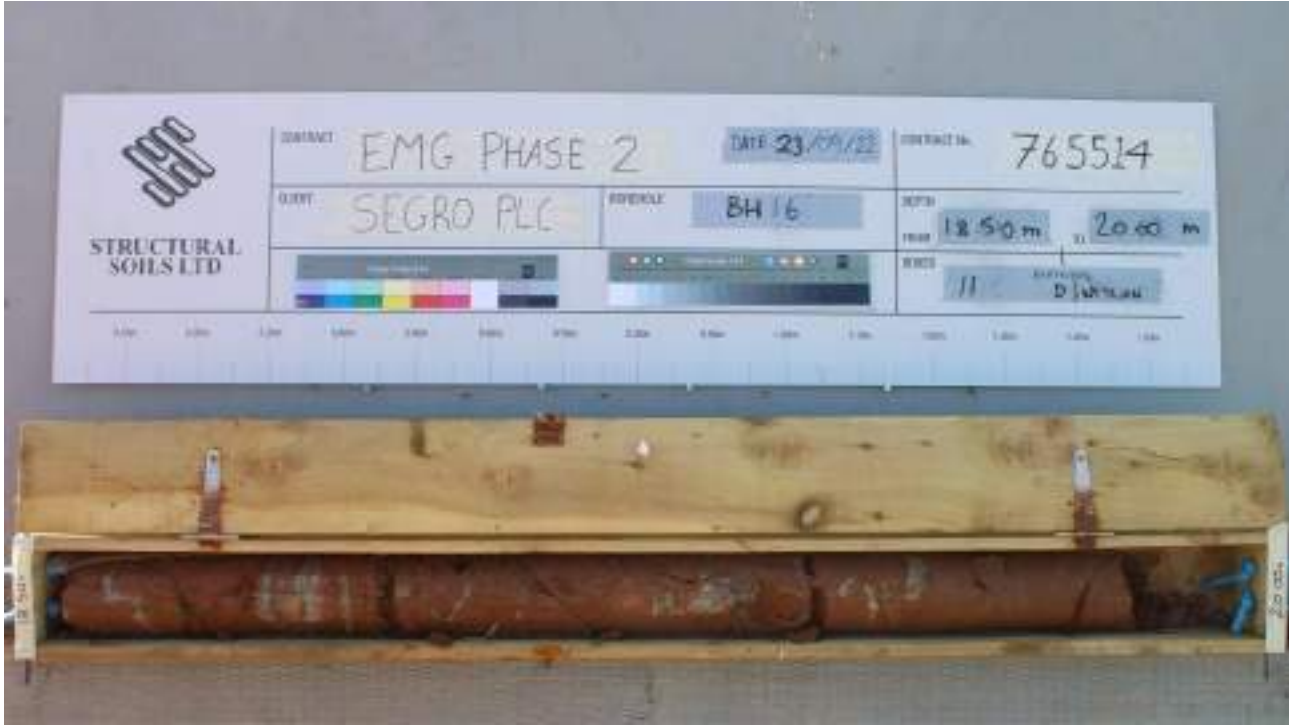
Contract: EMG Phase 2		Client: SEGRO		Borehole: BH16
Contract Ref: 765514	Start: 15.09.22 End: 15.09.22	Ground Level (m AOD): 73.98	National Grid Co-ordinate: E:446488.6 N:324866.7	Sheet: 11 of 11

Method Used: Inspection pit + Cable Percussion + Rotary Cored	Plant Used: Dando 3000 + Comacchio GEO 205	Drilled By: Jonny Hutt + Luke Bamford	Logged By: DNartey + DNeylon	Checked By: AS	AGS
---	--	---------------------------------------	------------------------------	----------------	-----

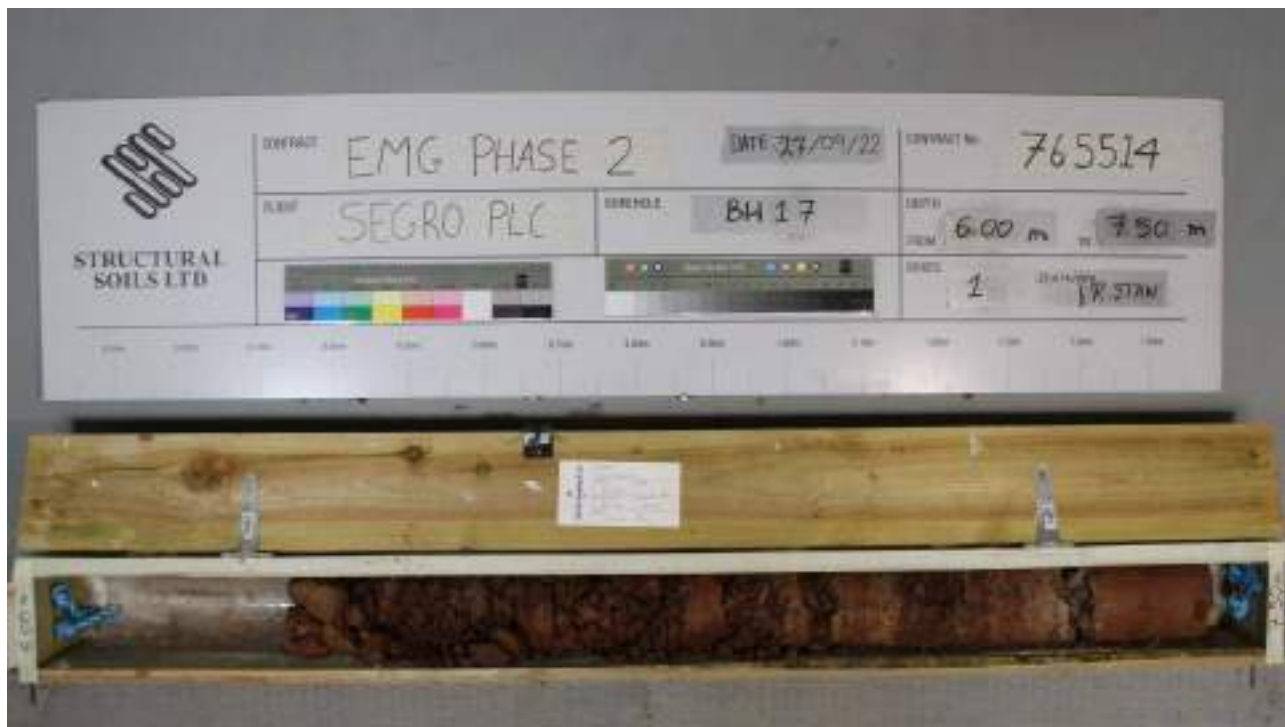
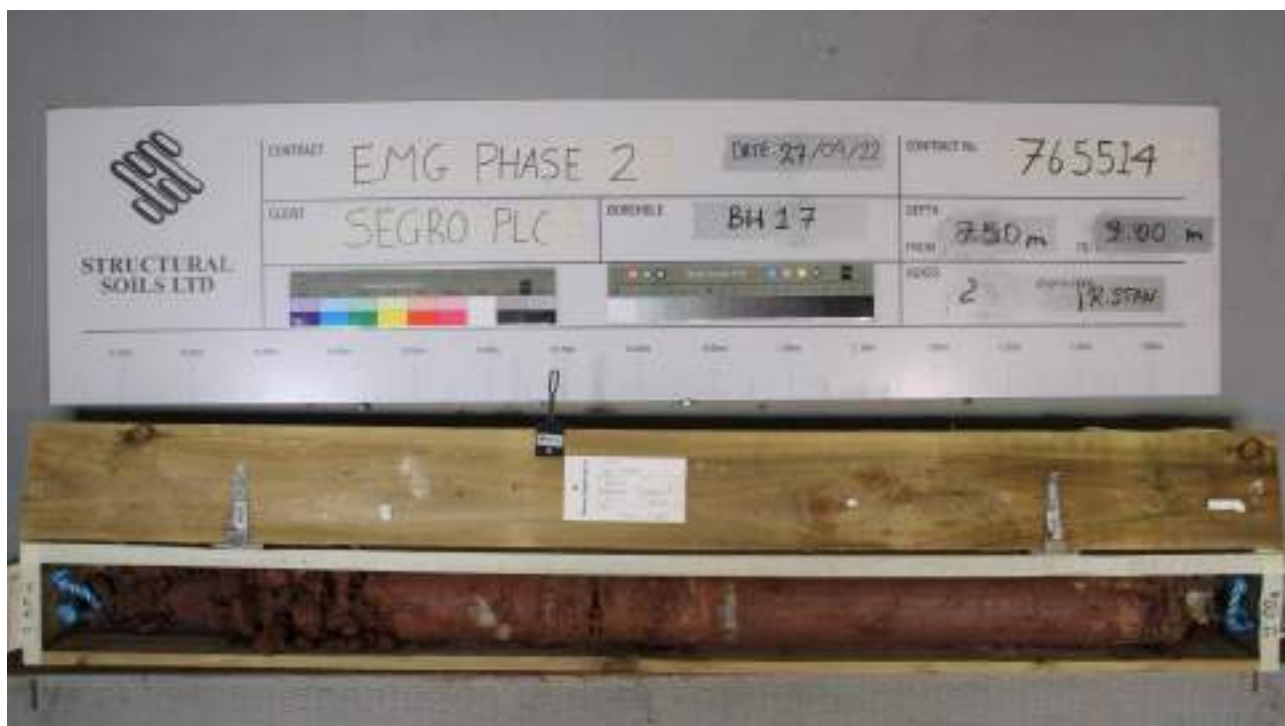
Contract: EMG Phase 2		Client: SEGRO		Borehole: BH17
Contract Ref: 765514	Start: 15.09.22 End: 16.09.22	Ground Level (m AOD): 74.45	National Grid Co-ordinate: E:446293.6 N:324881.8	Sheet: 6 of 10

Method Used: Inspection pit + Cable Percussion + Rotary Cored	Plant Used: Dando 3000 + Comacchio GEO 205	Drilled By: Jonny Hutt + Martin Speedie	Logged By: DNartey + RStan	Checked By: AS	AGS
---	--	---	----------------------------	----------------	-----

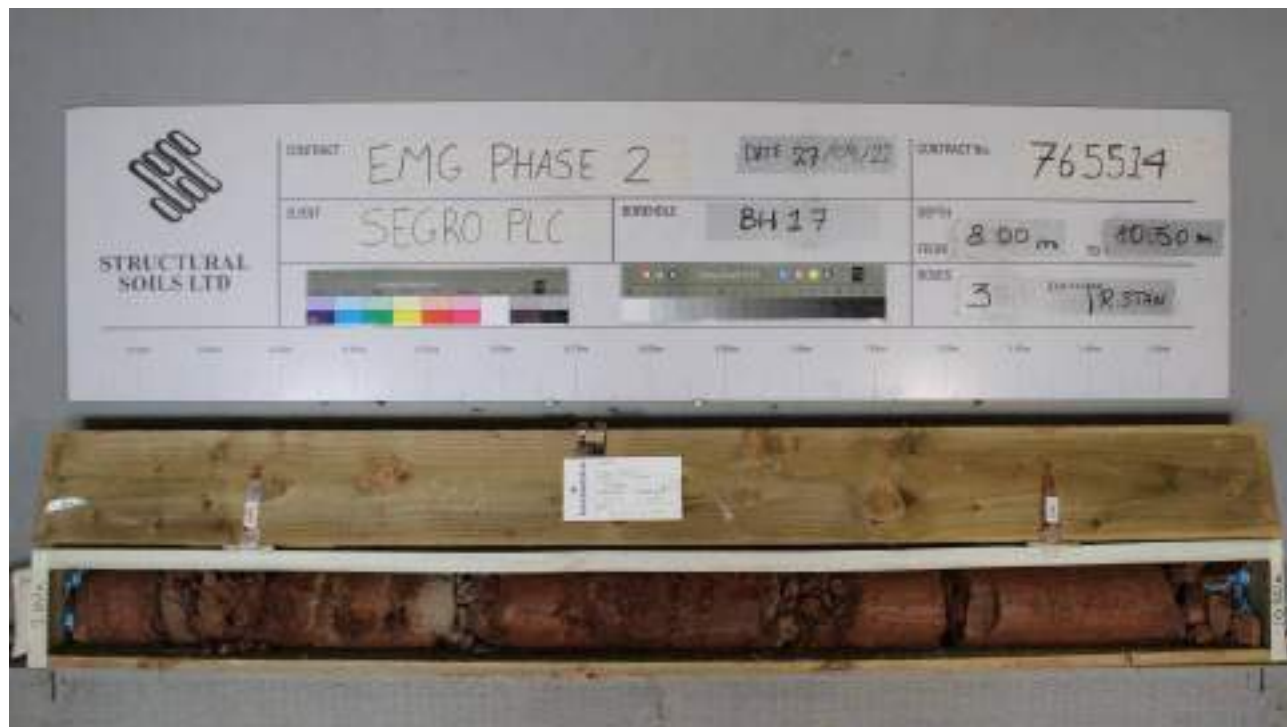
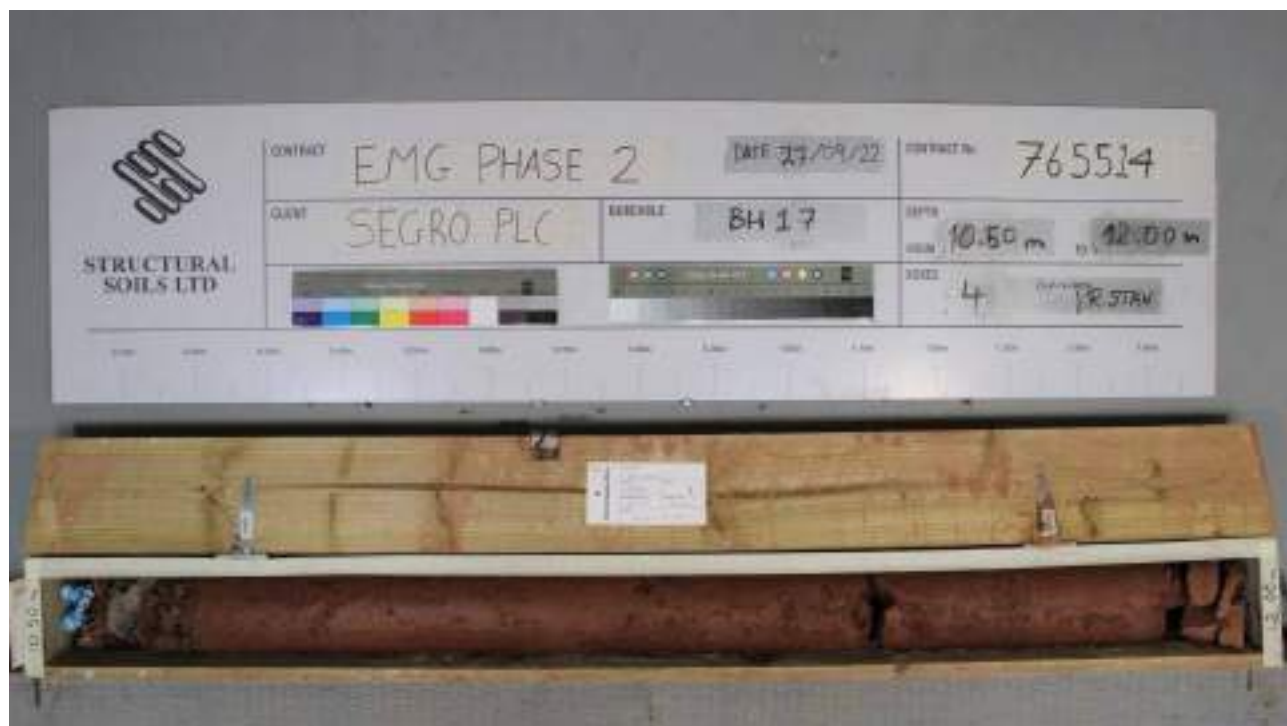
Contract: EMG Phase 2		Client: SEGRO		Borehole: BH17
Contract Ref: 765514	Start: 15.09.22 End: 16.09.22	Ground Level (m AOD): 74.45	National Grid Co-ordinate: E:446293.6 N:324881.8	Sheet: 7 of 10

Method Used: Inspection pit + Cable Percussion + Rotary Cored	Plant Used: Dando 3000 + Comacchio GEO 205	Drilled By: Jonny Hutt + Martin Speedie	Logged By: DNartey + RStan	Checked By: AS	AGS
---	--	---	----------------------------	----------------	-----

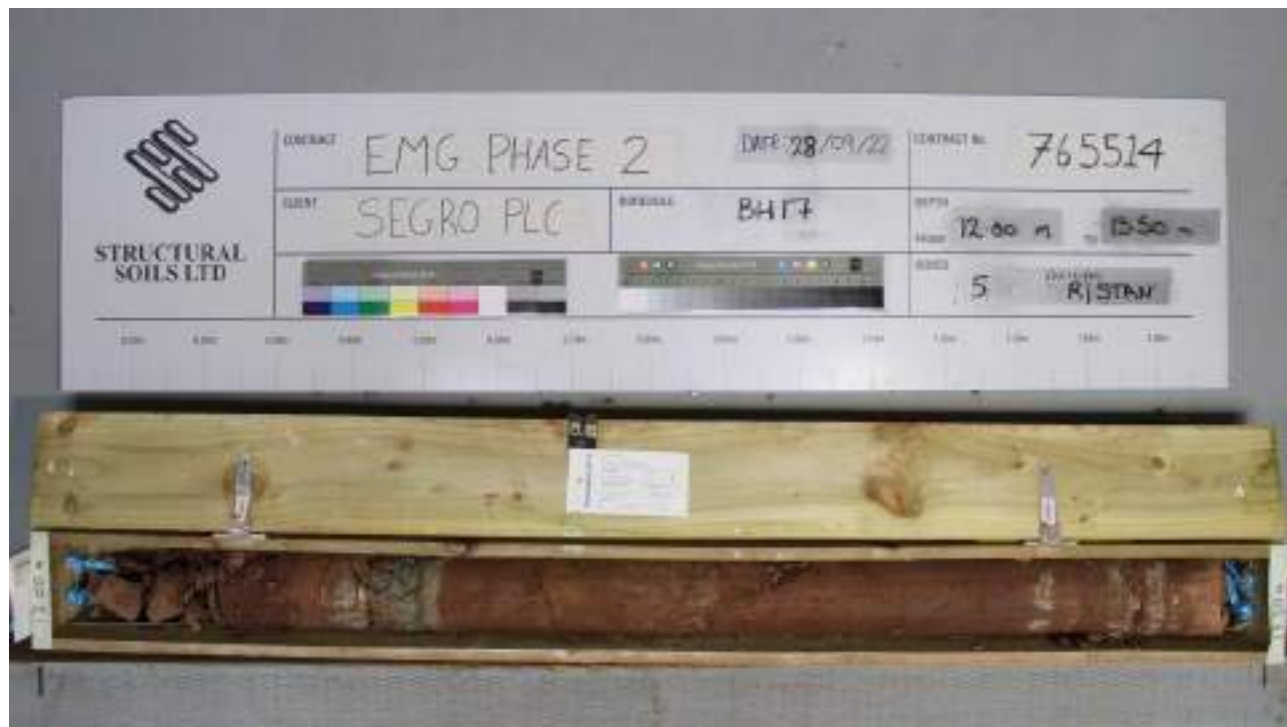
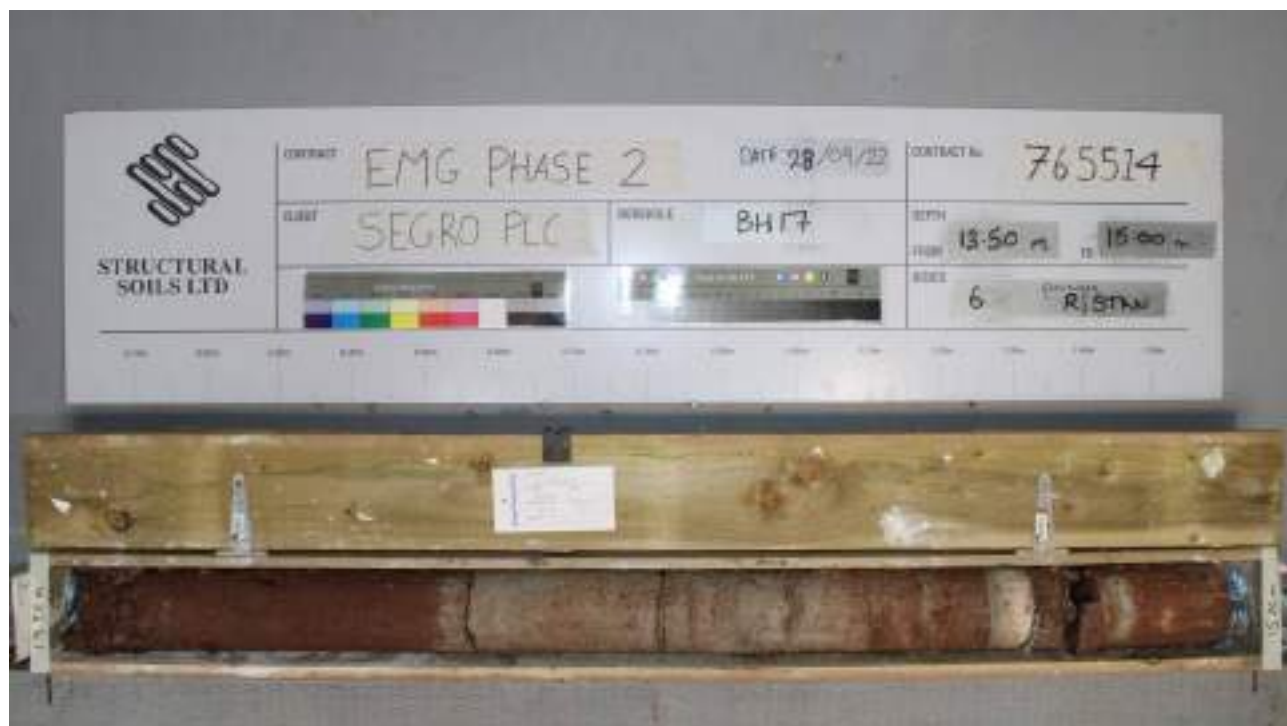
Contract: EMG Phase 2		Client: SEGRO		Borehole: BH17
Contract Ref: 765514	Start: 15.09.22 End: 16.09.22	Ground Level (m AOD): 74.45	National Grid Co-ordinate: E:446293.6 N:324881.8	Sheet: 8 of 10

Method Used: Inspection pit + Cable Percussion + Rotary Cored	Plant Used: Dando 3000 + Comacchio GEO 205	Drilled By: Jonny Hutt + Martin Speedie	Logged By: DNartey + RStan	Checked By: AS	AGS
---	--	---	----------------------------	----------------	-----

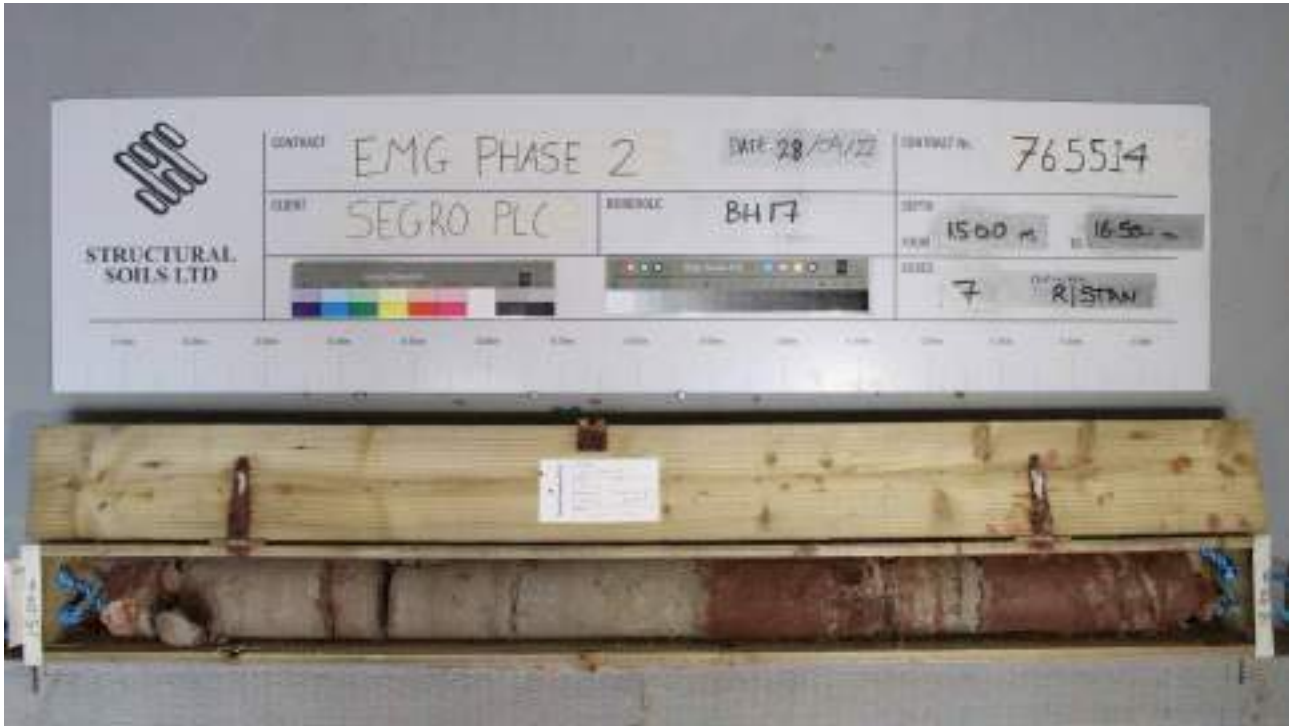
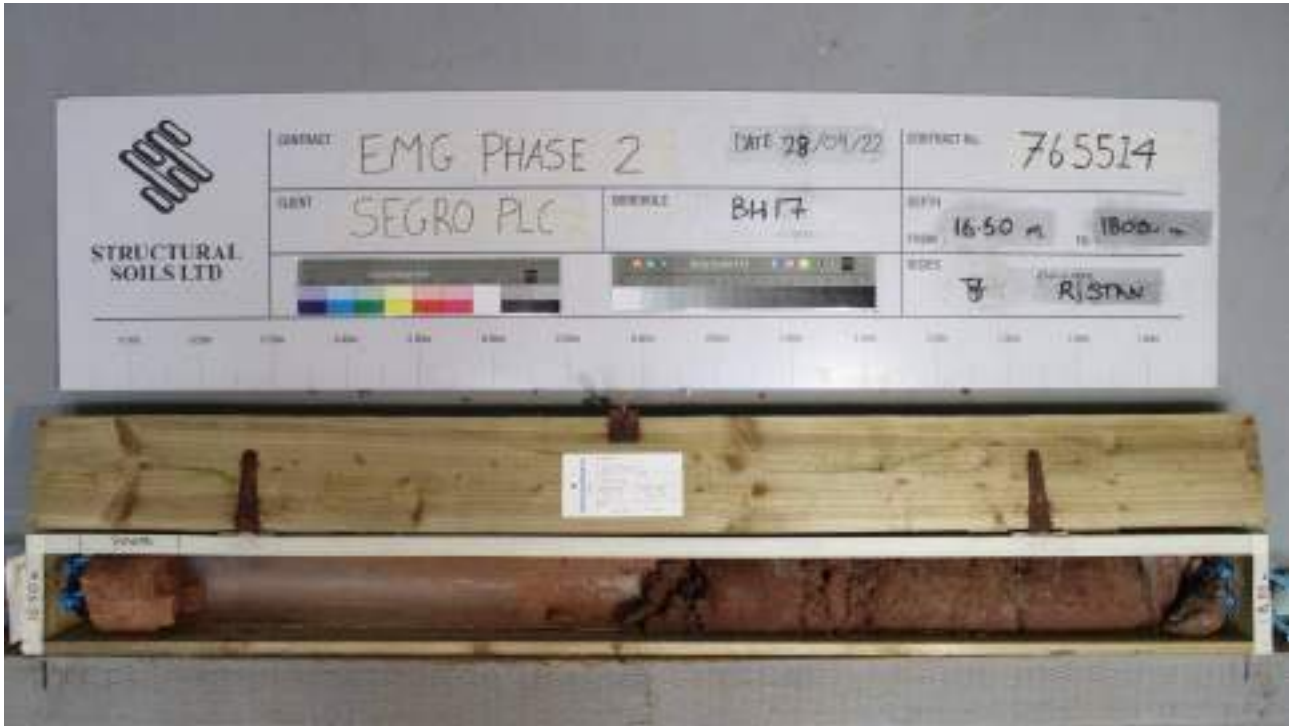
Contract: EMG Phase 2			Client: SEGRO	Borehole: BH17
Contract Ref: 765514	Start: 15.09.22 End: 16.09.22	Ground Level (m AOD): 74.45	National Grid Co-ordinate: E:446293.6 N:324881.8	Sheet: 9 of 10

Method Used: Inspection pit + Cable Percussion + Rotary Cored	Plant Used: Dando 3000 + Comacchio GEO 205	Drilled By: Jonny Hutt + Martin Speedie	Logged By: DNartey + RStan	Checked By: AS	AGS
---	--	---	----------------------------	----------------	-----

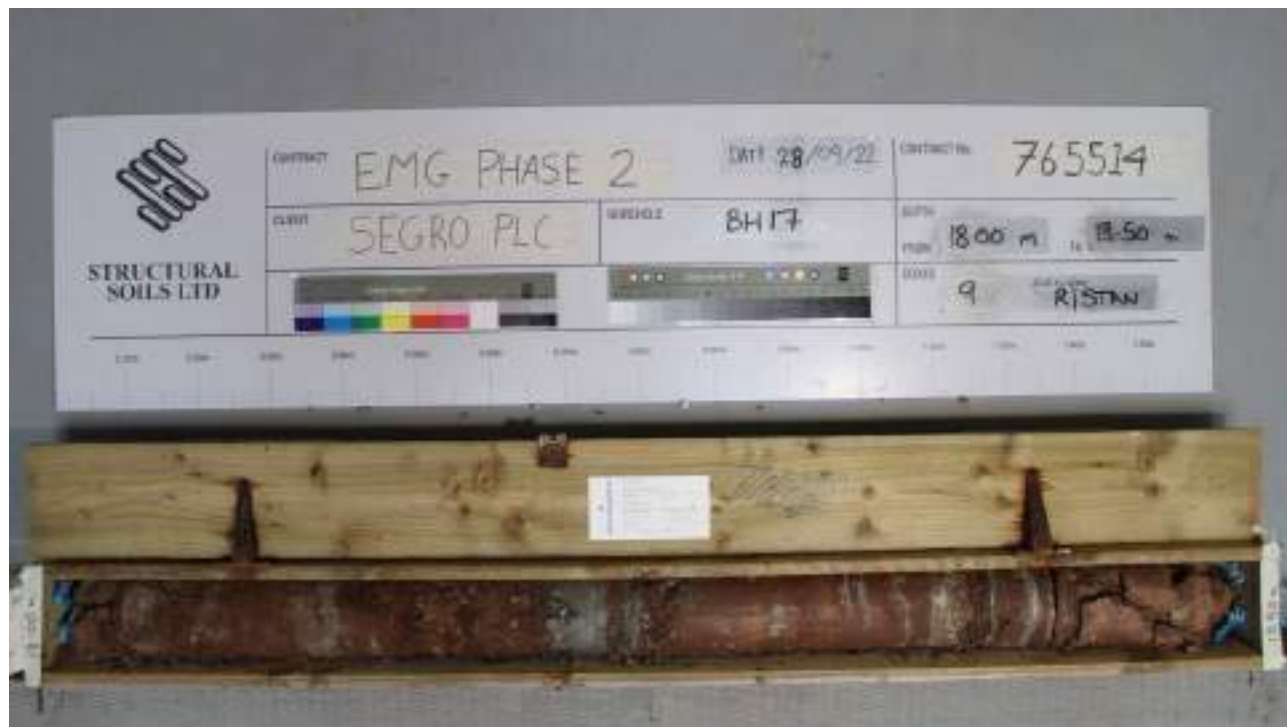
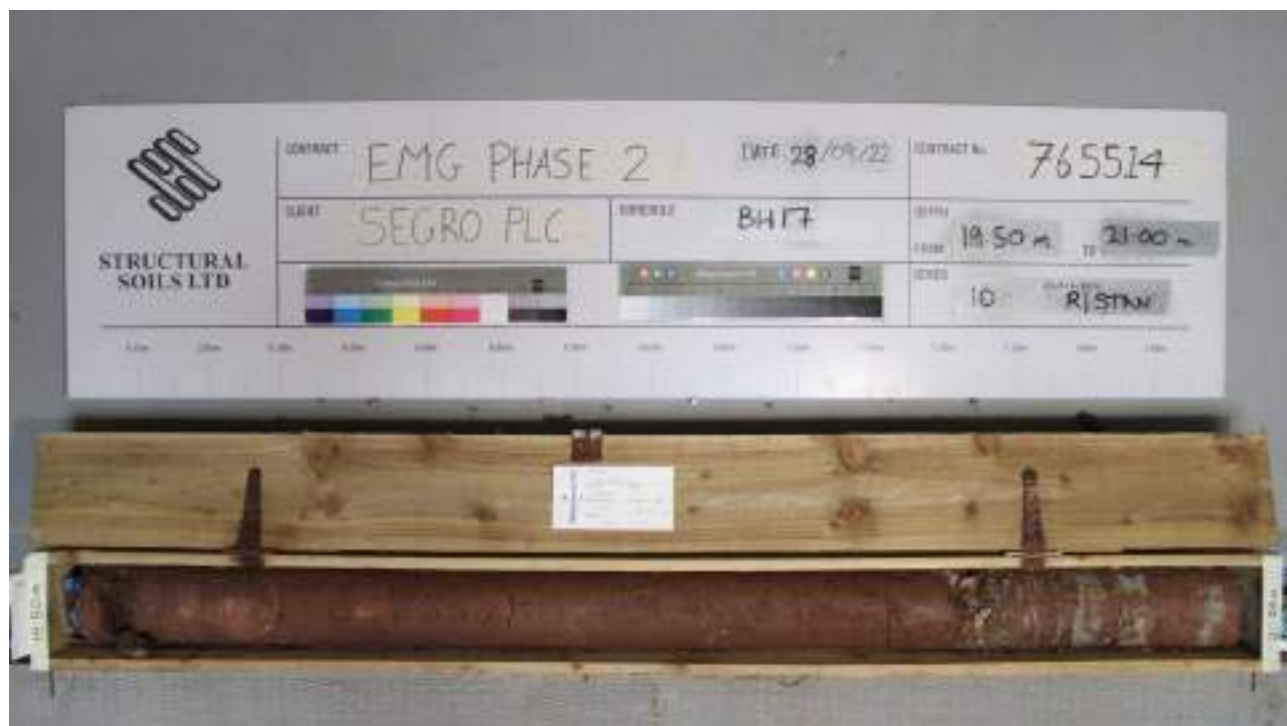
Contract: EMG Phase 2		Client: SEGRO		Borehole: BH17
Contract Ref: 765514	Start: 15.09.22 End: 16.09.22	Ground Level (m AOD): 74.45	National Grid Co-ordinate: E:446293.6 N:324881.8	Sheet: 10 of 10

Method Used: Inspection pit + Cable Percussion + Rotary Cored	Plant Used: Dando 3000 + Comacchio GEO 205	Drilled By: Jonny Hutt + Martin Speedie	Logged By: DNartey + RStan	Checked By: AS	AGS
---	--	---	----------------------------	----------------	-----

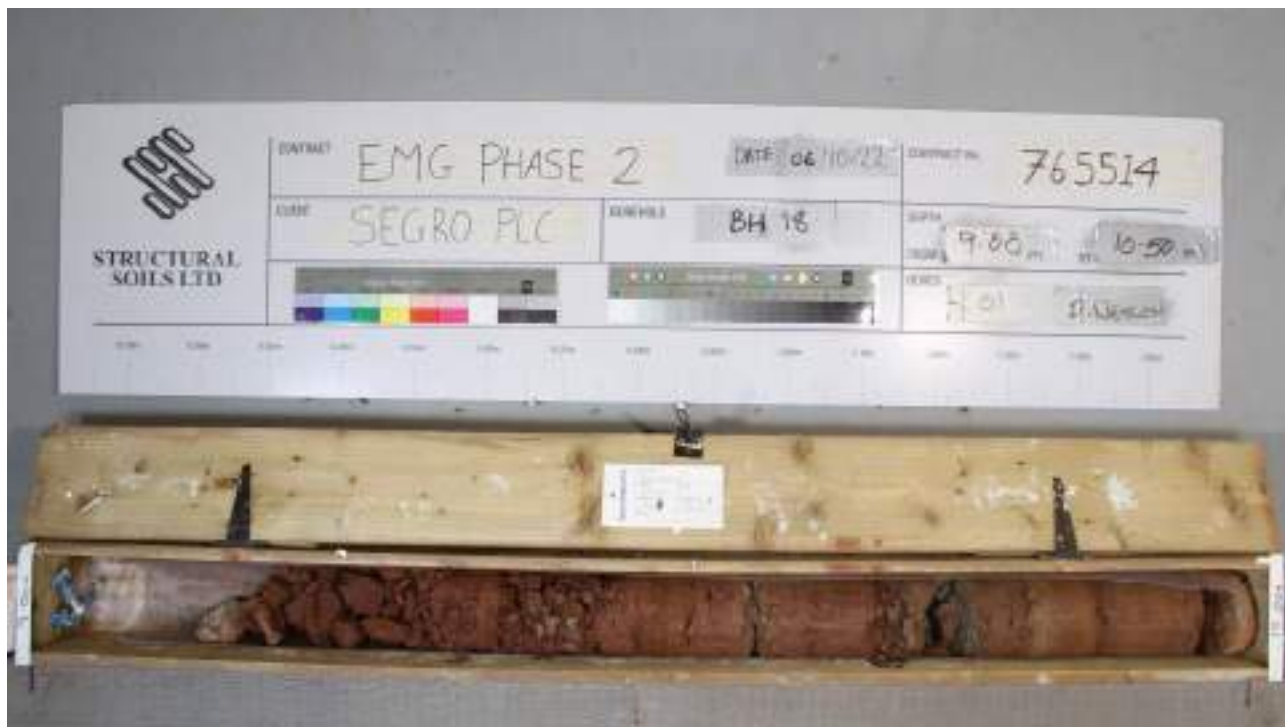
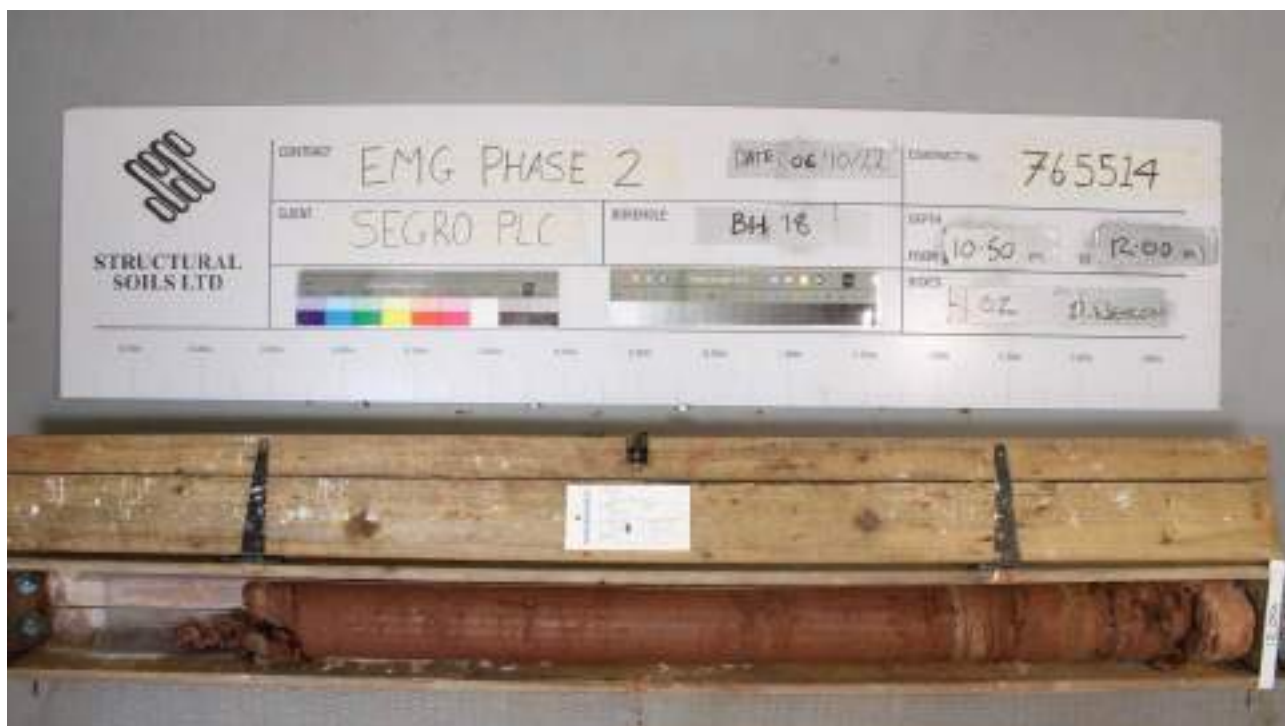
Contract: EMG Phase 2		Client: SEGRO		Borehole: BH18
Contract Ref: 765514	Start: 15.09.22 End: 06.10.22	Ground Level (m AOD): 77.62	National Grid Co-ordinate: E:446112.9 N:324864.2	Sheet: 7 of 12

Method Used: Inspection pit + Cable Percussion + Rotary Cored	Plant Used: Dando 3000 + Comacchio GEO 205	Drilled By: Chris Jobson + Martin Speedie	Logged By: DNeylon + JAlton	Checked By: AS	AGS
---	--	---	-----------------------------	----------------	-----

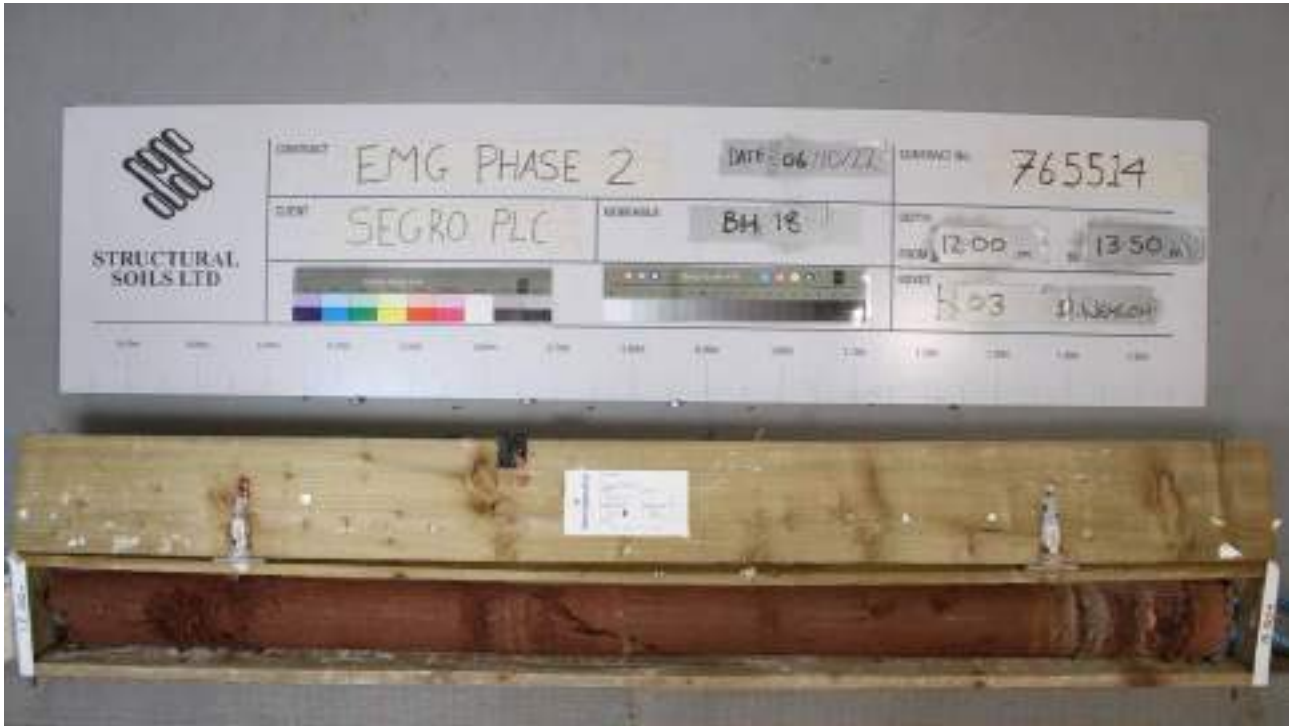
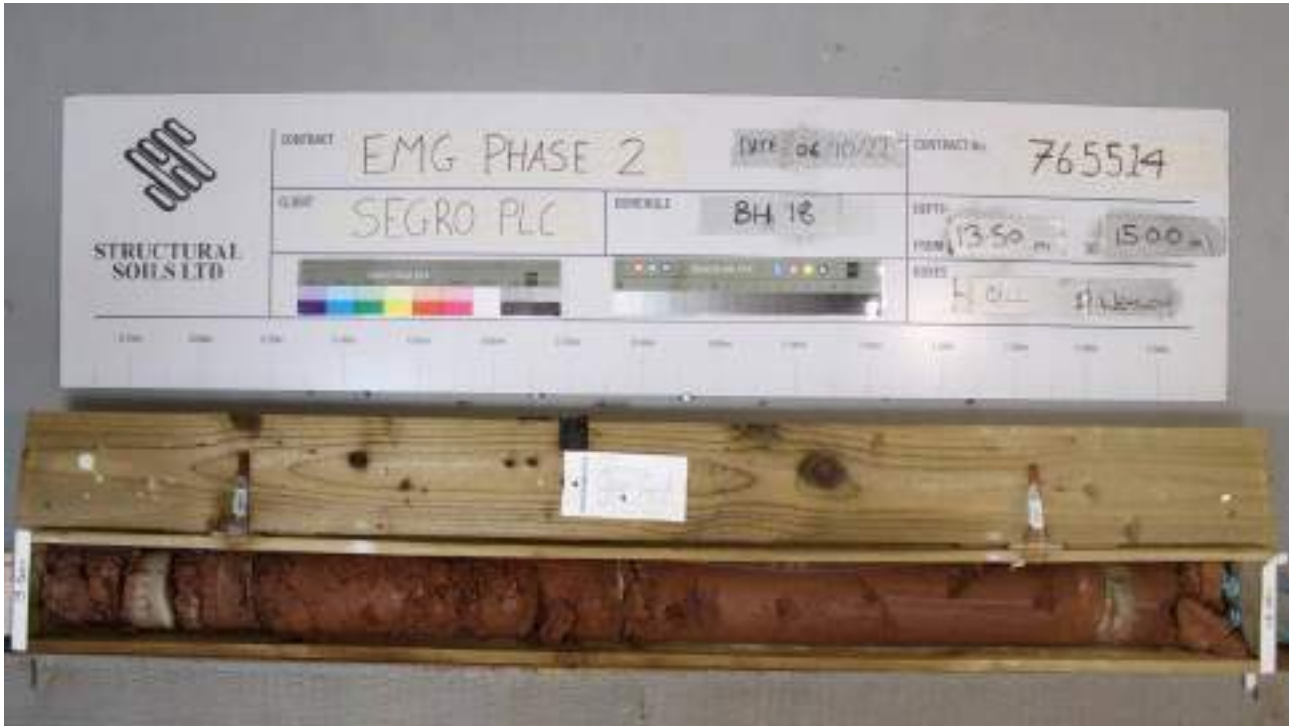
Contract: EMG Phase 2			Client: SEGRO		Borehole: BH18
Contract Ref: 765514	Start: 15.09.22 End: 06.10.22	Ground Level (m AOD): 77.62	National Grid Co-ordinate: E:446112.9 N:324864.2		Sheet: 8 of 12

Method Used: Inspection pit + Cable Percussion + Rotary Cored	Plant Used: Dando 3000 + Comacchio GEO 205	Drilled By: Chris Jobson + Martin Speedie	Logged By: DNeylon + JAlton	Checked By: AS	AGS
---	--	---	-----------------------------	----------------	-----
