**East Midlands Gateway
Phase 2 (EMG2)**

Fairhurst Ground Investigation Report (EMG2)

Ground Investigation Report

East Midlands Gateway Phase 2,
Land South of East Midlands
Airport, Derby

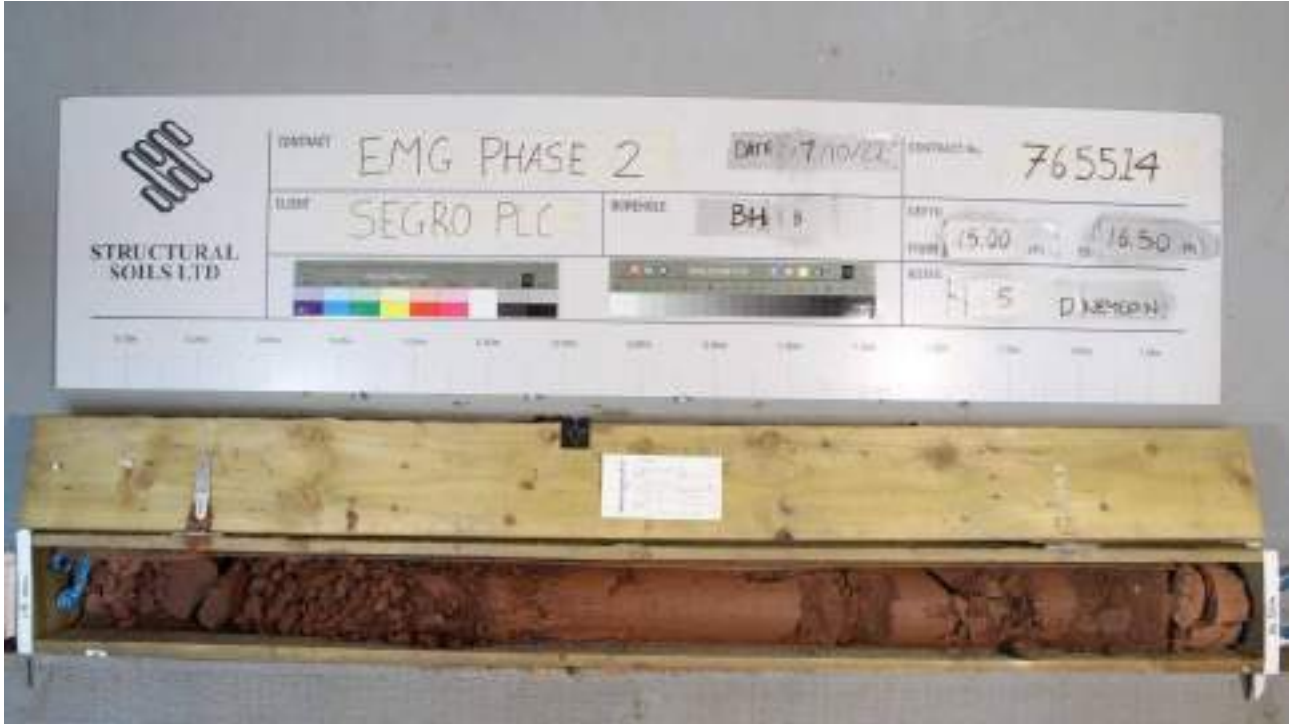
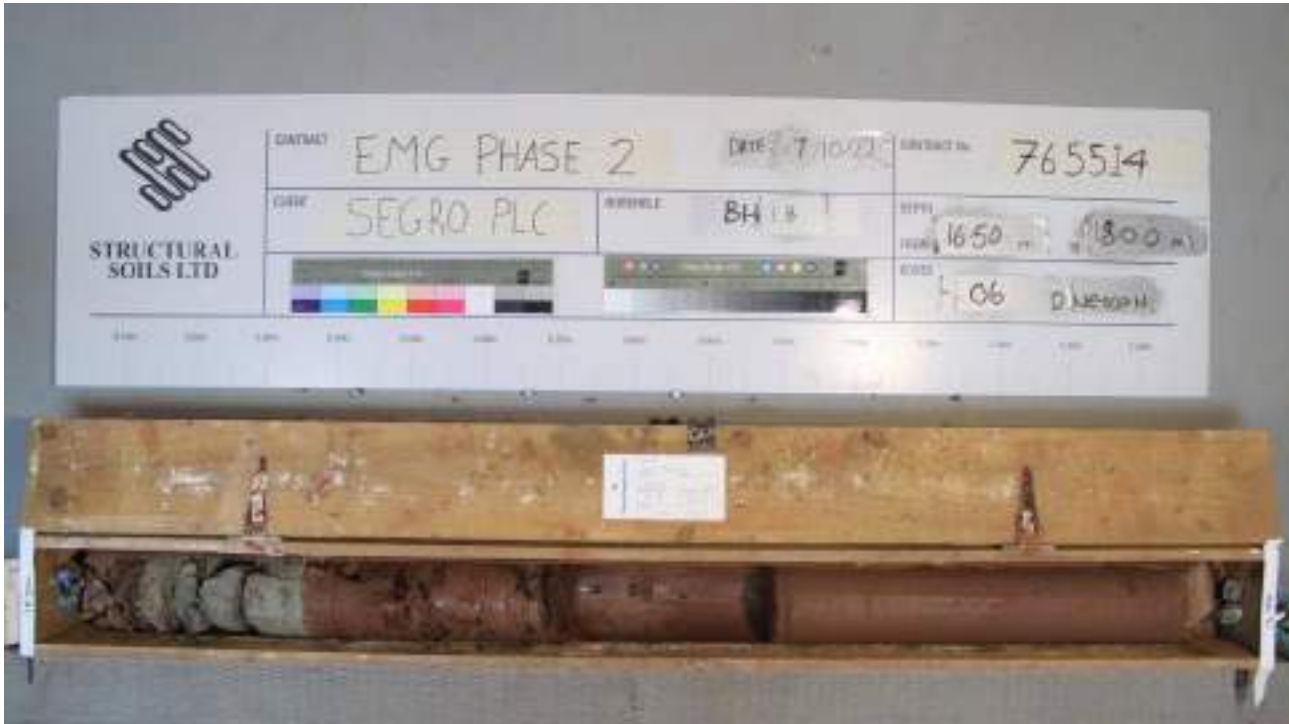
Contract: EMG Phase 2			Client: SEGRO	Borehole: BH18
Contract Ref: 765514	Start: 15.09.22 End: 06.10.22	Ground Level (m AOD): 77.62	National Grid Co-ordinate: E:446112.9 N:324864.2	Sheet: 9 of 12

Method Used: Inspection pit + Cable Percussion + Rotary Cored	Plant Used: Dando 3000 + Comacchio GEO 205	Drilled By: Chris Jobson + Martin Speedie	Logged By: D.Neylon + J.Aiton	Checked By: AS	AGS
---	--	---	-------------------------------	----------------	-----

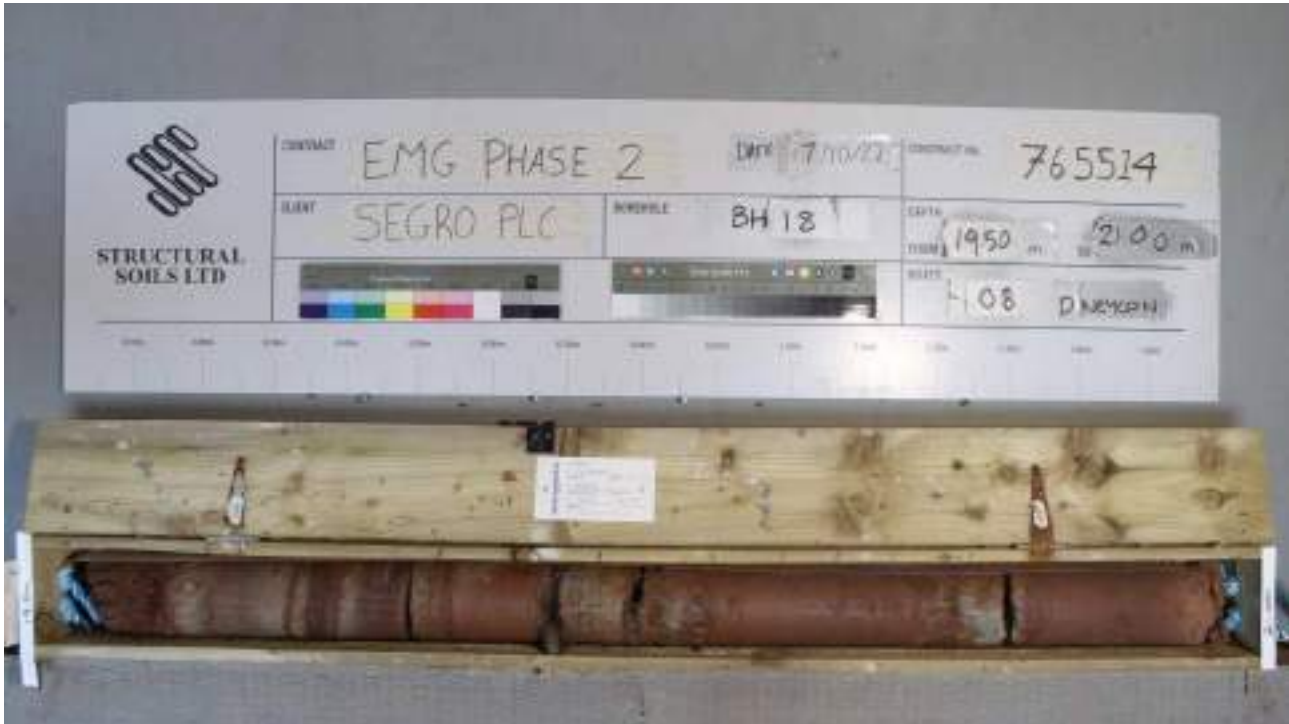
Contract: EMG Phase 2		Client: SEGRO		Borehole: BH18
Contract Ref: 765514	Start: 15.09.22 End: 06.10.22	Ground Level (m AOD): 77.62	National Grid Co-ordinate: E:446112.9 N:324864.2	Sheet: 10 of 12

Method Used: Inspection pit + Cable Percussion + Rotary Cored	Plant Used: Dando 3000 + Comacchio GEO 205	Drilled By: Chris Jobson + Martin Speedie	Logged By: DNeylon + JAlton	Checked By: AS	AGS
---	--	---	-----------------------------	----------------	-----

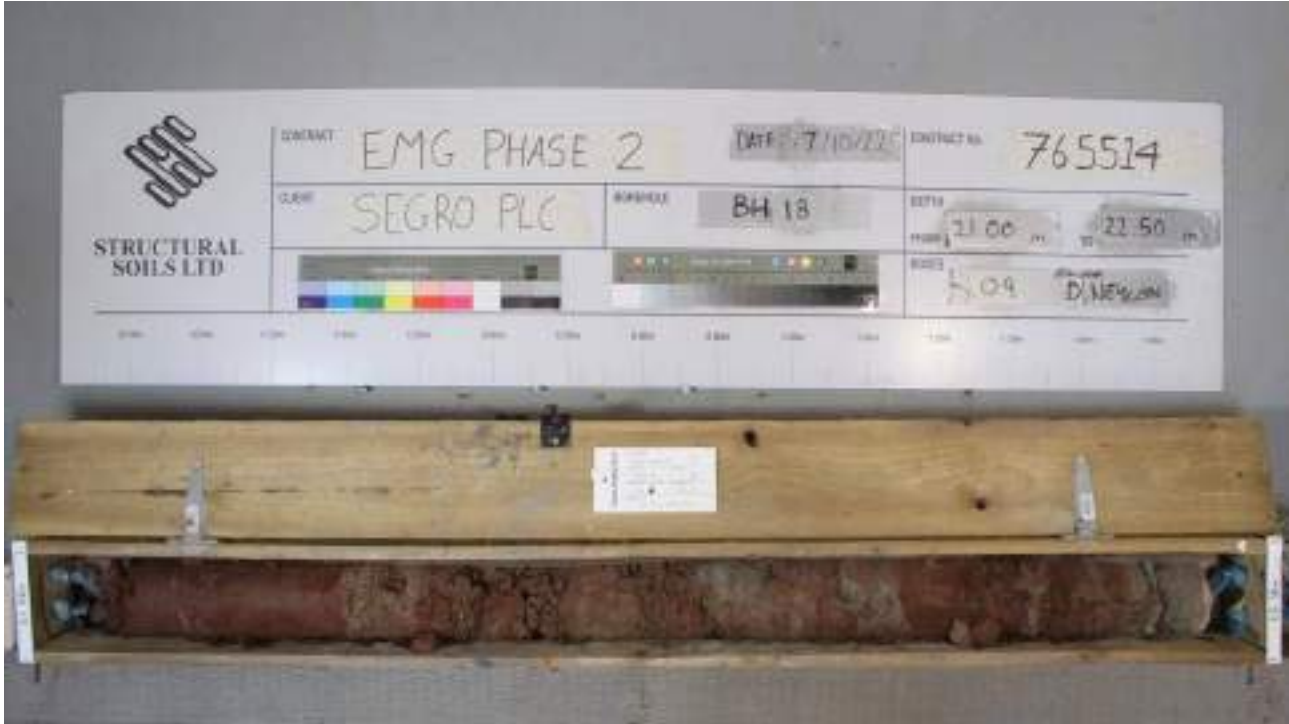
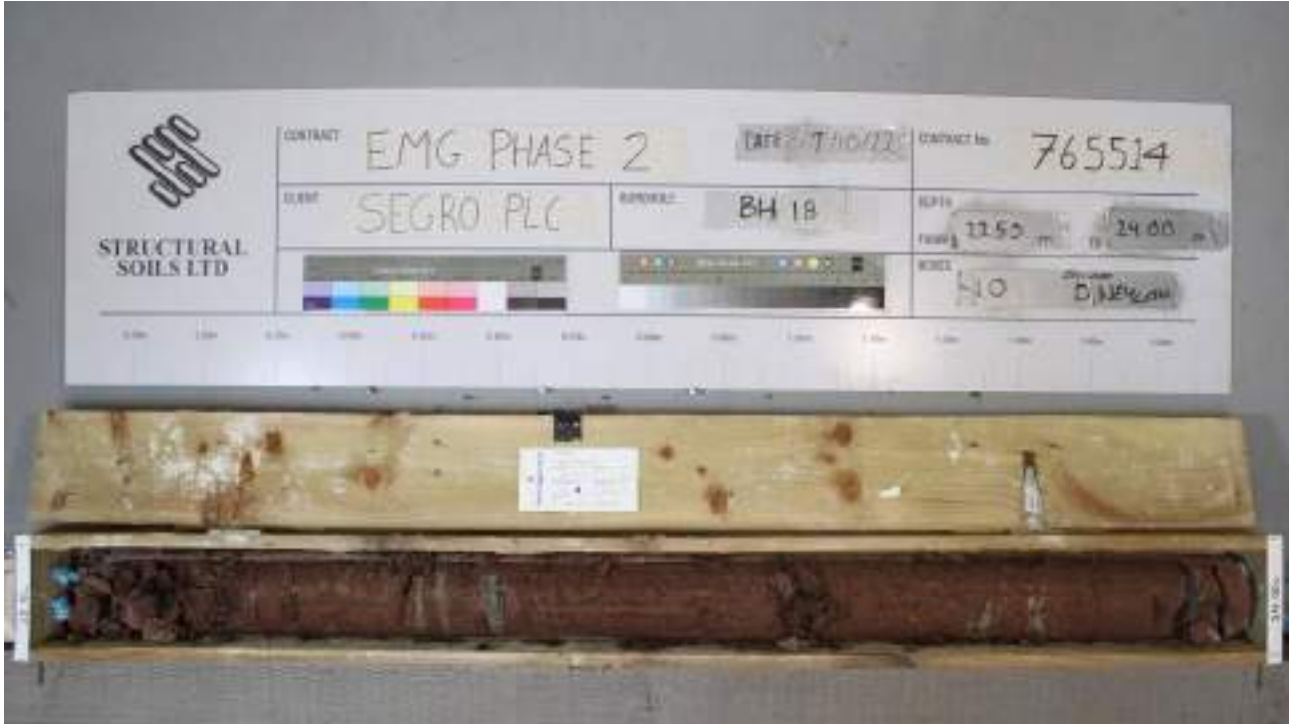
Contract: EMG Phase 2			Client: SEGRO	Borehole: BH18
Contract Ref: 765514	Start: 15.09.22 End: 06.10.22	Ground Level (m AOD): 77.62	National Grid Co-ordinate: E:446112.9 N:324864.2	Sheet: 11 of 12

Method Used: Inspection pit + Cable Percussion + Rotary Cored	Plant Used: Dando 3000 + Comacchio GEO 205	Drilled By: Chris Jobson + Martin Speedie	Logged By: D.Neylon + J.Aiton	Checked By: AS	AGS
---	--	---	-------------------------------	----------------	-----

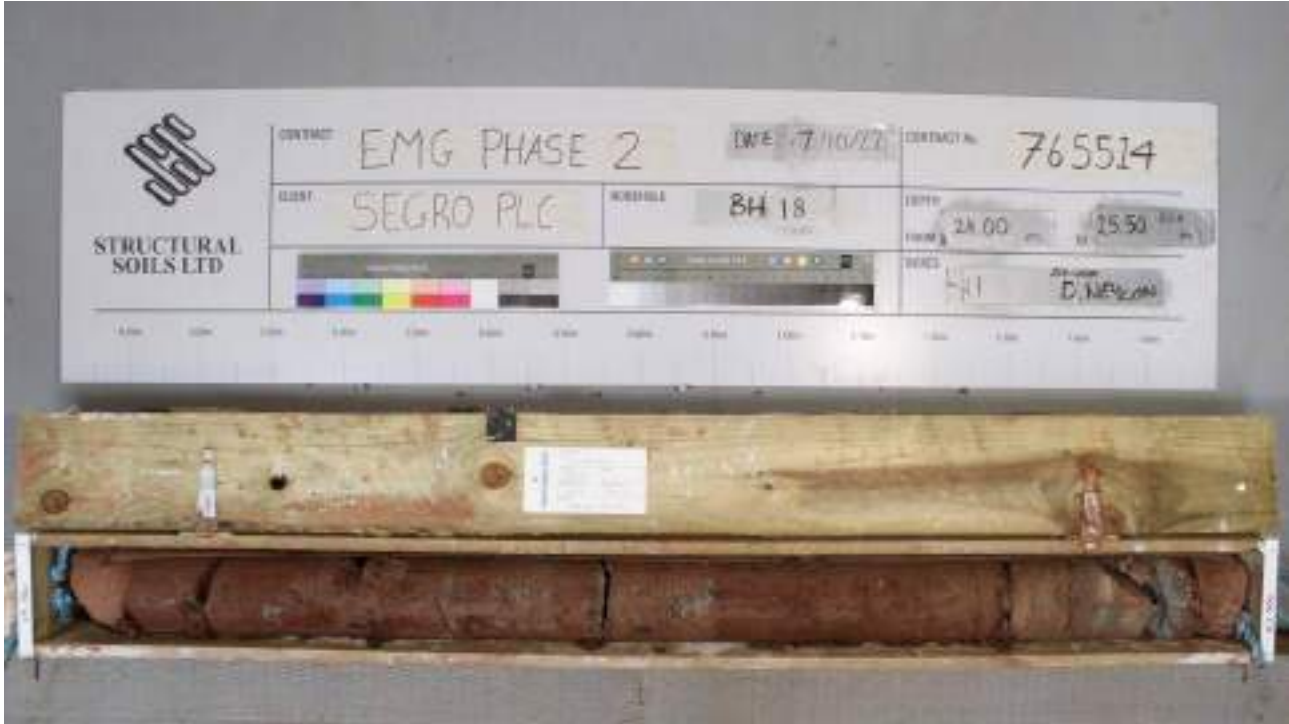
Contract: EMG Phase 2		Client: SEGRO		Borehole: BH18
Contract Ref: 765514	Start: 15.09.22 End: 06.10.22	Ground Level (m AOD): 77.62	National Grid Co-ordinate: E:446112.9 N:324864.2	Sheet: 12 of 12

Method Used: Inspection pit + Cable Percussion + Rotary Cored	Plant Used: Dando 3000 + Comacchio GEO 205	Drilled By: Chris Jobson + Martin Speedie	Logged By: DNeylon + JAlton	Checked By: AS	AGS
--	---	--	--------------------------------	-------------------	-----

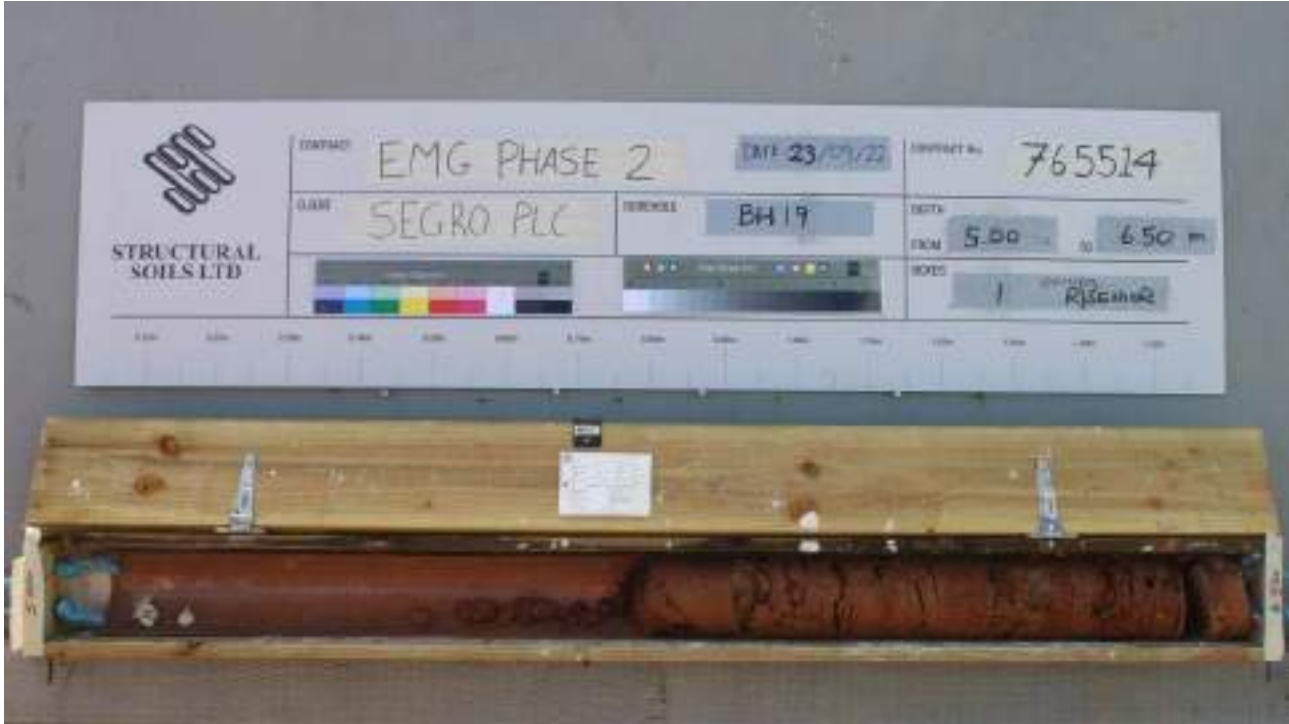
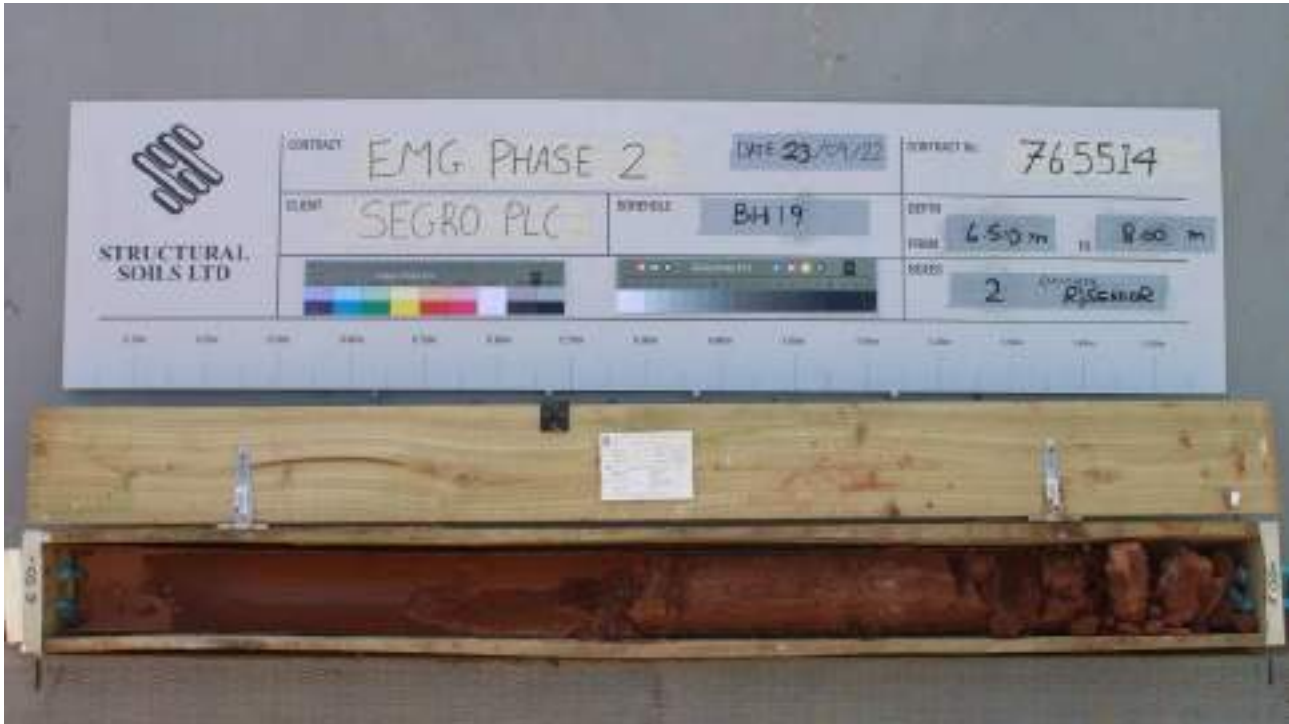
Contract: EMG Phase 2			Client: SEGRO	Borehole: BH19
Contract Ref: 765514	Start: 14.09.22 End: 16.09.22	Ground Level (m AOD): 76.63	National Grid Co-ordinate: E:446150.1 N:324740.8	Sheet: 7 of 11

Method Used: Inspection pit + Cable Percussion + Rotary Cored	Plant Used: Dando 3000 + Comacchio GEO 205	Drilled By: Jonny Hutt + Martin Speedie	Logged By: JAlton + RSenior	Checked By: AS	AGS
---	--	---	-----------------------------	----------------	-----

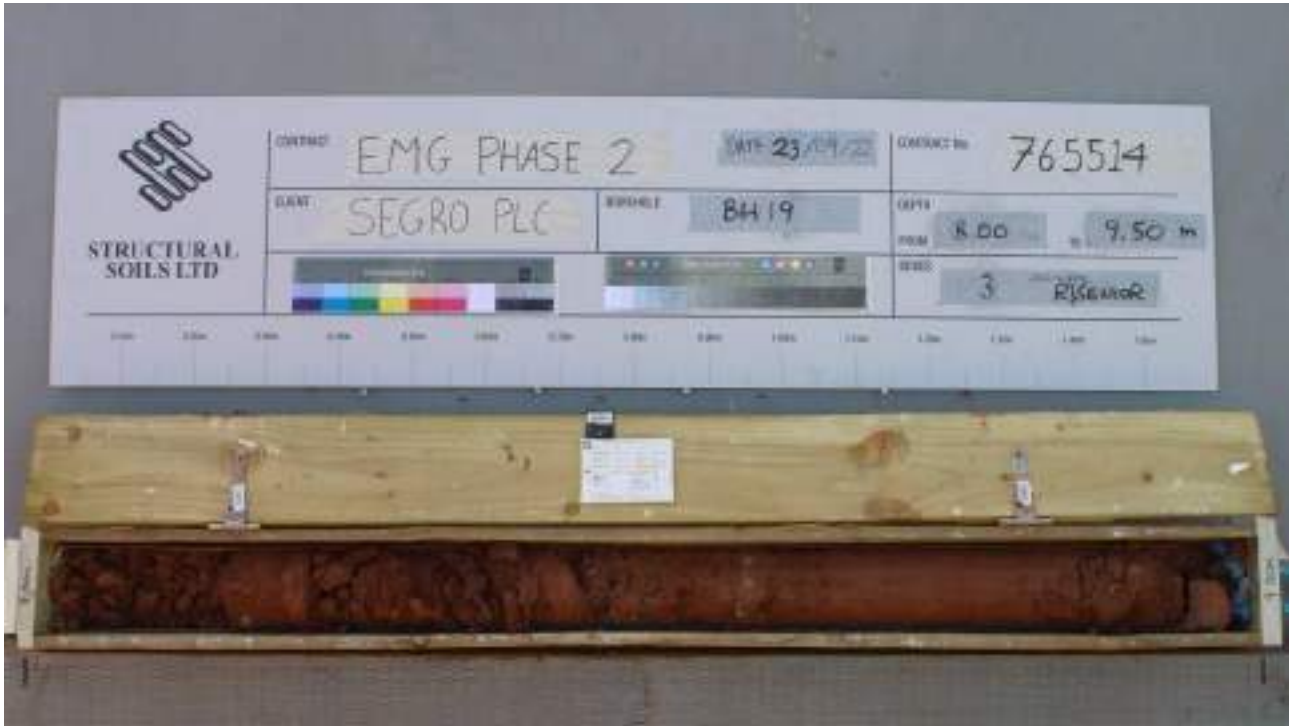
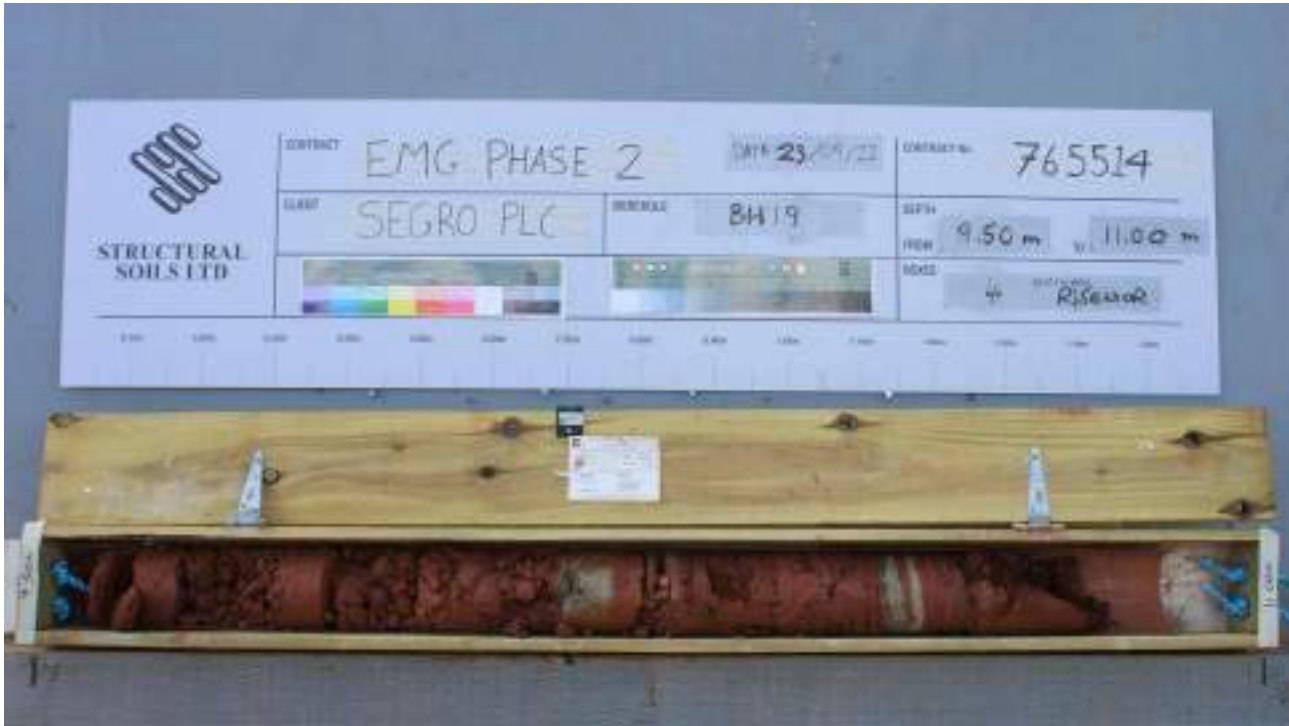
Contract: EMG Phase 2			Client: SEGRO	Borehole: BH19
Contract Ref: 765514	Start: 14.09.22 End: 16.09.22	Ground Level (m AOD): 76.63	National Grid Co-ordinate: E:446150.1 N:324740.8	Sheet: 8 of 11

Method Used: Inspection pit + Cable Percussion + Rotary Cored	Plant Used: Dando 3000 + Comacchio GEO 205	Drilled By: Jonny Hutt + Martin Speedie	Logged By: JAlton + RSenior	Checked By: AS	AGS
---	--	---	-----------------------------	----------------	-----

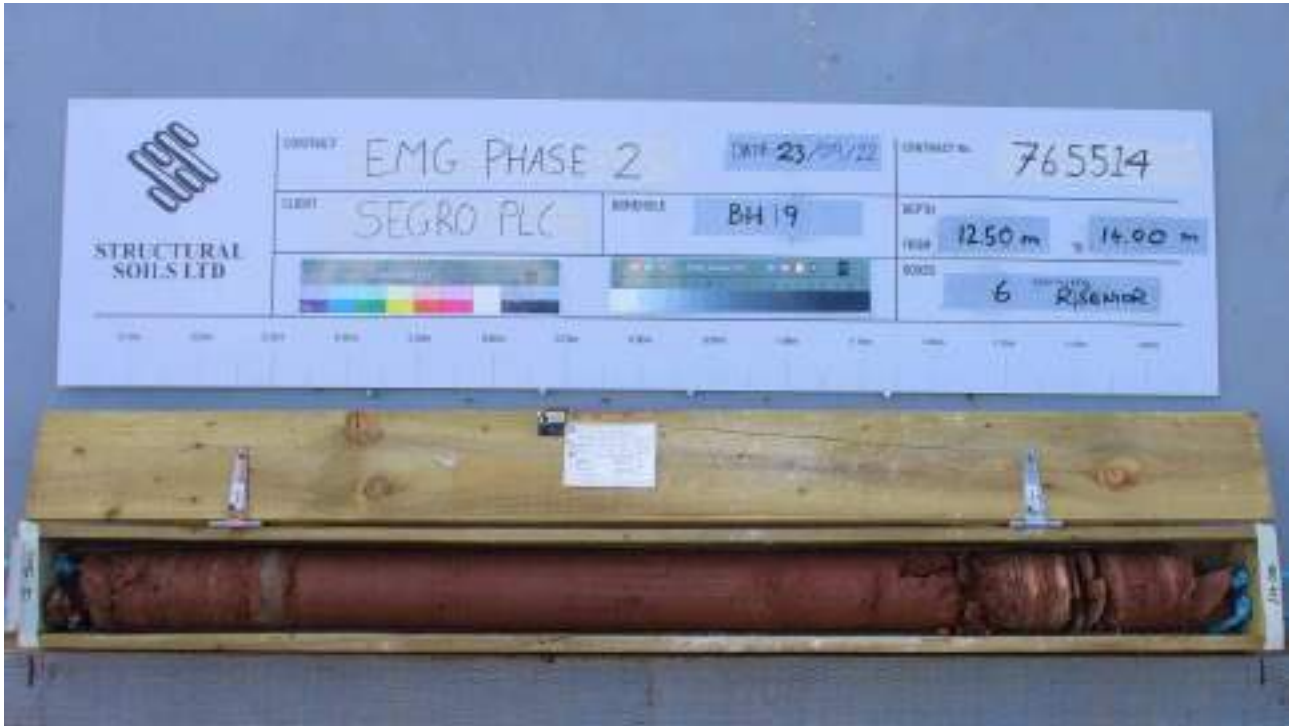
Contract: EMG Phase 2		Client: SEGRO		Borehole: BH19
Contract Ref: 765514	Start: 14.09.22 End: 16.09.22	Ground Level (m AOD): 76.63	National Grid Co-ordinate: E:446150.1 N:324740.8	Sheet: 9 of 11

Method Used: Inspection pit + Cable Percussion + Rotary Cored	Plant Used: Dando 3000 + Comacchio GEO 205	Drilled By: Jonny Hutt + Martin Speedie	Logged By: JAlton + RSenior	Checked By: AS	AGS
---	--	---	-----------------------------	----------------	-----

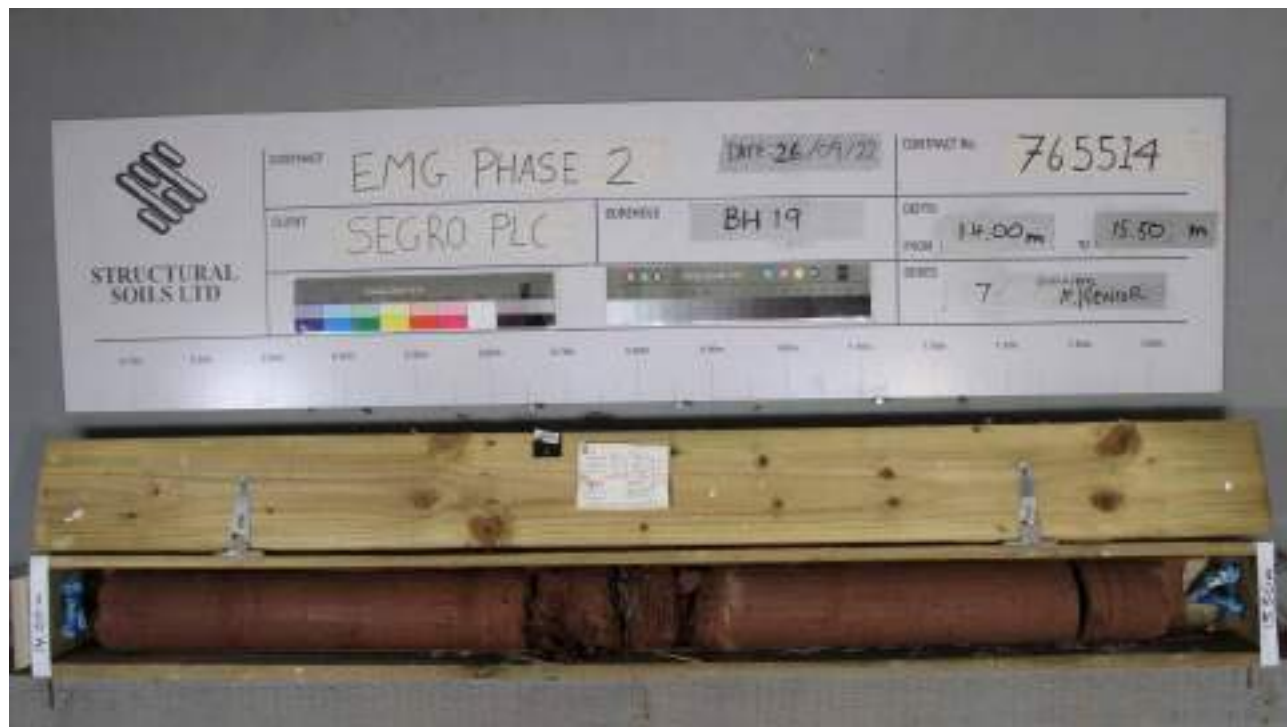
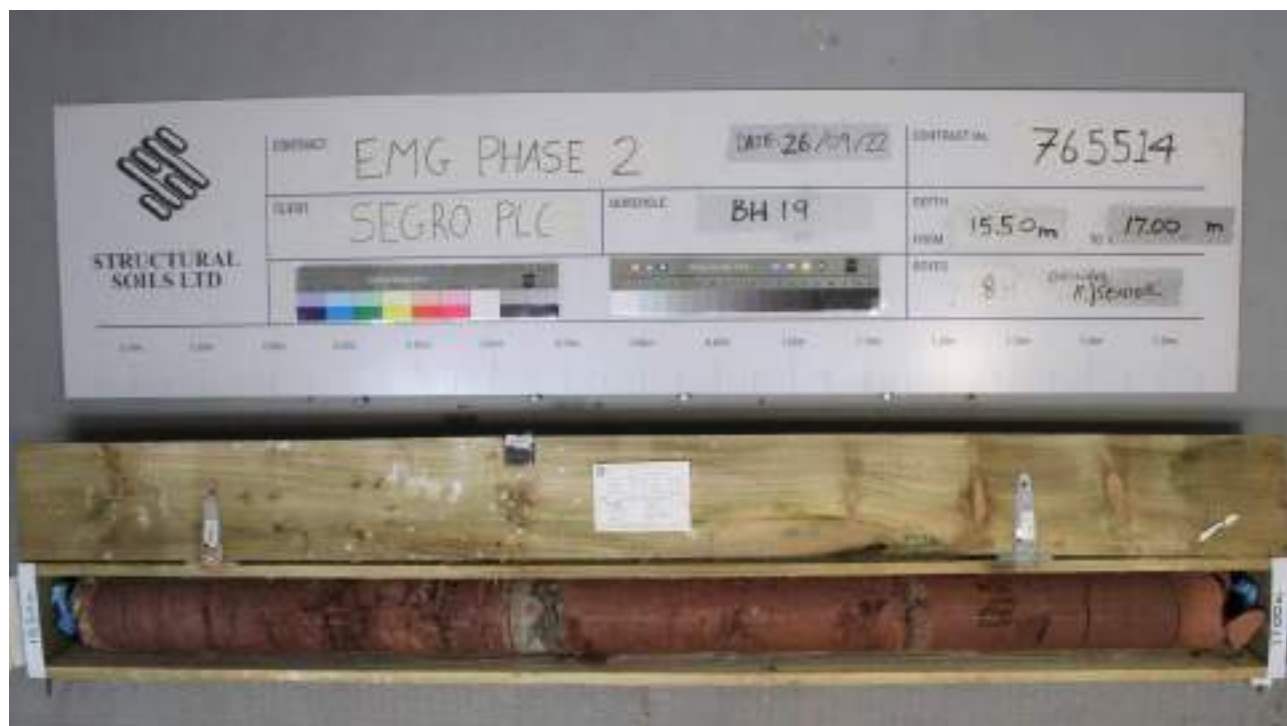
Contract: EMG Phase 2		Client: SEGRO		Borehole: BH19
Contract Ref: 765514	Start: 14.09.22 End: 16.09.22	Ground Level (m AOD): 76.63	National Grid Co-ordinate: E:446150.1 N:324740.8	Sheet: 10 of 11

Method Used: Inspection pit + Cable Percussion + Rotary Cored	Plant Used: Dando 3000 + Comacchio GEO 205	Drilled By: Jonny Hutt + Martin Speedie	Logged By: JAlton + RSenior	Checked By: AS	AGS
---	--	---	-----------------------------	----------------	-----

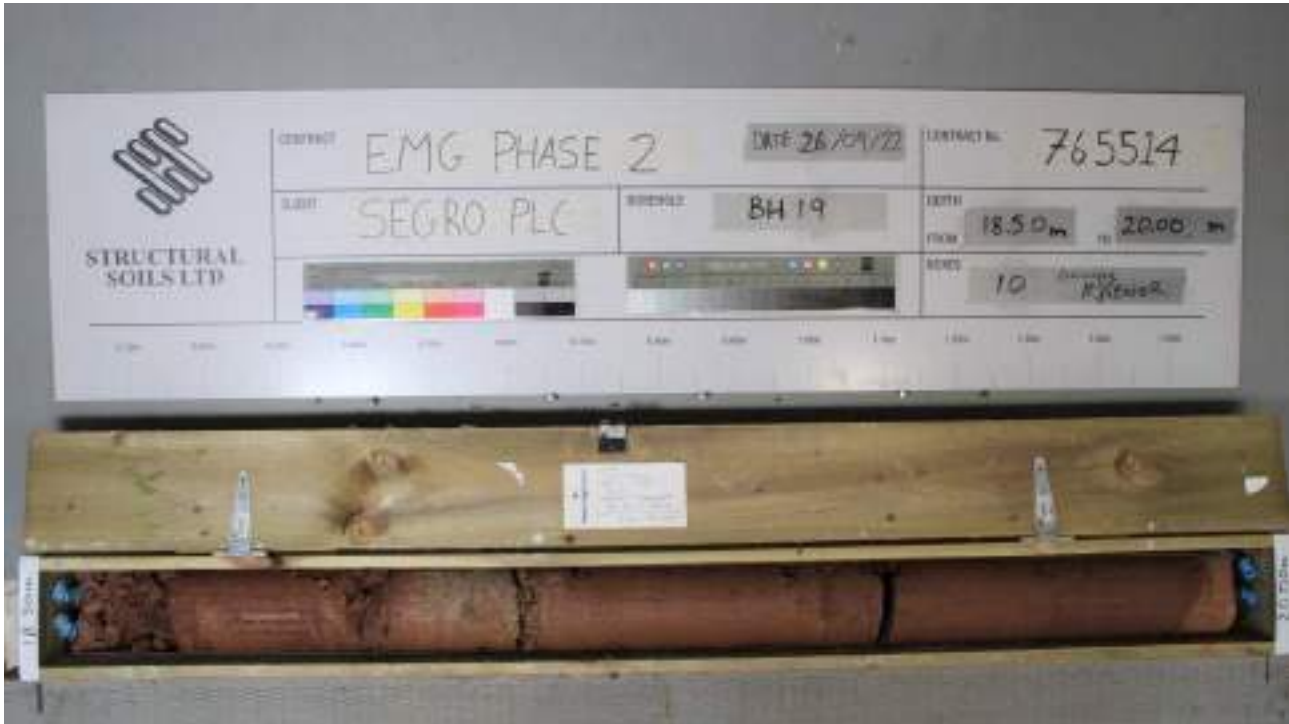
Contract: EMG Phase 2			Client: SEGRO	Borehole: BH19
Contract Ref: 765514	Start: 14.09.22 End: 16.09.22	Ground Level (m AOD): 76.63	National Grid Co-ordinate: E:446150.1 N:324740.8	Sheet: 11 of 11

Method Used: Inspection pit + Cable Percussion + Rotary Cored	Plant Used: Dando 3000 + Comacchio GEO 205	Drilled By: Jonny Hutt + Martin Speedie	Logged By: JAlton + RSenior	Checked By: AS	AGS
---	--	---	-----------------------------	----------------	-----

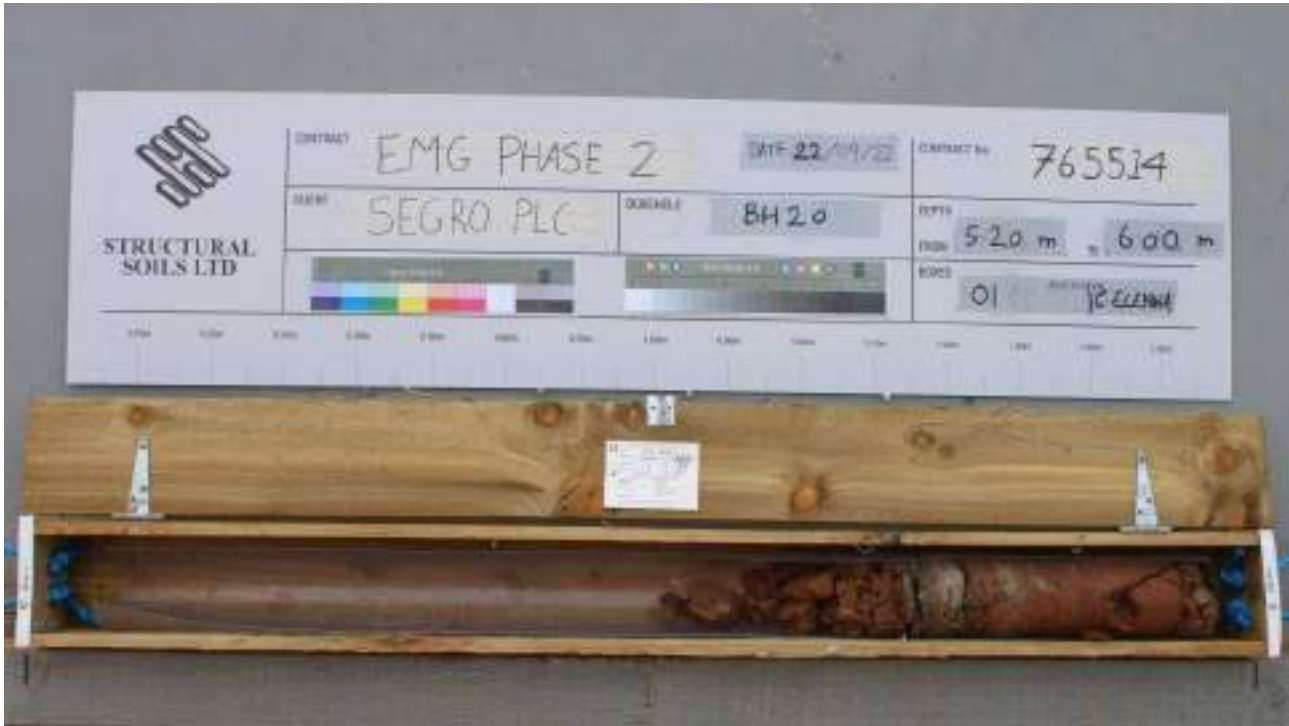
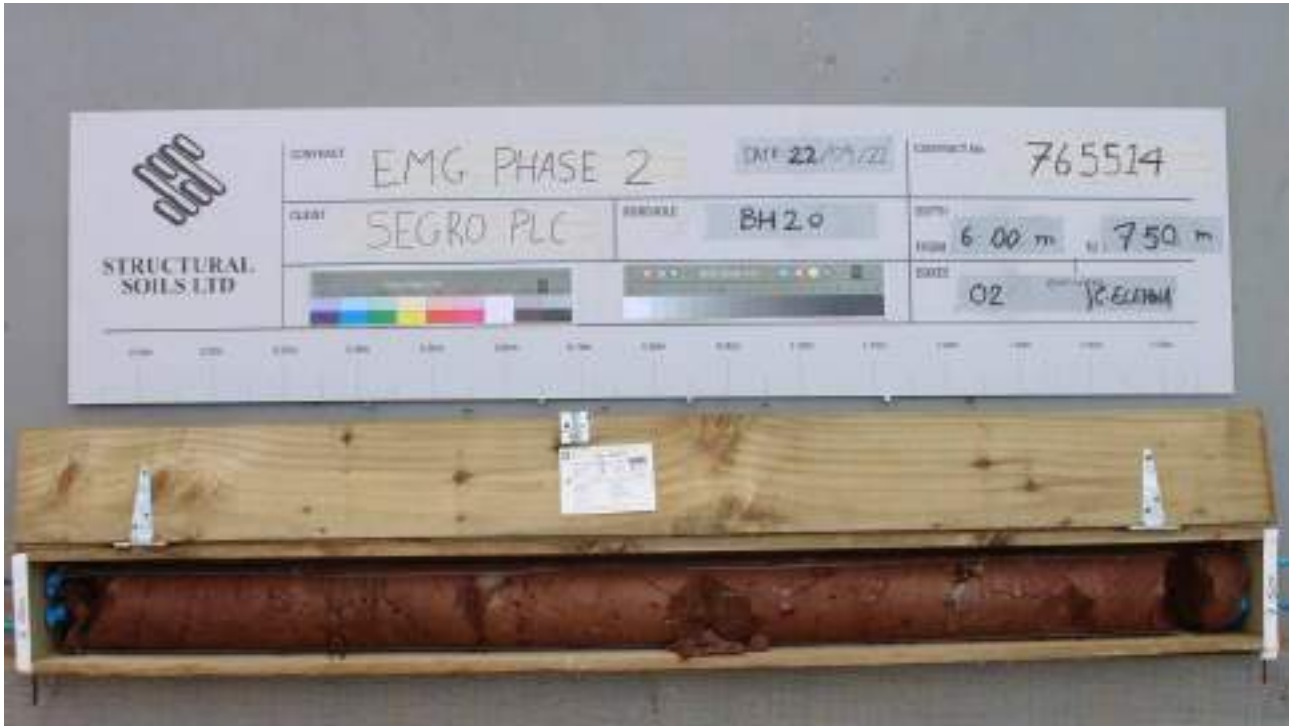
Contract: EMG Phase 2			Client: SEGRO	Borehole: BH20
Contract Ref: 765514	Start: 15.09.22 End: 15.09.22	Ground Level (m AOD): 76.91	National Grid Co-ordinate: E:446017.0 N:324870.9	Sheet: 8 of 16

Method Used: Inspection pit + Cable Percussion + Rotary Cored	Plant Used: Dando 3000 + Comacchio GEO 205	Drilled By: Jonny Hutt + Marc Pearson	Logged By: DNartey + DNeylon	Checked By: AS	AGS
---	--	---------------------------------------	------------------------------	----------------	-----

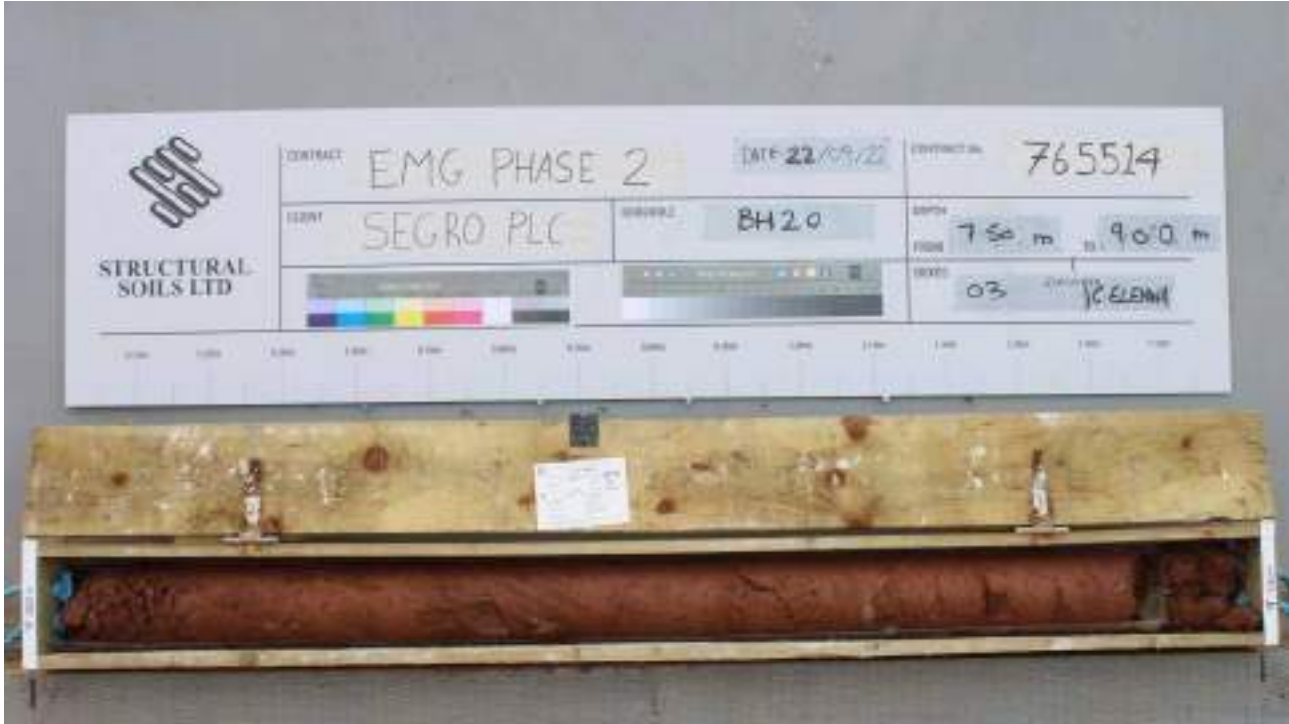
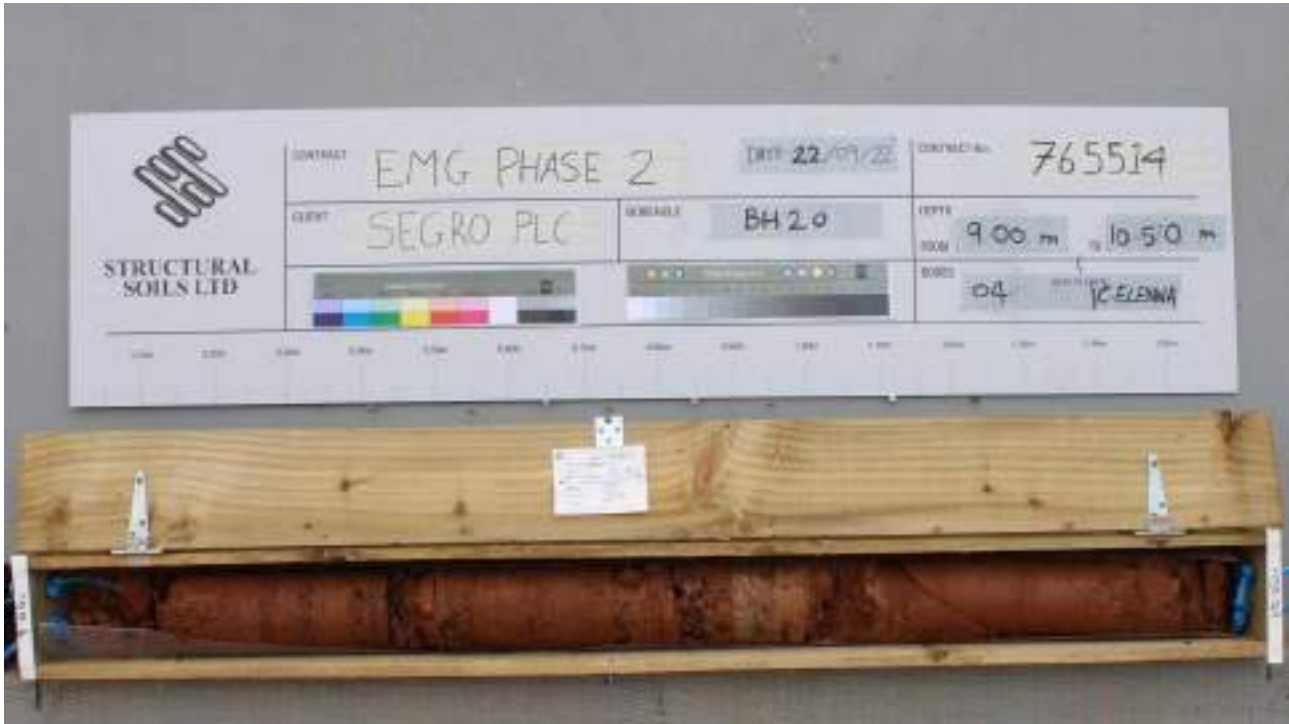
Contract: EMG Phase 2			Client: SEGRO	Borehole: BH20
Contract Ref: 765514	Start: 15.09.22 End: 15.09.22	Ground Level (m AOD): 76.91	National Grid Co-ordinate: E:446017.0 N:324870.9	Sheet: 9 of 16

Method Used: Inspection pit + Cable Percussion + Rotary Cored	Plant Used: Dando 3000 + Comacchio GEO 205	Drilled By: Jonny Hutt + Marc Pearson	Logged By: DNartey + DNeylon	Checked By: AS	
---	--	---------------------------------------	------------------------------	----------------	--

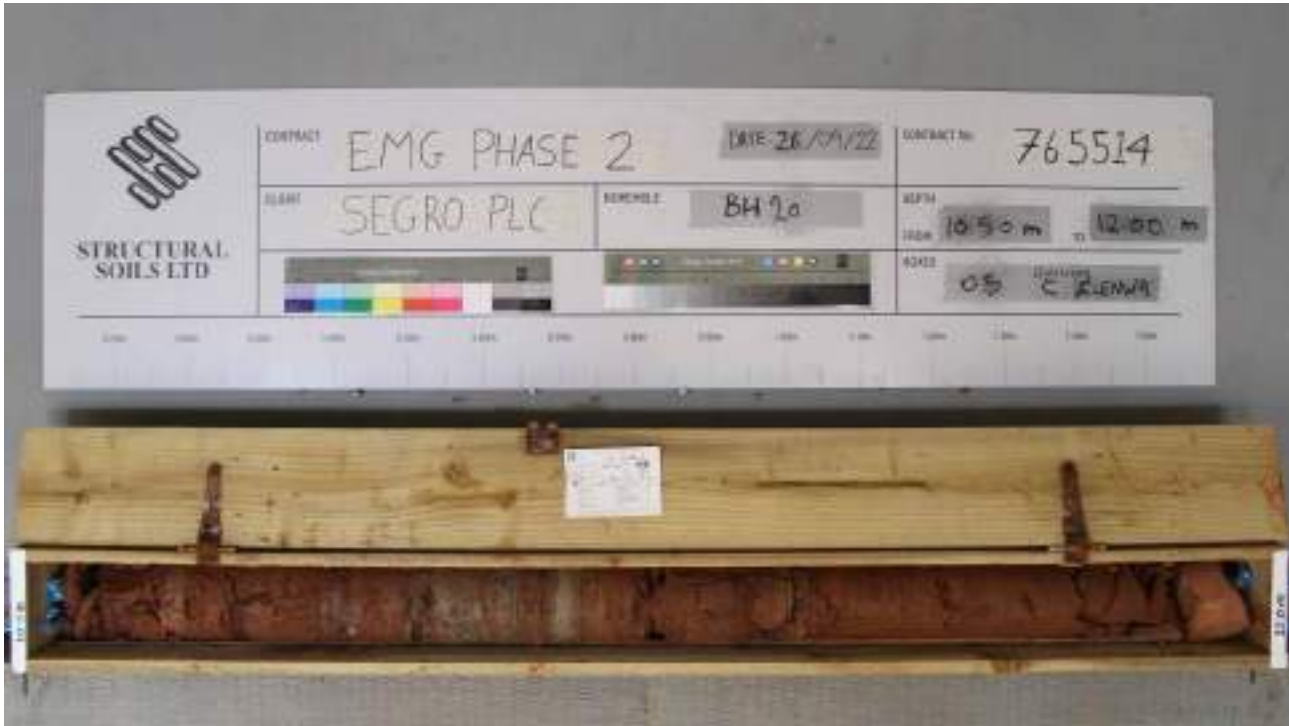
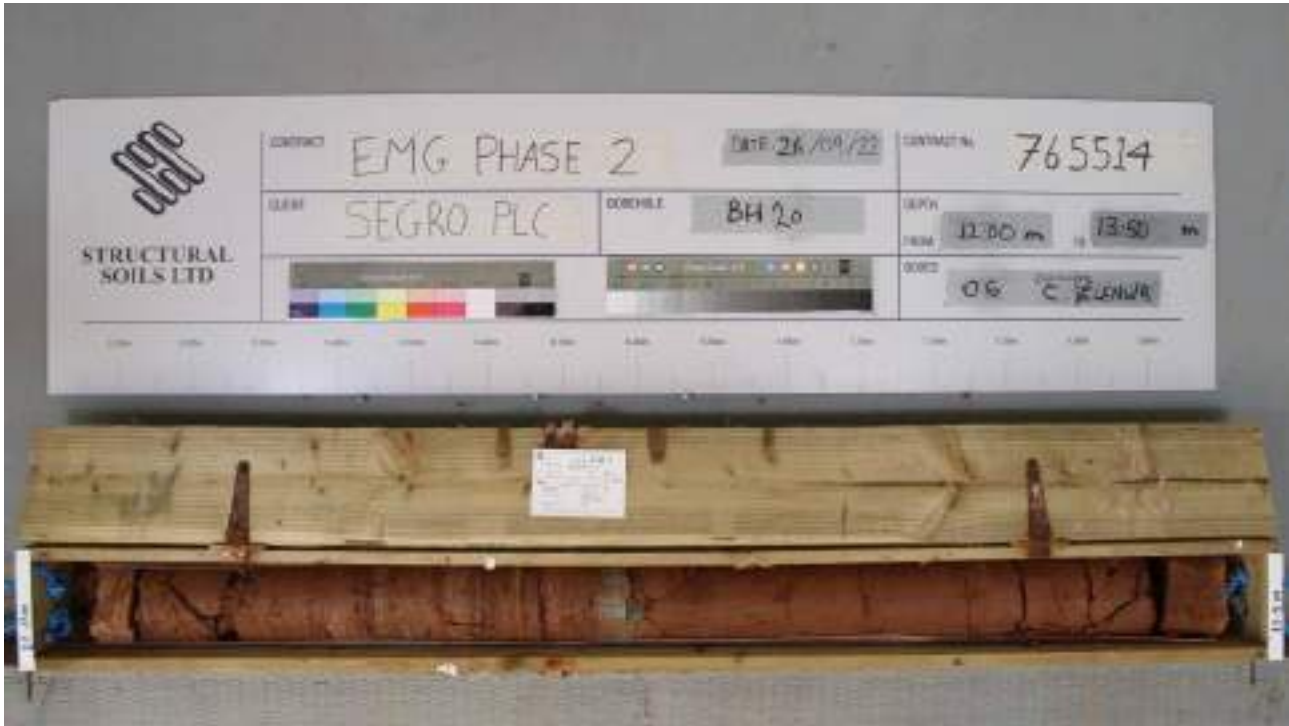
Contract: EMG Phase 2			Client: SEGRO	Borehole: BH20
Contract Ref: 765514	Start: 15.09.22 End: 15.09.22	Ground Level (m AOD): 76.91	National Grid Co-ordinate: E:446017.0 N:324870.9	Sheet: 10 of 16

Method Used: Inspection pit + Cable Percussion + Rotary Cored	Plant Used: Dando 3000 + Comacchio GEO 205	Drilled By: Jonny Hutt + Marc Pearson	Logged By: DNartey + DNeylon	Checked By: AS	AGS
---	--	---------------------------------------	------------------------------	----------------	-----

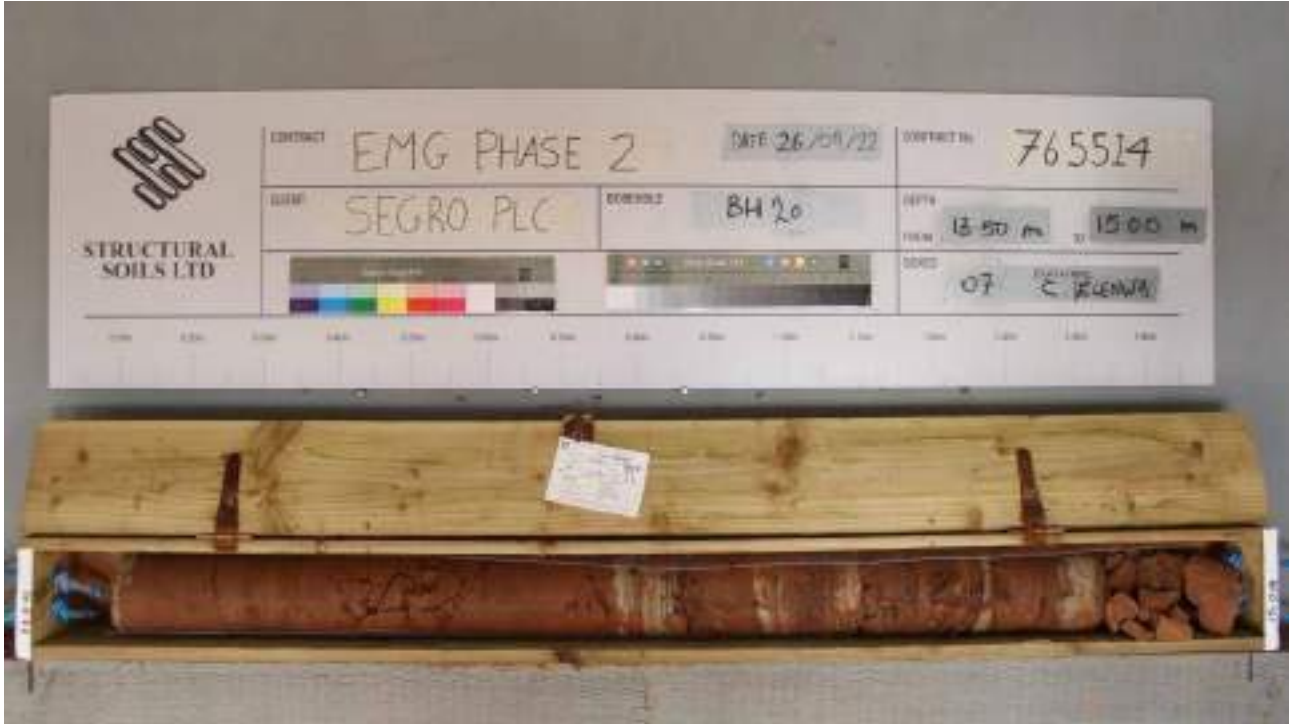
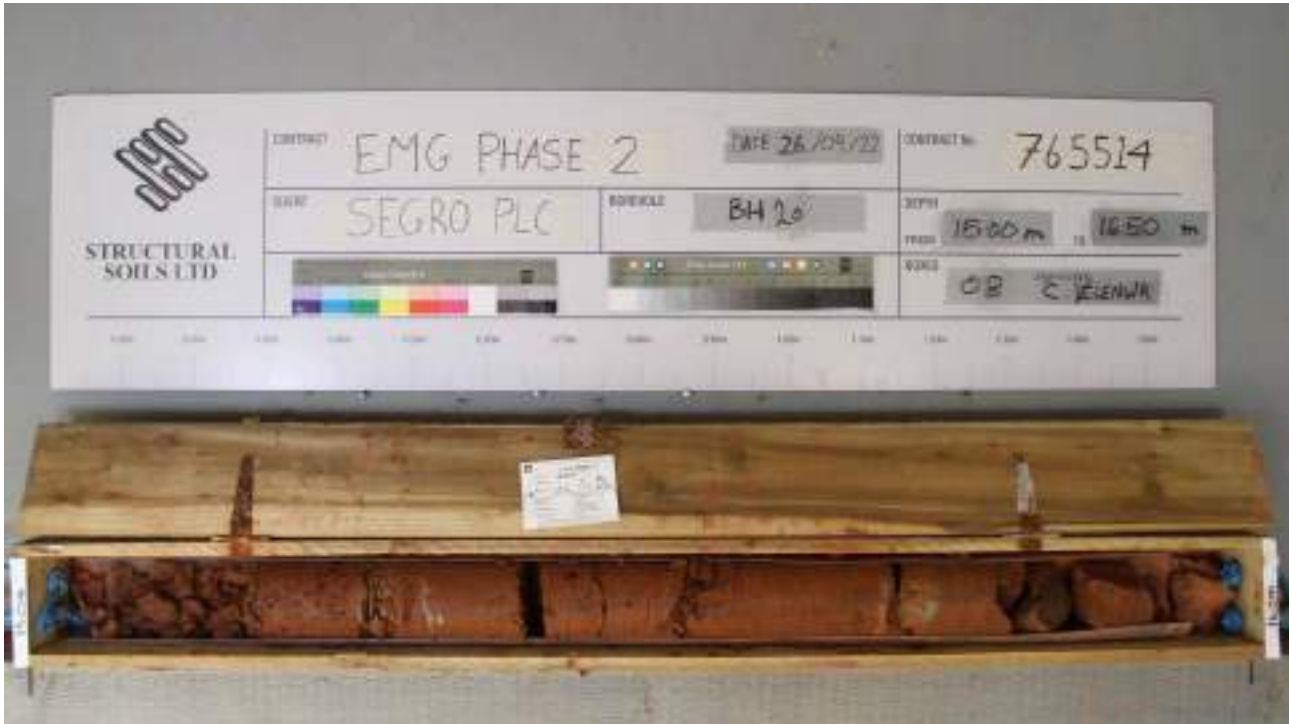
Contract: EMG Phase 2			Client: SEGRO	Borehole: BH20
Contract Ref: 765514	Start: 15.09.22 End: 15.09.22	Ground Level (m AOD): 76.91	National Grid Co-ordinate: E:446017.0 N:324870.9	Sheet: 11 of 16

Method Used: Inspection pit + Cable Percussion + Rotary Cored	Plant Used: Dando 3000 + Comacchio GEO 205	Drilled By: Jonny Hutt + Marc Pearson	Logged By: DNartey + DNeylon	Checked By: AS	AGS
---	--	---------------------------------------	------------------------------	----------------	-----
