**East Midlands Gateway
Phase 2 (EMG2)**

Fairhurst Ground Investigation Report (EMG2)

Ground Investigation Report

East Midlands Gateway Phase 2,
Land South of East Midlands
Airport, Derby

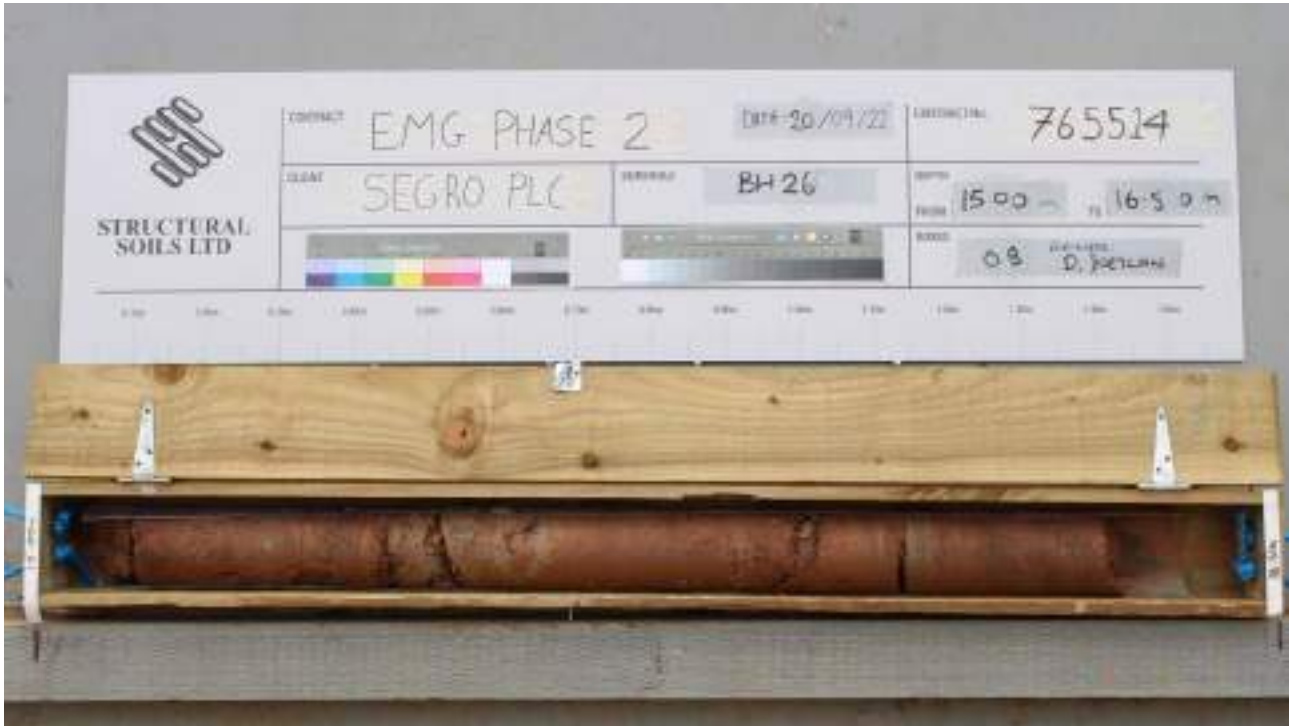
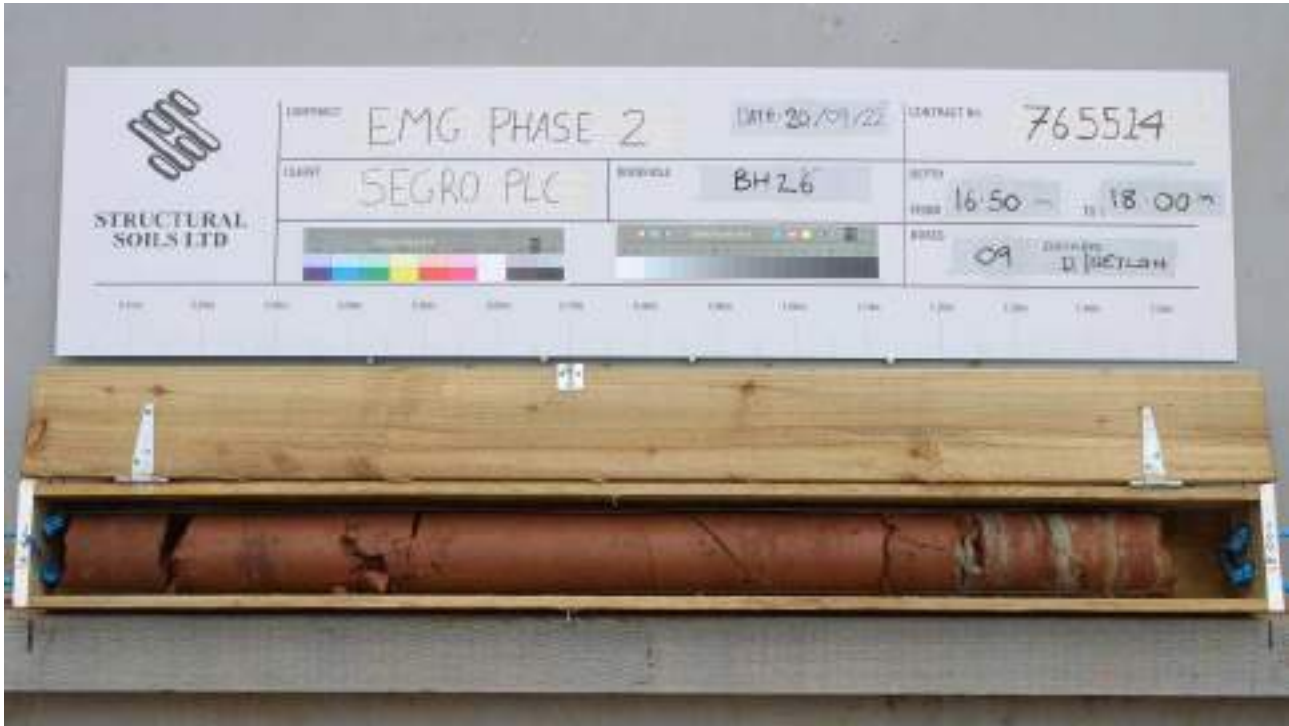
Contract: EMG Phase 2			Client: SEGRO		Borehole: BH26
Contract Ref: 765514	Start: 09.09.22 End: 20.09.22	Ground Level (m AOD): 66.17	National Grid Co-ordinate: E:446600.8 N:324651.0		Sheet: 9 of 10

Method Used: Cable Percussion + Rotary Cored	Plant Used: Dando 3000 + Comacchio GEO 205	Drilled By: Chris Jobson + Luke Bamford	Logged By: DNartey + RStan	Checked By: AS	AGS
--	--	---	----------------------------	----------------	-----

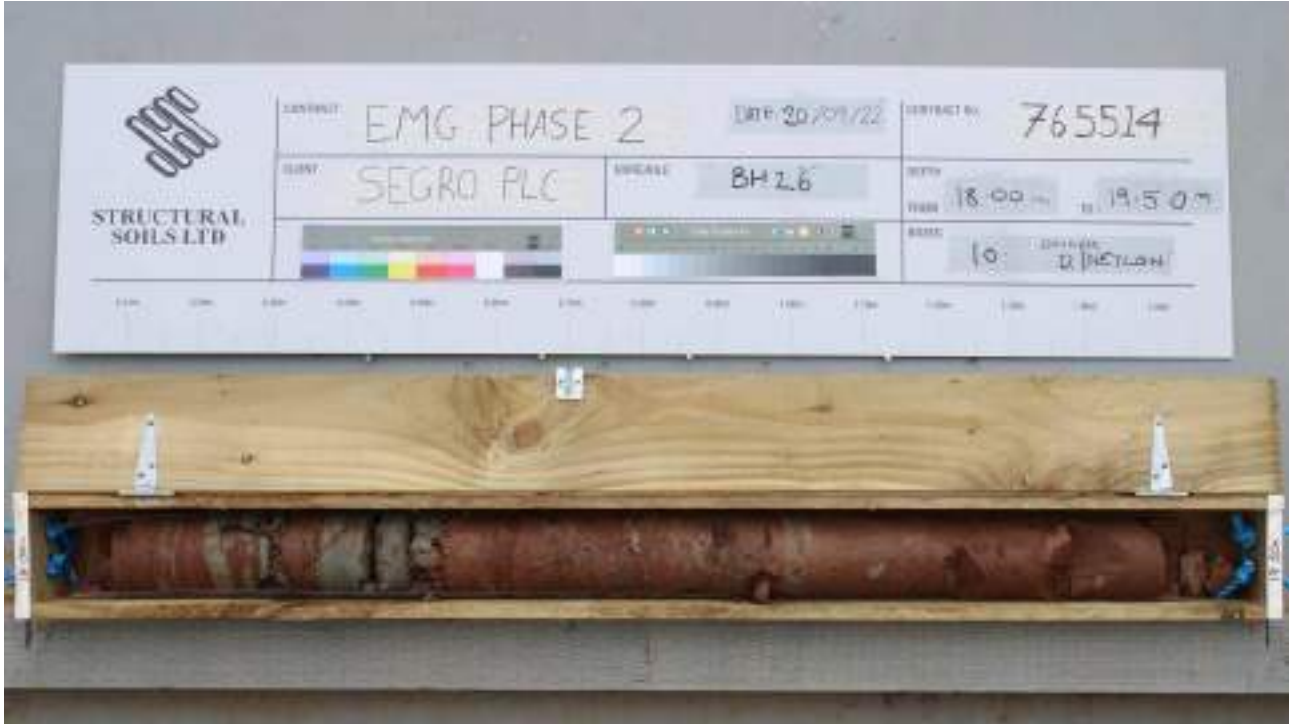
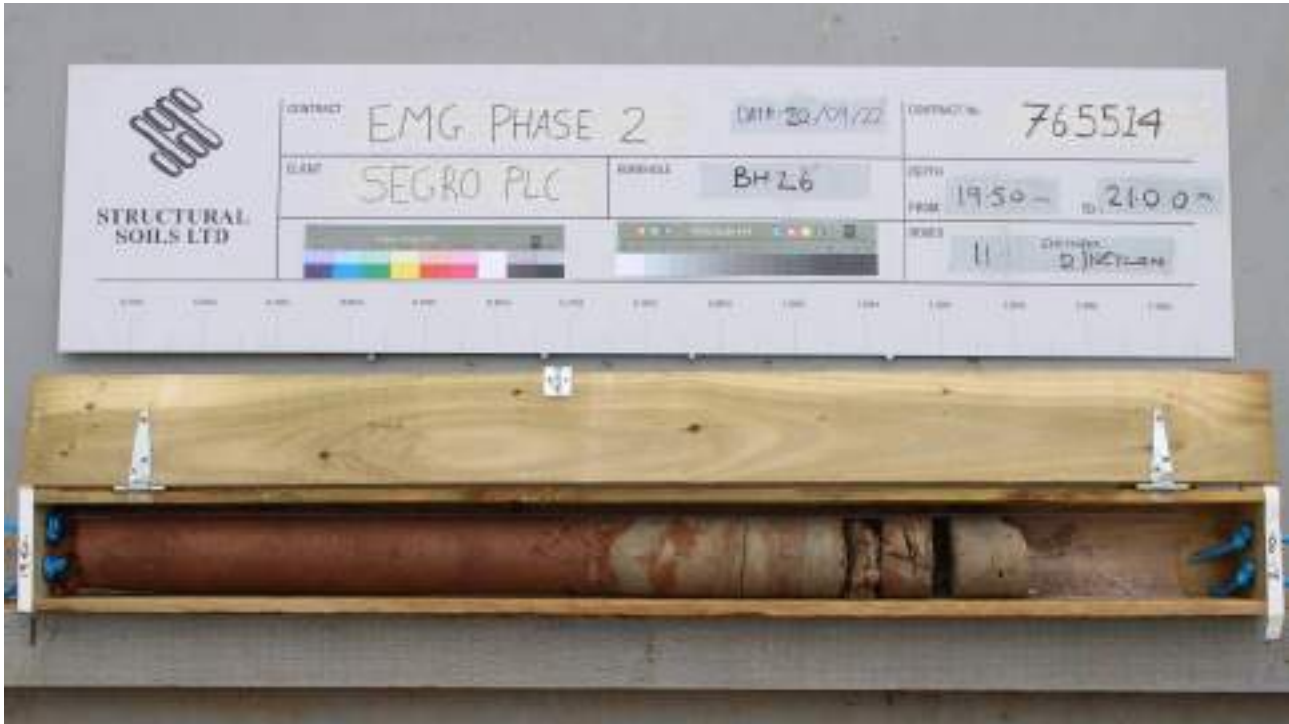
Contract: EMG Phase 2			Client: SEGRO		Borehole: BH26
Contract Ref: 765514	Start: 09.09.22 End: 20.09.22	Ground Level (m AOD): 66.17	National Grid Co-ordinate: E:446600.8 N:324651.0		Sheet: 10 of 10

Method Used: Cable Percussion + Rotary Cored	Plant Used: Dando 3000 + Comacchio GEO 205	Drilled By: Chris Jobson + Luke Bamford	Logged By: DNartey + RStan	Checked By: AS	AGS
--	--	---	----------------------------	----------------	-----

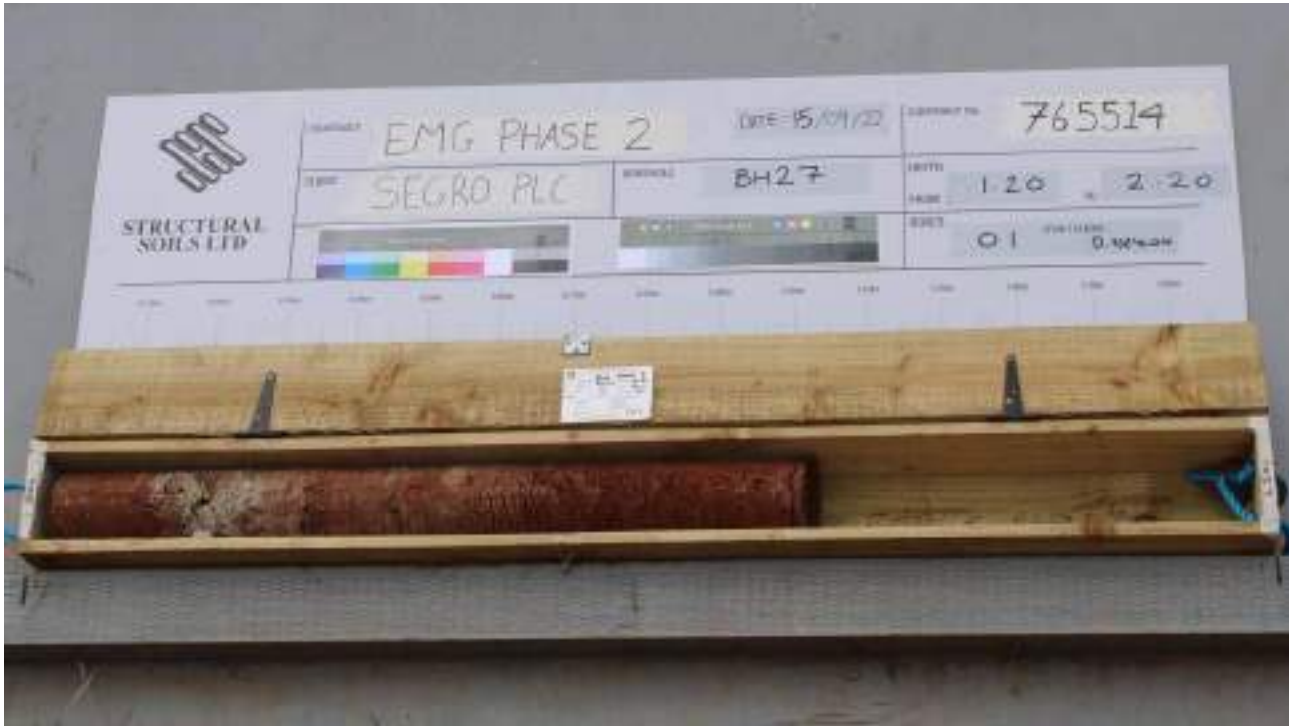
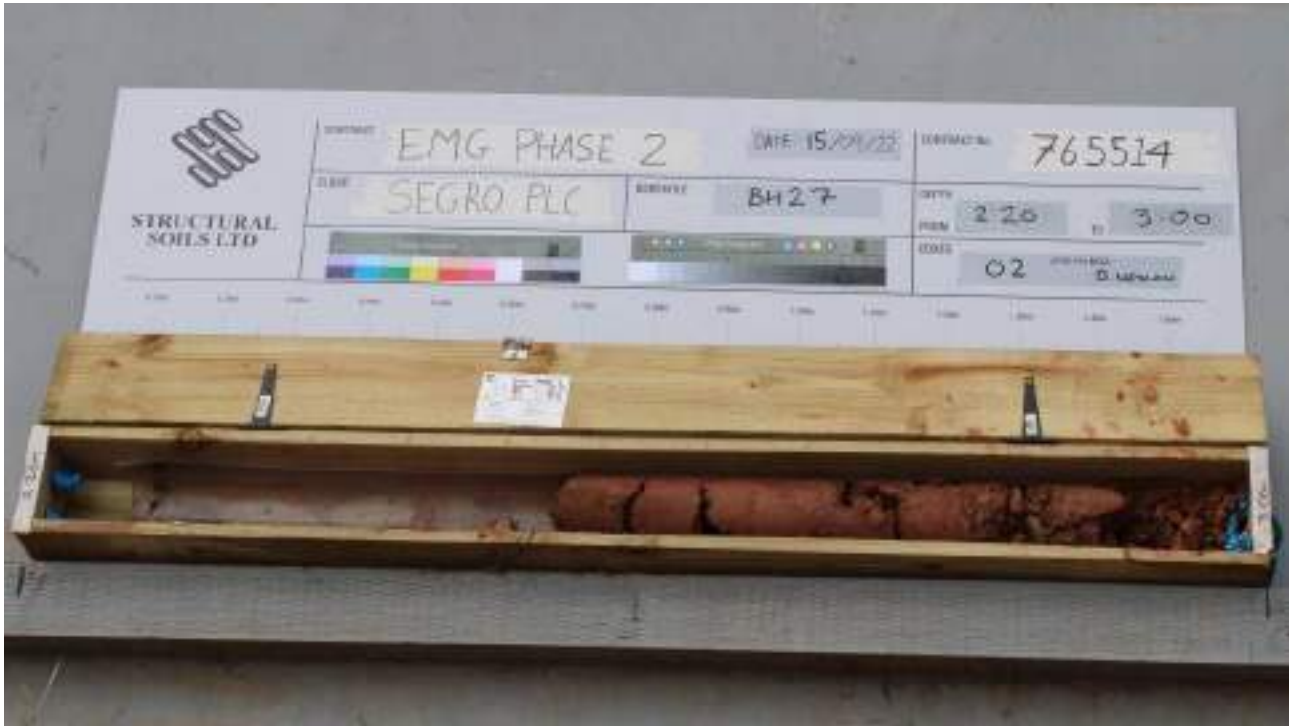
Contract: EMG Phase 2			Client: SEGRO		Borehole: BH27
Contract Ref: 765514	Start: 12.09.22 End: 14.09.22	Ground Level (m AOD): 59.09	National Grid Co-ordinate: E:446622.8 N:324516.7		Sheet: 8 of 17

Method Used: Inspection pit + Dynamic sampling + Rotary Cored	Plant Used: Comacchio GEO 205	Drilled By: Lee Smith	Logged By: DNeylon + JAlton	Checked By: AS	AGS
---	-------------------------------	-----------------------	-----------------------------	----------------	-----

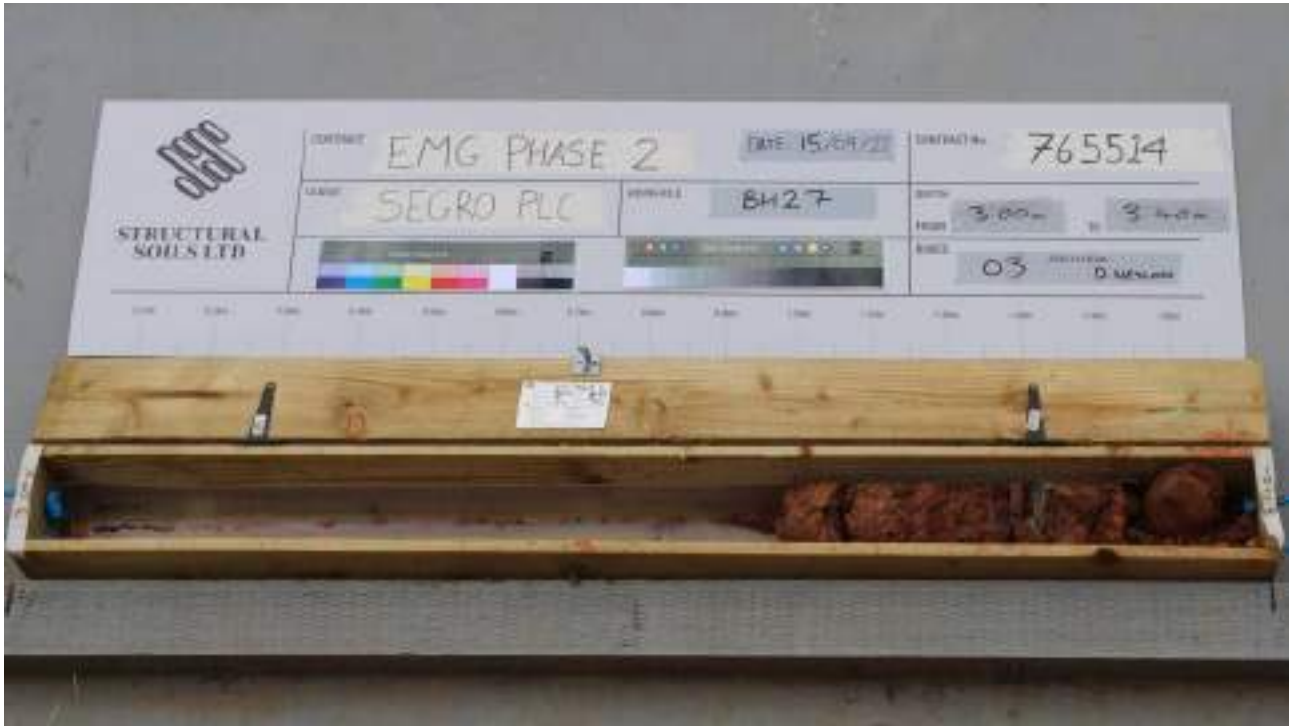
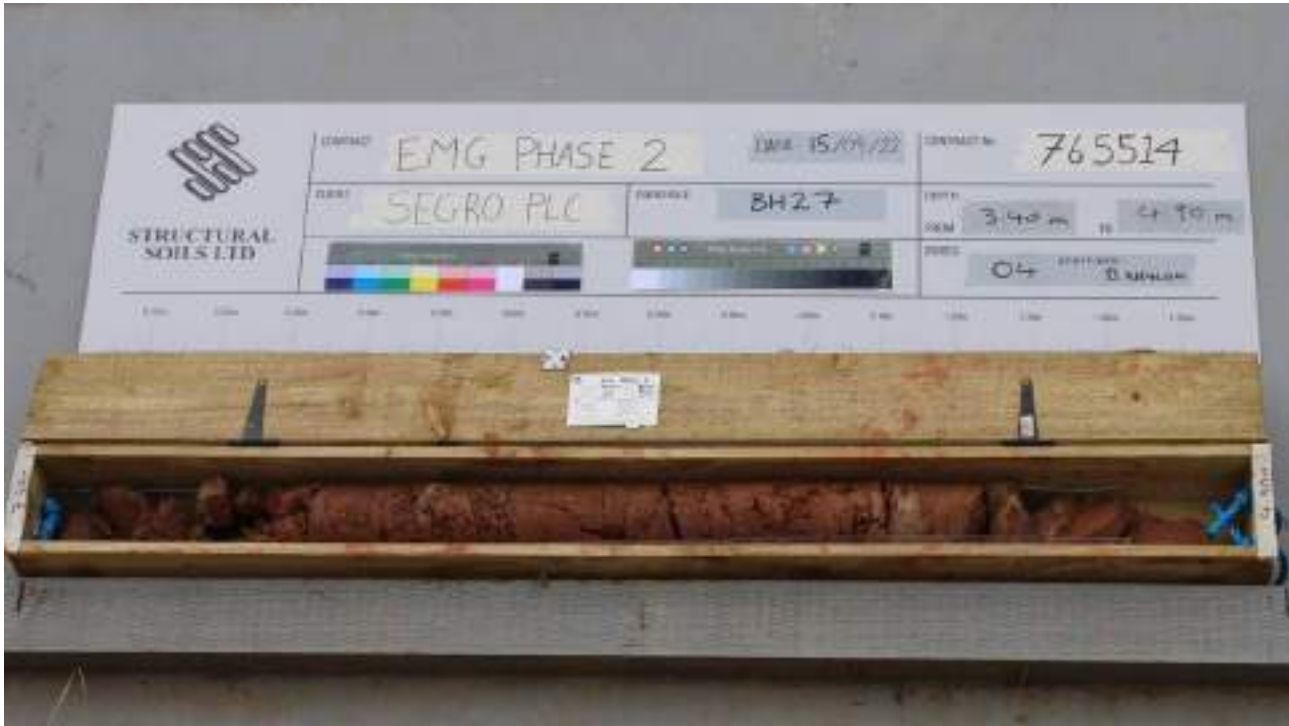
Contract: EMG Phase 2			Client: SEGRO		Borehole: BH27
Contract Ref: 765514	Start: 12.09.22 End: 14.09.22	Ground Level (m AOD): 59.09	National Grid Co-ordinate: E:446622.8 N:324516.7		Sheet: 9 of 17

Method Used: Inspection pit + Dynamic sampling + Rotary Cored	Plant Used: Comacchio GEO 205	Drilled By: Lee Smith	Logged By: DNeylon + JAlton	Checked By: AS	AGS
---	-------------------------------	-----------------------	-----------------------------	----------------	-----

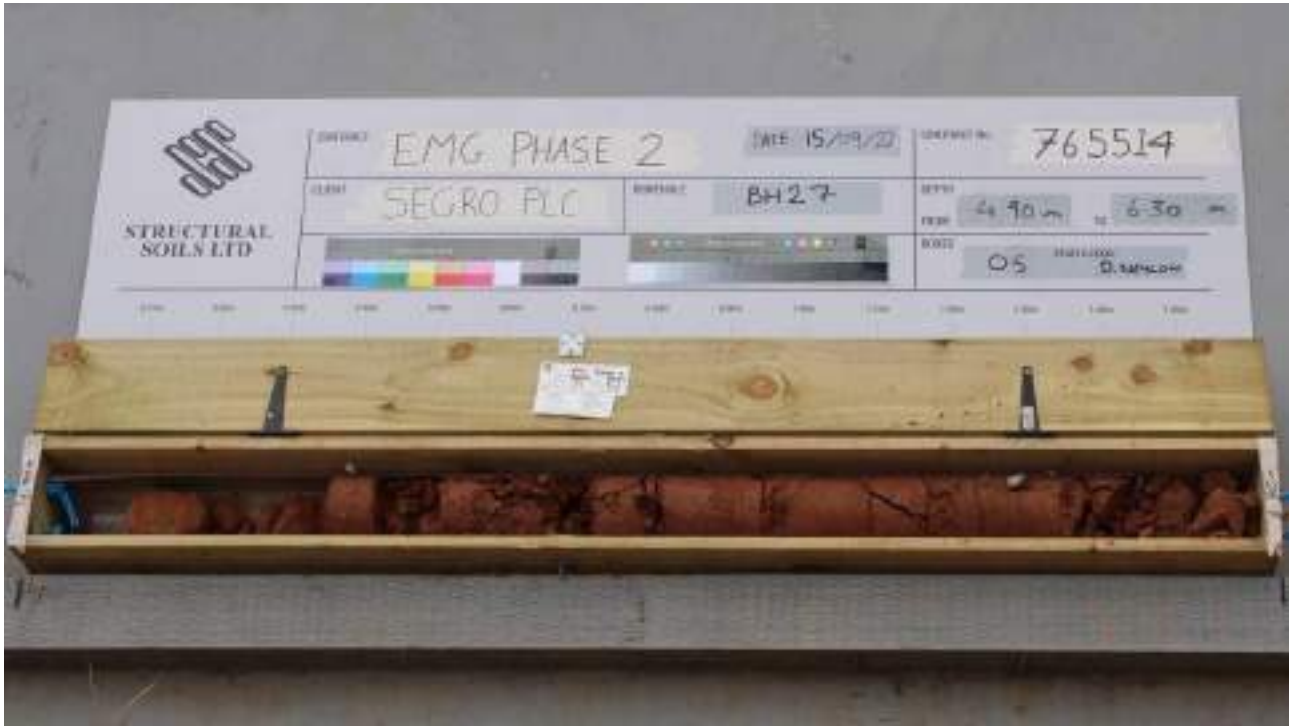
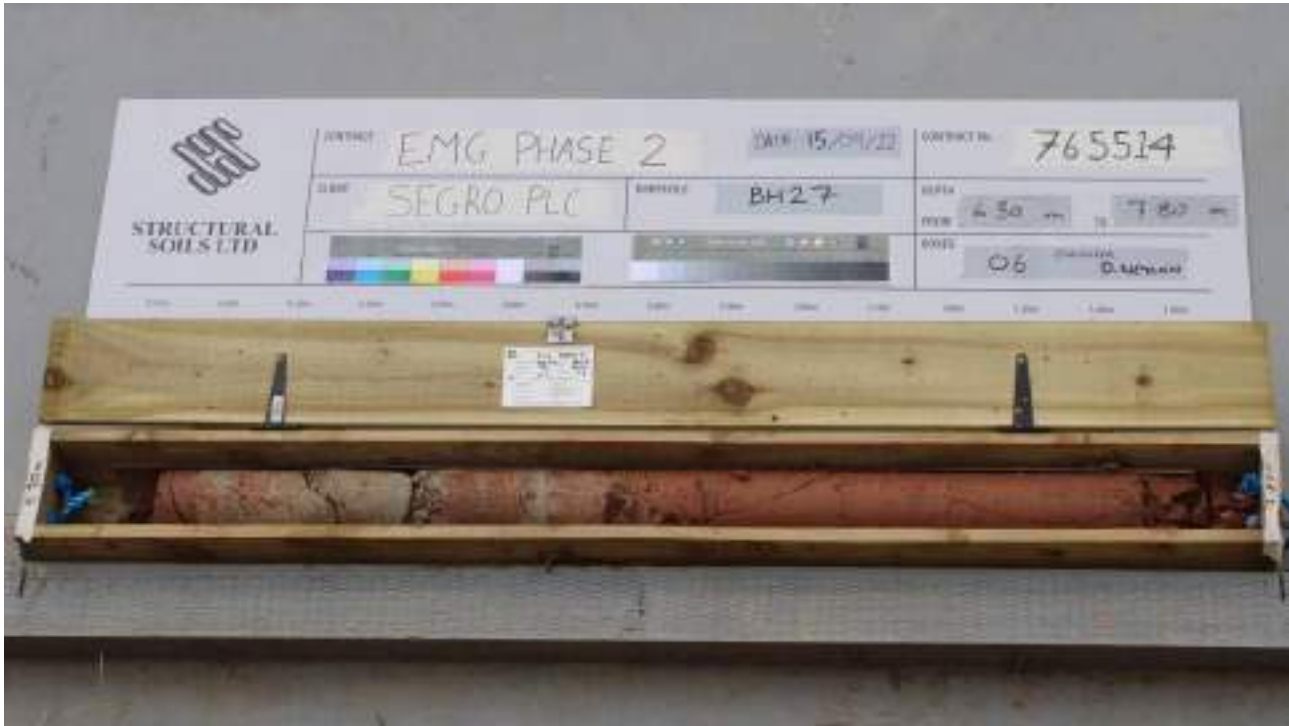
Contract: EMG Phase 2		Client: SEGRO		Borehole: BH27
Contract Ref: 765514	Start: 12.09.22 End: 14.09.22	Ground Level (m AOD): 59.09	National Grid Co-ordinate: E:446622.8 N:324516.7	Sheet: 10 of 17

Method Used: Inspection pit + Dynamic sampling + Rotary Cored	Plant Used: Comacchio GEO 205	Drilled By: Lee Smith	Logged By: DNeylon + JAlton	Checked By: AS	AGS
---	-------------------------------	-----------------------	-----------------------------	----------------	-----

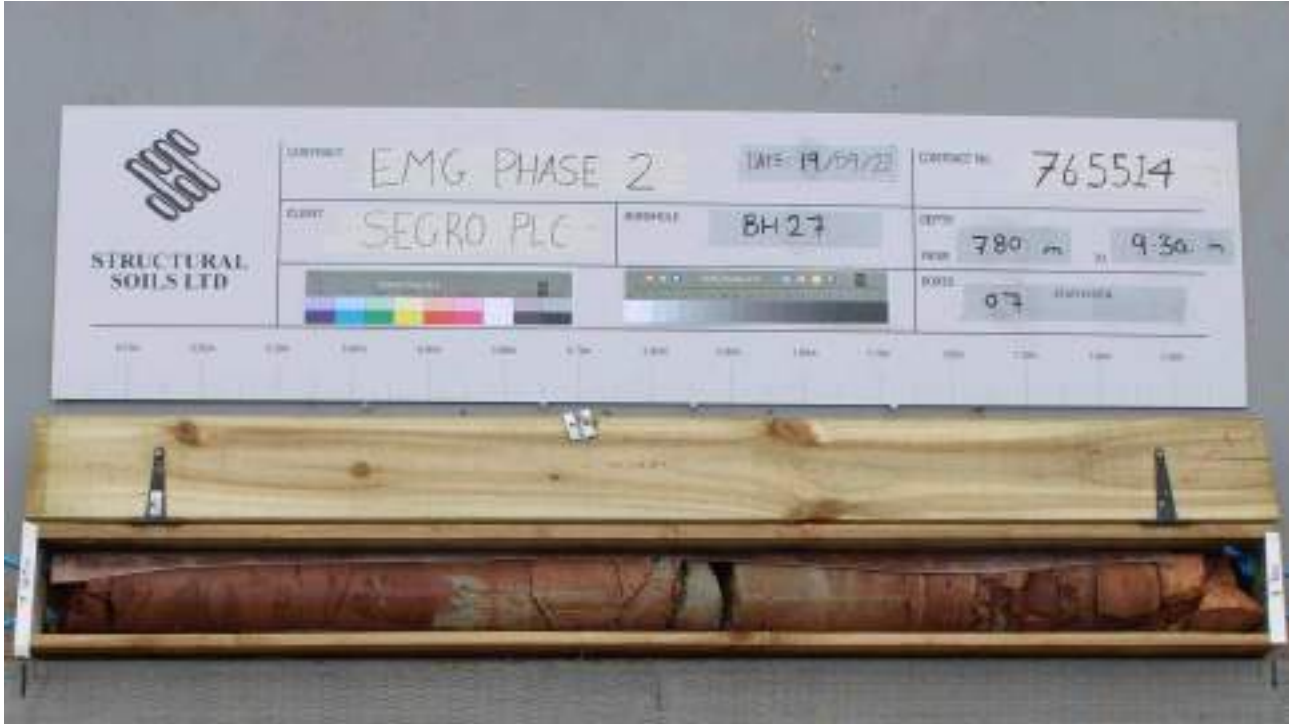
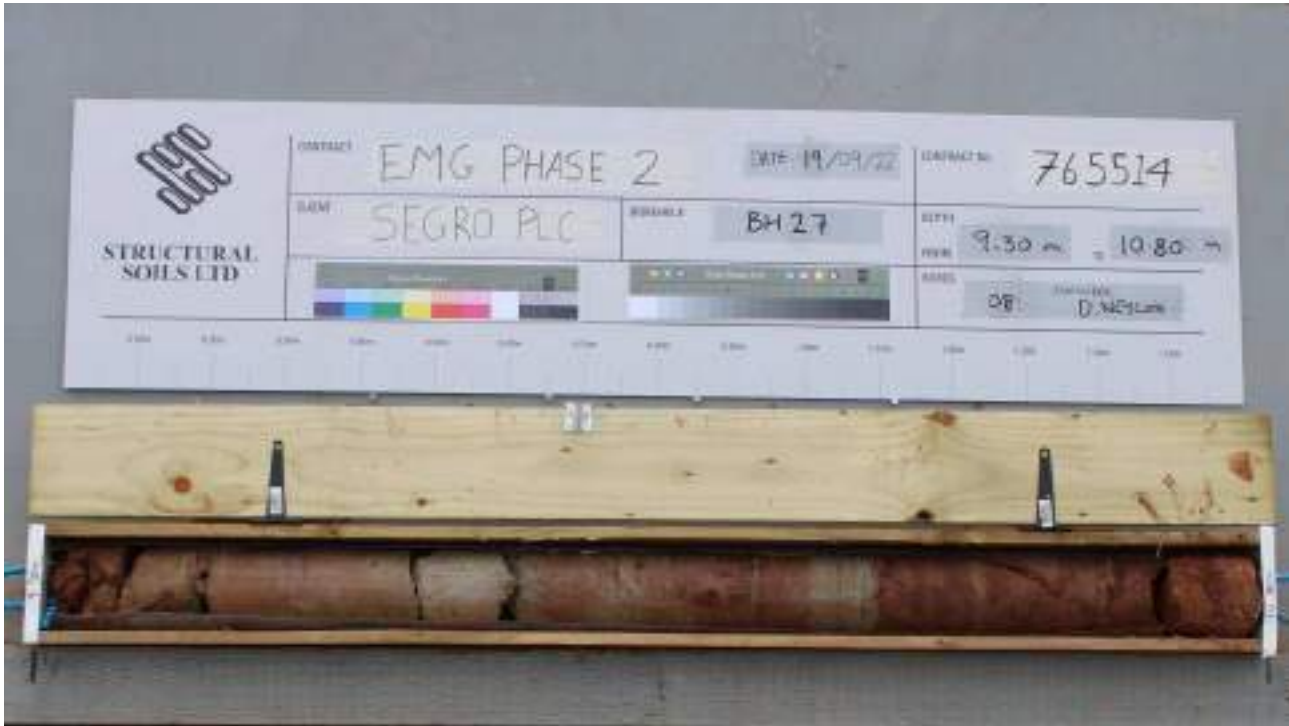
Contract: EMG Phase 2			Client: SEGRO	Borehole: BH27
Contract Ref: 765514	Start: 12.09.22 End: 14.09.22	Ground Level (m AOD): 59.09	National Grid Co-ordinate: E:446622.8 N:324516.7	Sheet: 11 of 17

Method Used: Inspection pit + Dynamic sampling + Rotary Cored	Plant Used: Comacchio GEO 205	Drilled By: Lee Smith	Logged By: D.Neylon + J.Allton	Checked By: AS	AGS
---	-------------------------------	-----------------------	--------------------------------	----------------	-----

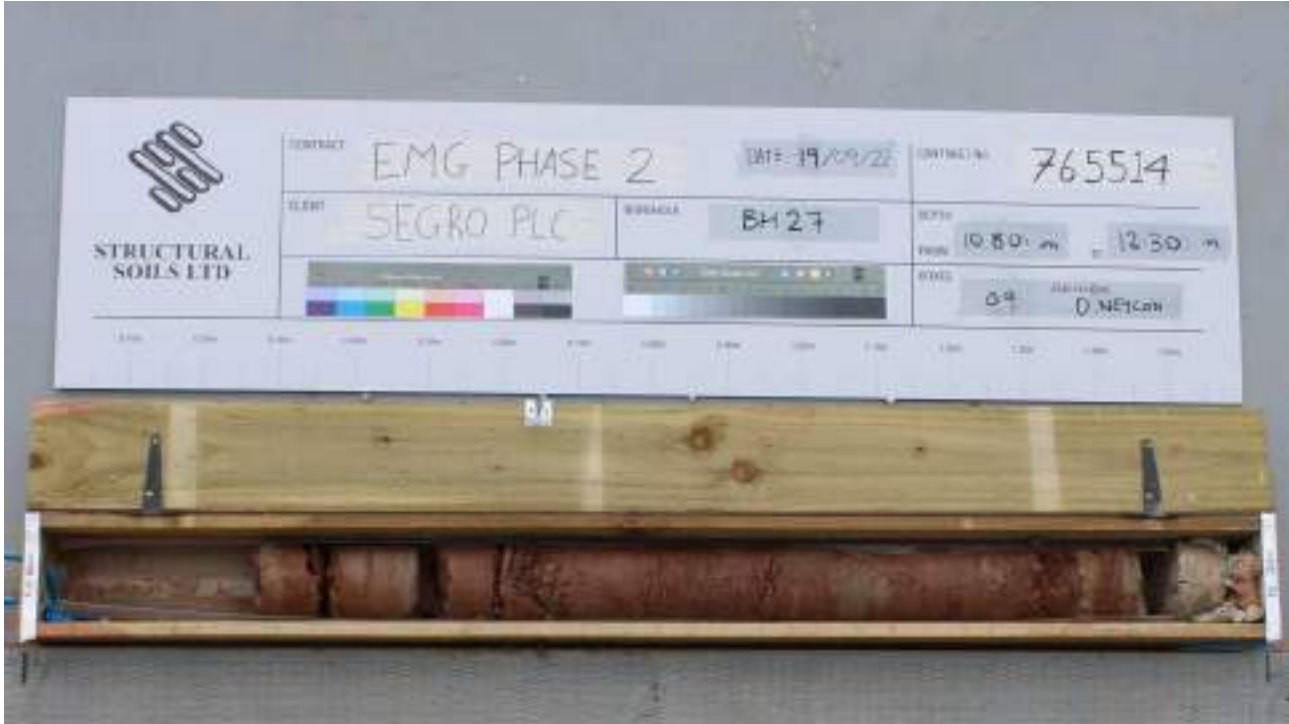
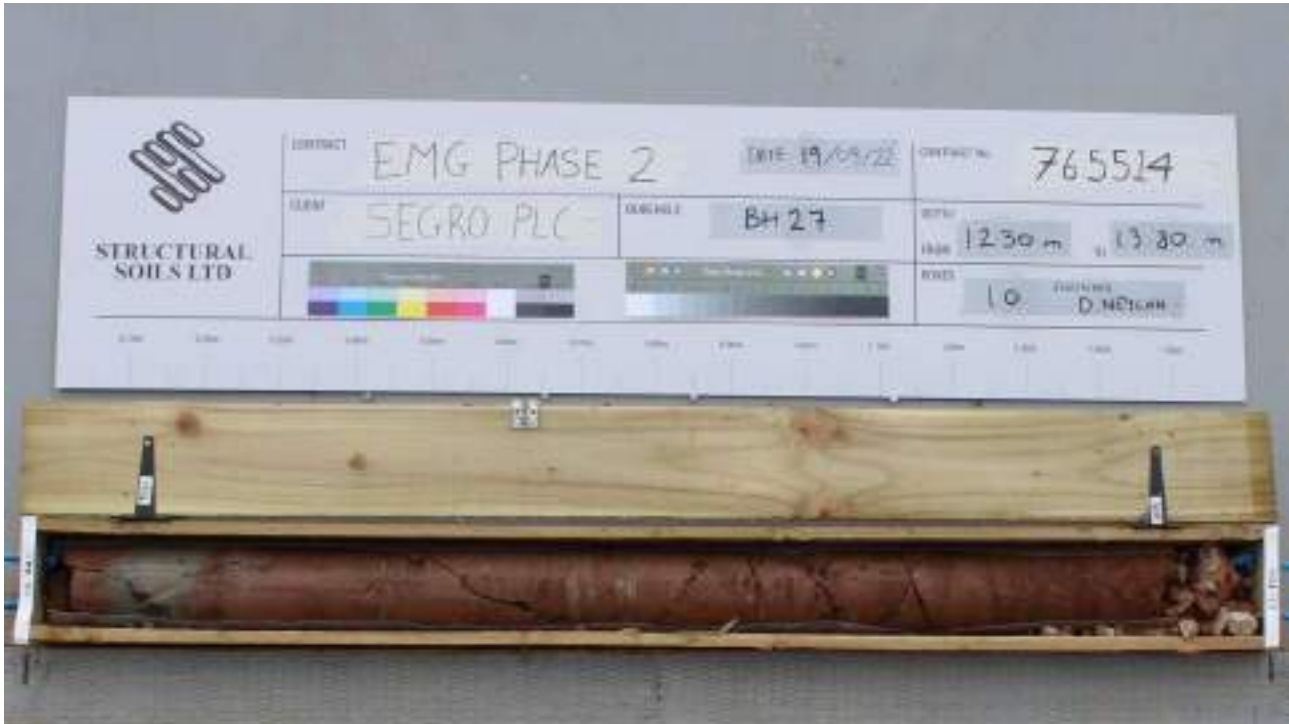
Contract: EMG Phase 2			Client: SEGRO		Borehole: BH27
Contract Ref: 765514	Start: 12.09.22 End: 14.09.22	Ground Level (m AOD): 59.09	National Grid Co-ordinate: E:446622.8 N:324516.7		Sheet: 12 of 17

Method Used: Inspection pit + Dynamic sampling + Rotary Cored	Plant Used: Comacchio GEO 205	Drilled By: Lee Smith	Logged By: D.Neylan + J.Allton	Checked By: AS	AGS
---	-------------------------------	-----------------------	--------------------------------	----------------	-----

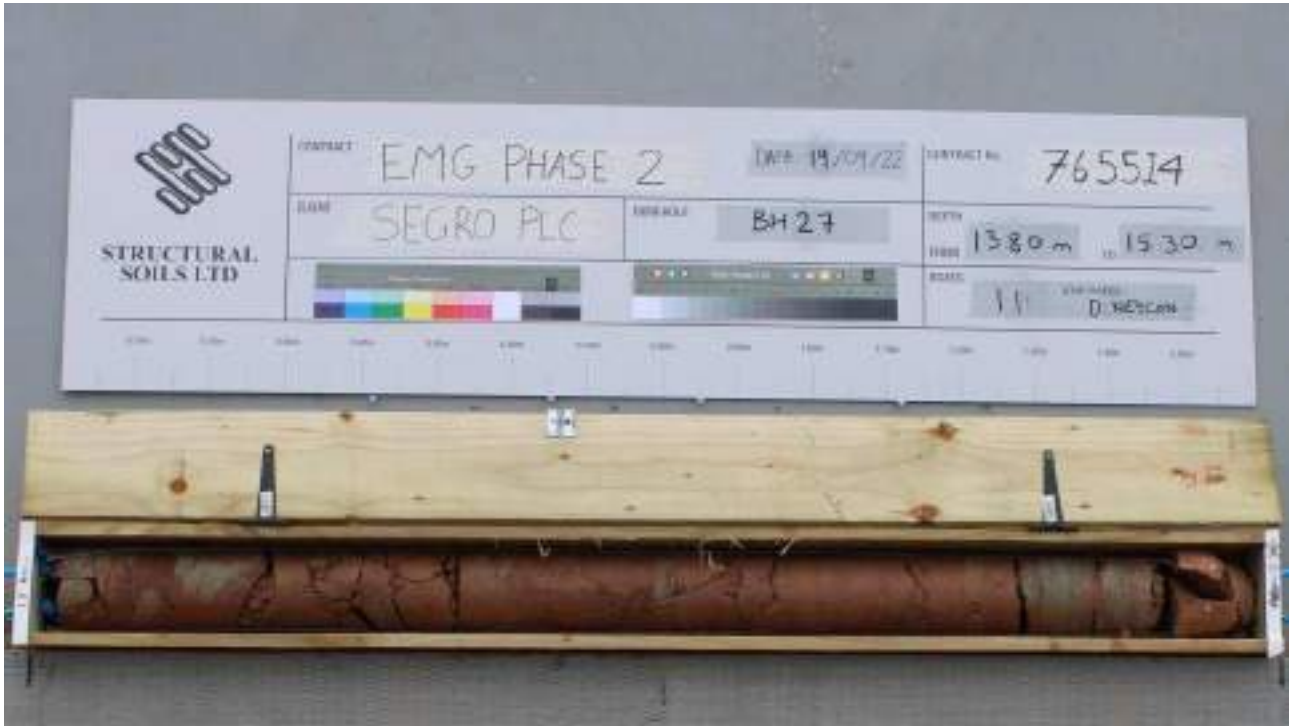
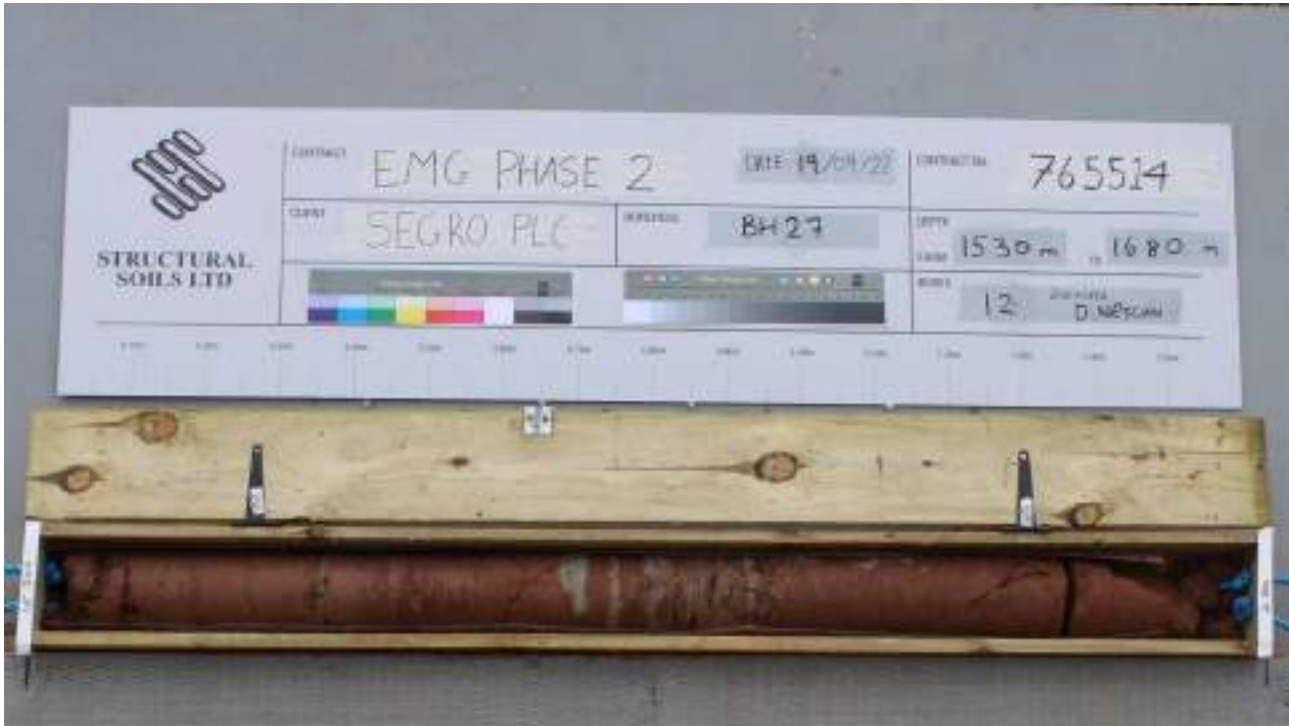
Contract: EMG Phase 2			Client: SEGRO	Borehole: BH27
Contract Ref: 765514	Start: 12.09.22 End: 14.09.22	Ground Level (m AOD): 59.09	National Grid Co-ordinate: E:446622.8 N:324516.7	Sheet: 13 of 17

Method Used: Inspection pit + Dynamic sampling + Rotary Cored	Plant Used: Comacchio GEO 205	Drilled By: Lee Smith	Logged By: D.Neylon + J.Allton	Checked By: AS	AGS
---	-------------------------------	-----------------------	--------------------------------	----------------	-----

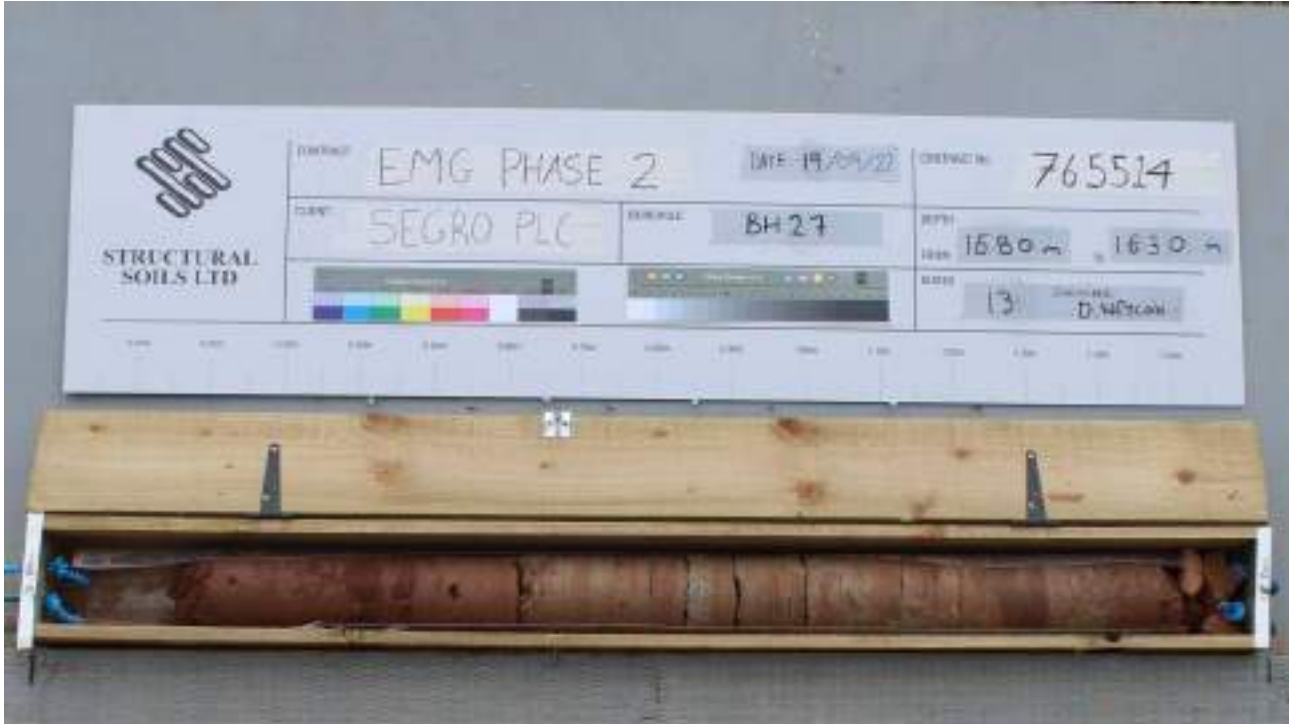
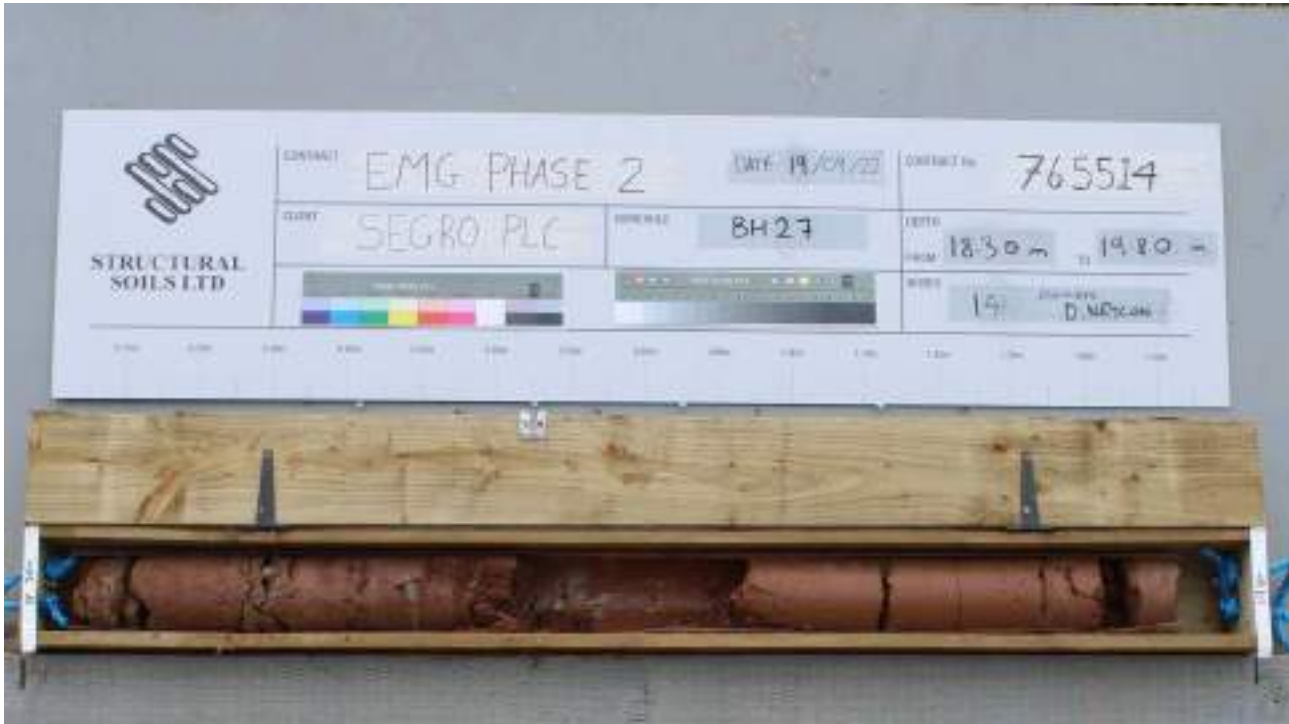
Contract: EMG Phase 2			Client: SEGRO		Borehole: BH27
Contract Ref: 765514	Start: 12.09.22	Ground Level (m AOD): 59.09	National Grid Co-ordinate: E:446622.8 N:324516.7		Sheet: 14 of 17
End: 14.09.22

Method Used: Inspection pit + Dynamic sampling + Rotary Cored	Plant Used: Comacchio GEO 205	Drilled By: Lee Smith	Logged By: D.Neylon + J.Allton	Checked By: AS	AGS
---	-------------------------------	-----------------------	--------------------------------	----------------	-----

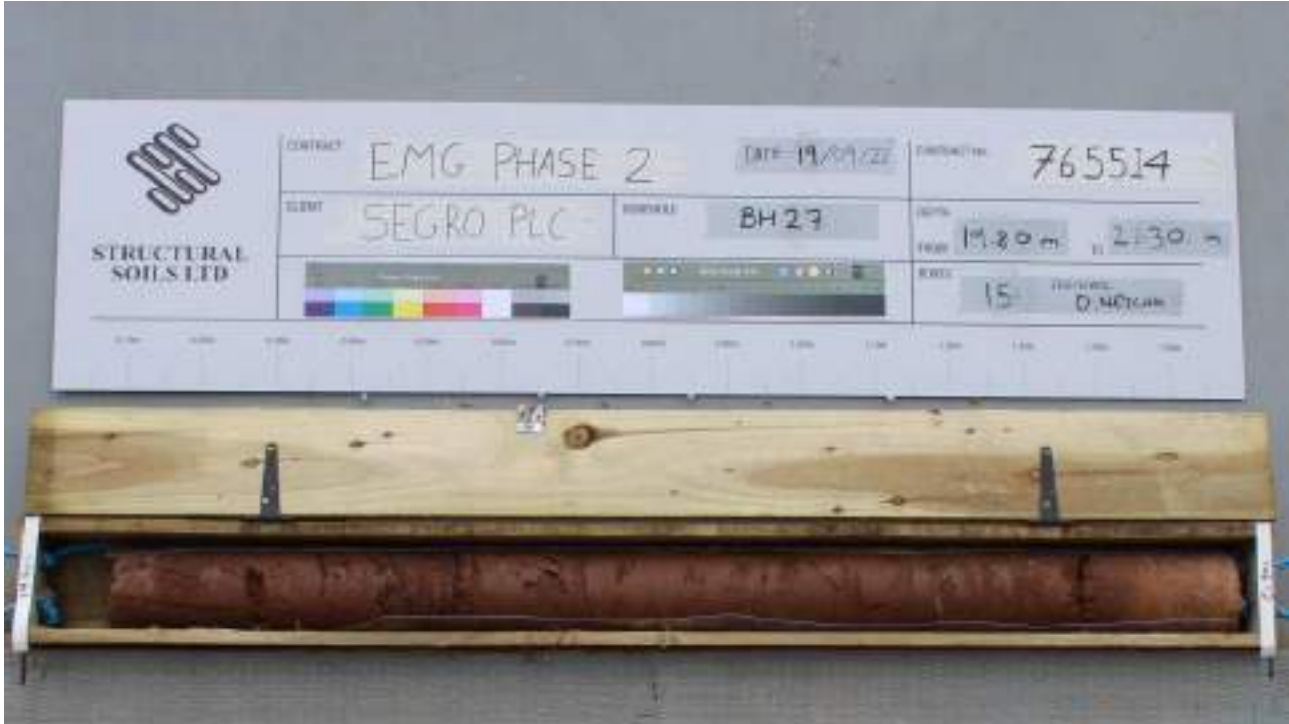
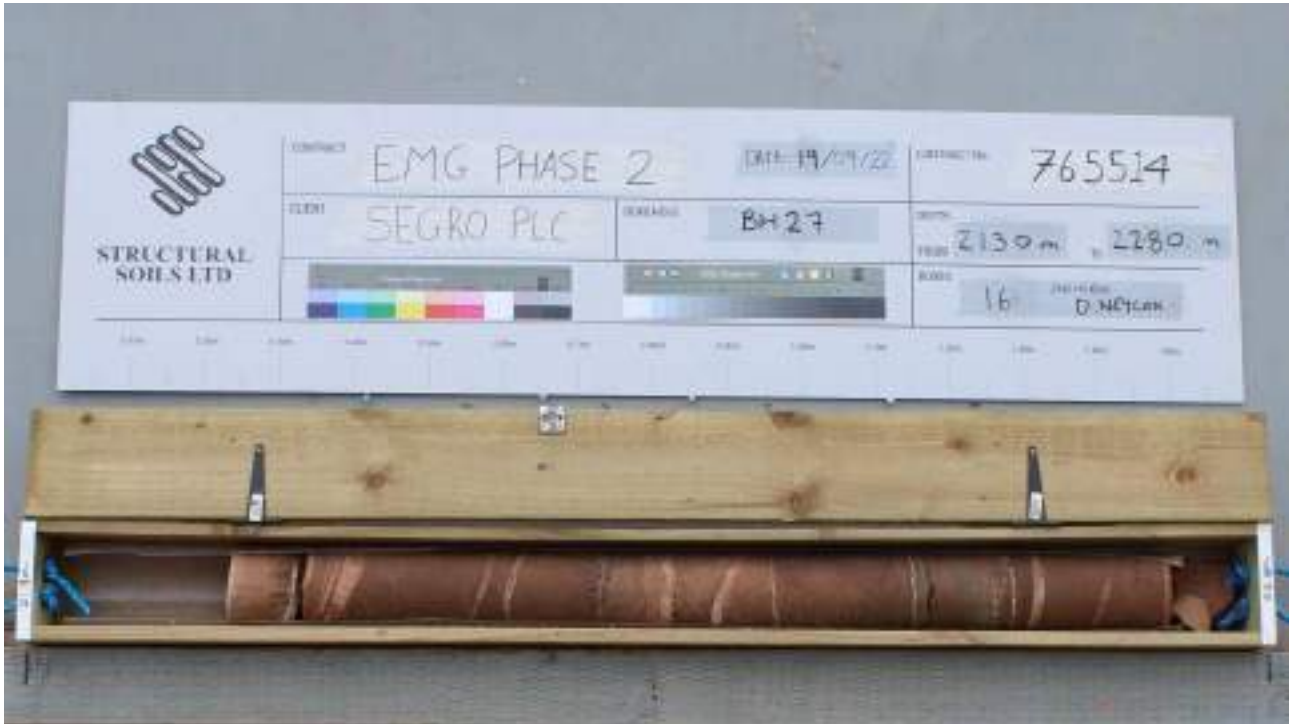
Contract: EMG Phase 2			Client: SEGRO		Borehole: BH27
Contract Ref: 765514	Start: 12.09.22 End: 14.09.22	Ground Level (m AOD): 59.09	National Grid Co-ordinate: E:446622.8 N:324516.7		Sheet: 15 of 17

Method Used: Inspection pit + Dynamic sampling + Rotary Cored	Plant Used: Comacchio GEO 205	Drilled By: Lee Smith	Logged By: D.Neylon + J.Allton	Checked By: AS	AGS
---	-------------------------------	-----------------------	--------------------------------	----------------	-----

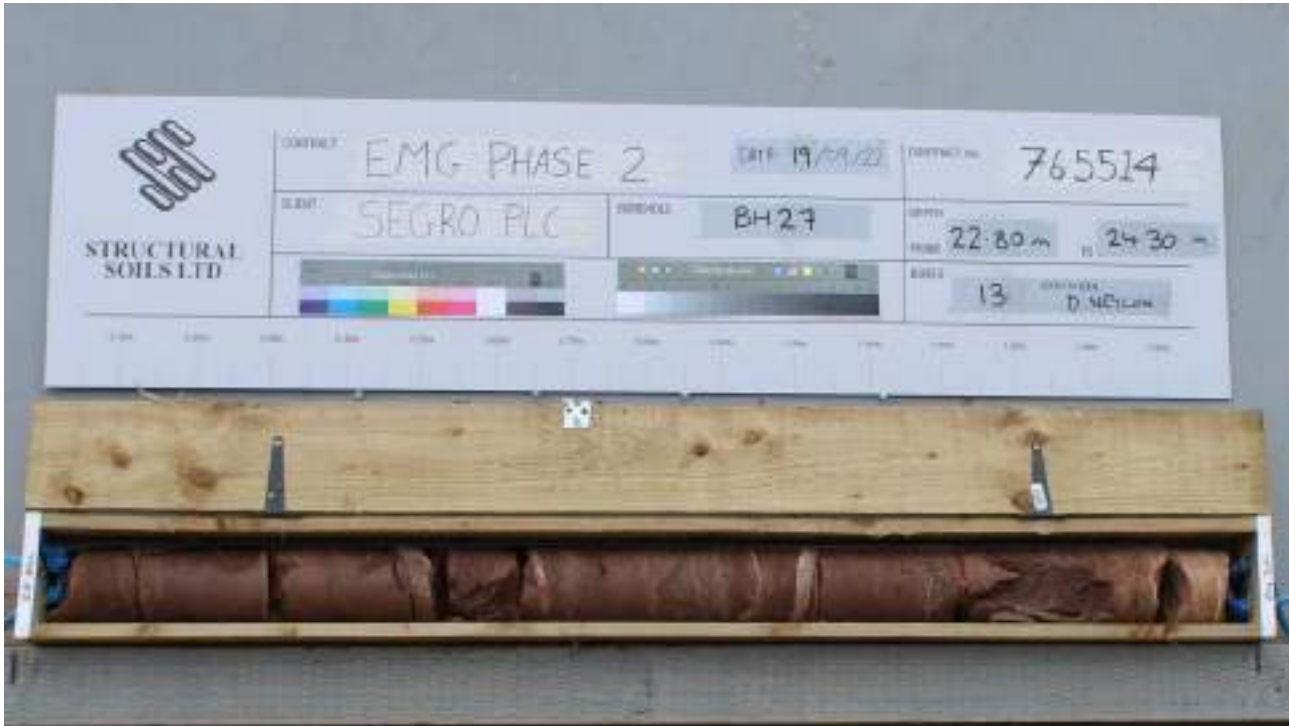
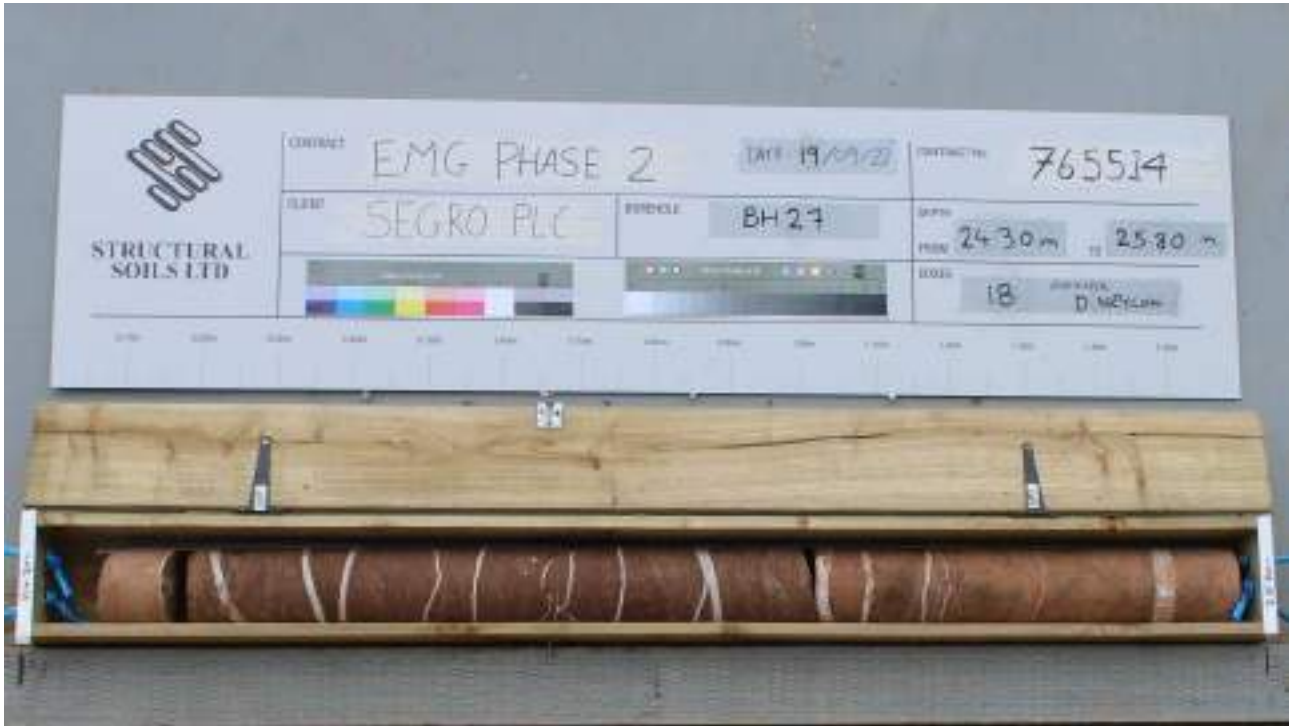
Contract: EMG Phase 2			Client: SEGRO	Borehole: BH27
Contract Ref: 765514	Start: 12.09.22 End: 14.09.22	Ground Level (m AOD): 59.09	National Grid Co-ordinate: E:446622.8 N:324516.7	Sheet: 16 of 17

Method Used: Inspection pit + Dynamic sampling + Rotary Cored	Plant Used: Comacchio GEO 205	Drilled By: Lee Smith	Logged By: D.Neylon + J.Allton	Checked By: AS	AGS
---	-------------------------------	-----------------------	--------------------------------	----------------	-----
