**East Midlands Gateway
Phase 2 (EMG2)**

Fairhurst Ground Investigation Report (EMG2)

Ground Investigation Report

East Midlands Gateway Phase 2,
Land South of East Midlands
Airport, Derby

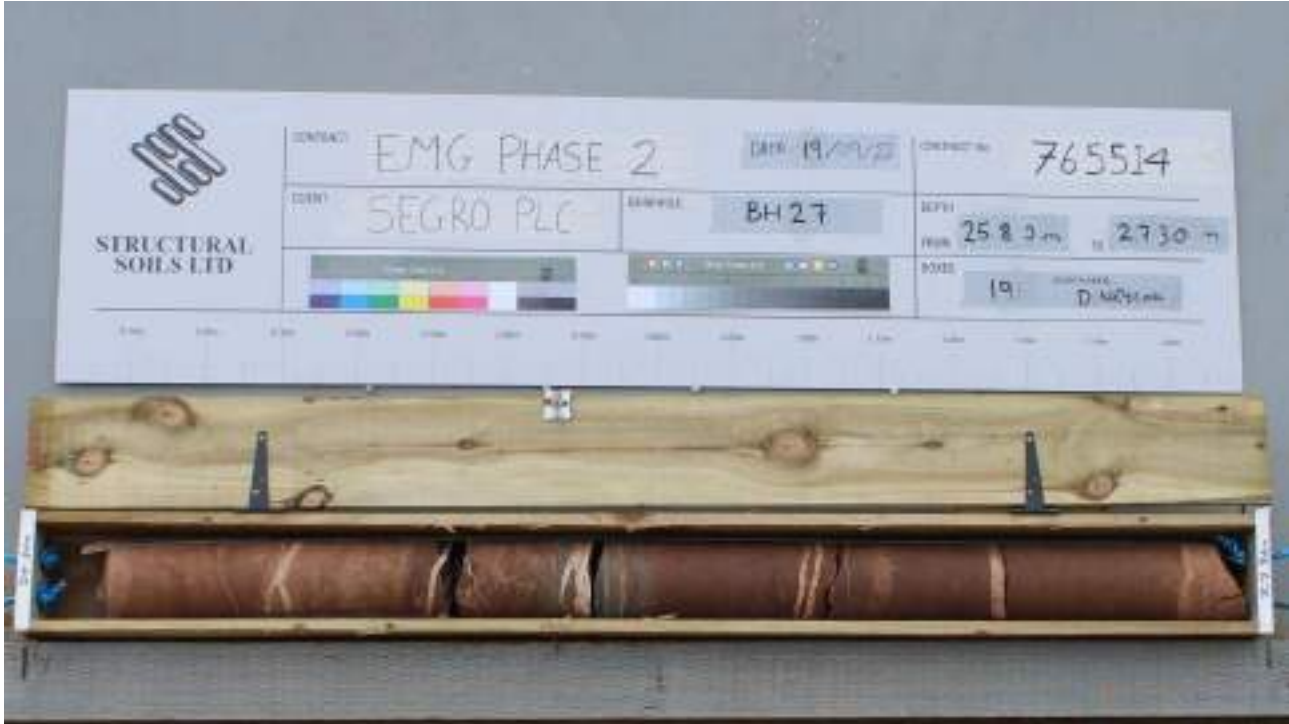
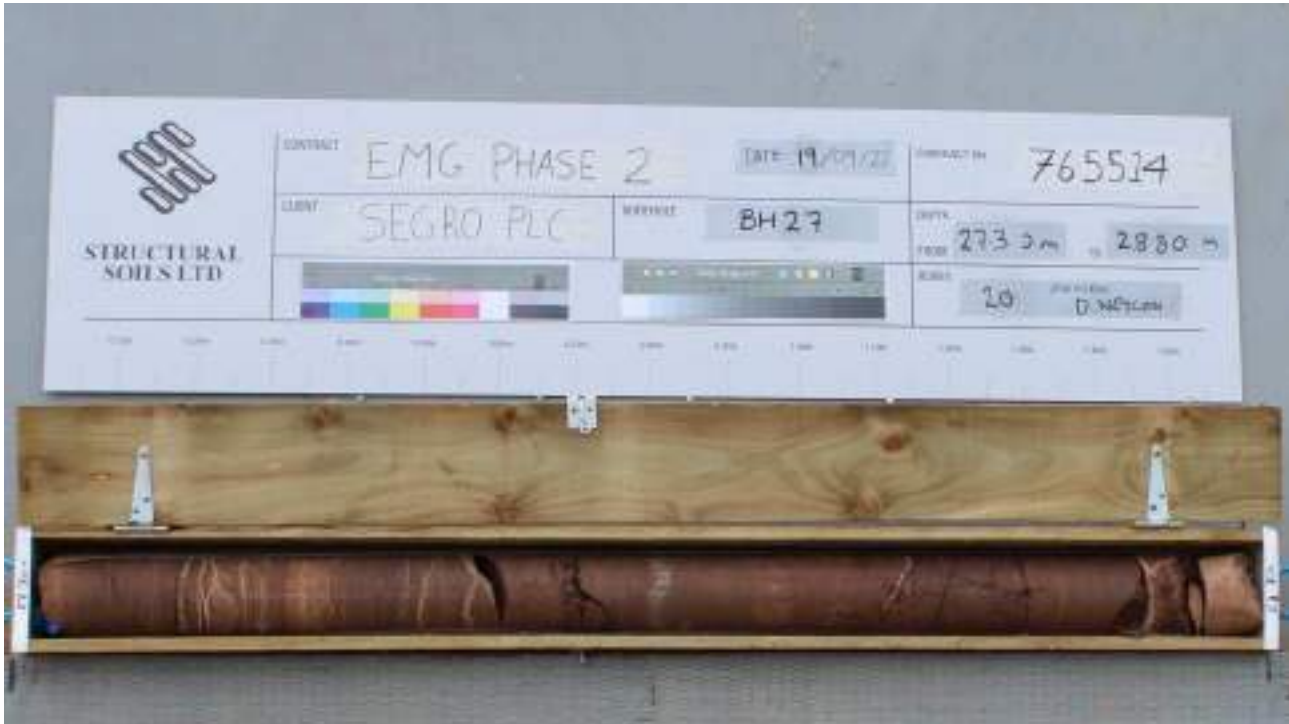
Contract: EMG Phase 2		Client: SEGRO		Borehole: BH27
Contract Ref: 765514	Start: 12.09.22 End: 14.09.22	Ground Level (m AOD): 59.09	National Grid Co-ordinate: E:446622.8 N:324516.7	Sheet: 17 of 17

Method Used: Inspection pit + Dynamic sampling + Rotary Cored	Plant Used: Comacchio GEO 205	Drilled By: Lee Smith	Logged By: D.Neyton + J.Allton	Checked By: AS	AGS
--	----------------------------------	--------------------------	--------------------------------------	-------------------	-----

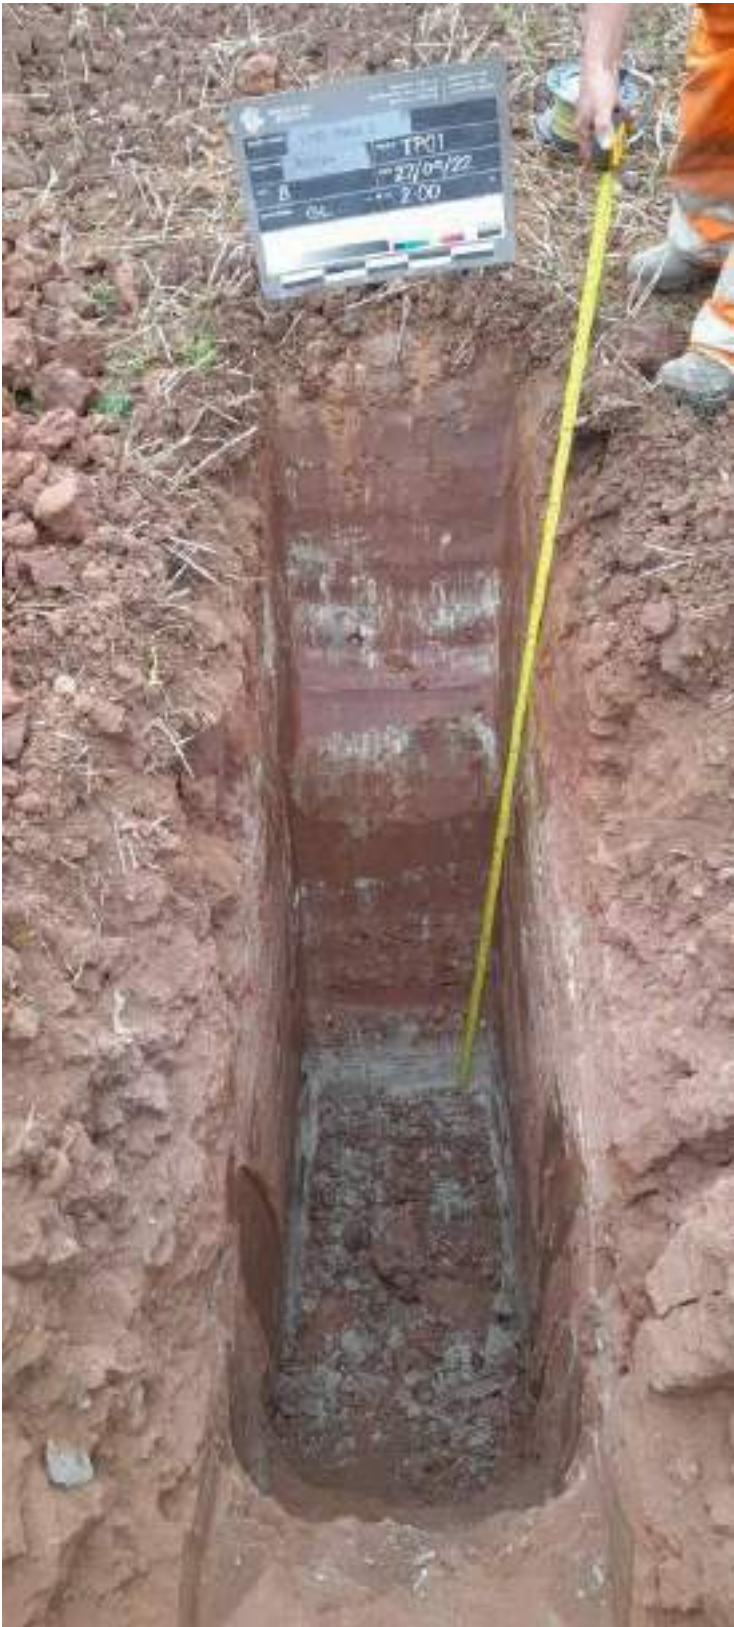
Face 1

Contract: EMG Phase 2		Client: SEGRO		Trial Pit: TP01
Contract Ref: 765514	Start: 27.09.22 End: 27.09.22	Ground Level (m AOD): 90.15	National Grid Co-ordinate: E:446482.7 N:325312.7	Sheet: 2 of 3

Method Used: Machine dug	Plant Used: Tracked excavator	Logged By: GKalaher	Checked By: RL	
---------------------------------	--------------------------------------	----------------------------	-----------------------	--

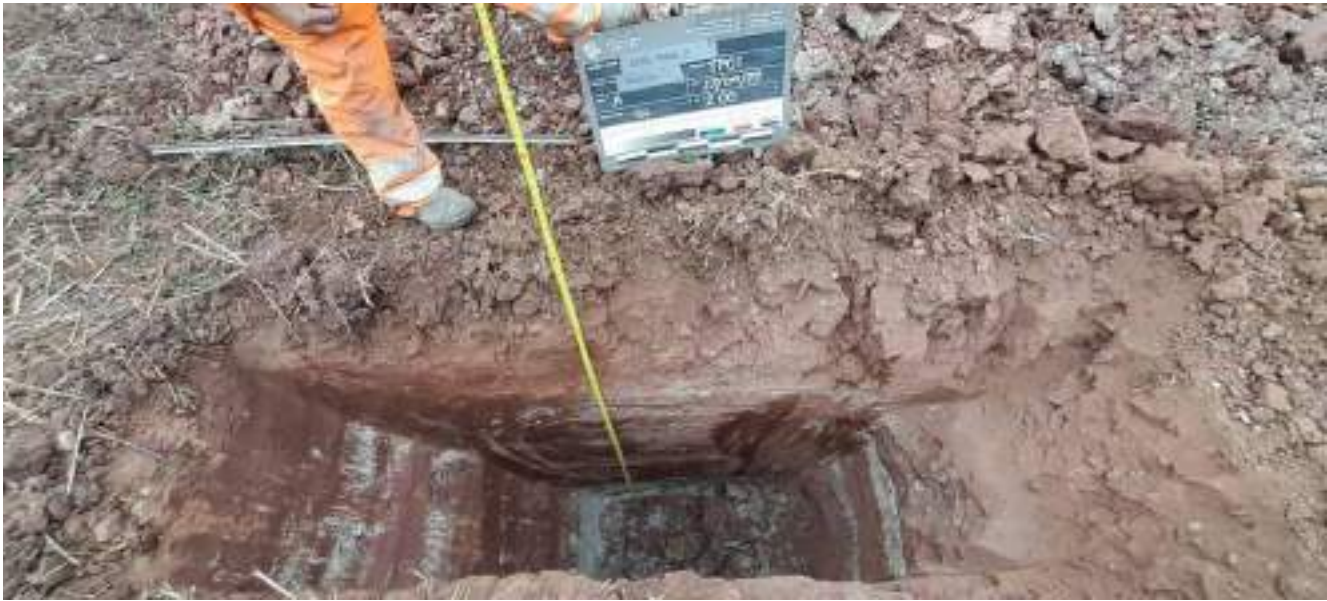
Contract: EMG Phase 2		Client: SEGRO		Trial Pit: TP01
Contract Ref: 765514	Start: 27.09.22 End: 27.09.22	Ground Level (m AOD): 90.15	National Grid Co-ordinate: E:446482.7 N:325312.7	Sheet: 3 of 3

Method Used: Machine dug	Plant Used: Tracked excavator	Logged By: GKalaher	Checked By: RL	
---------------------------------	--------------------------------------	----------------------------	-----------------------	--

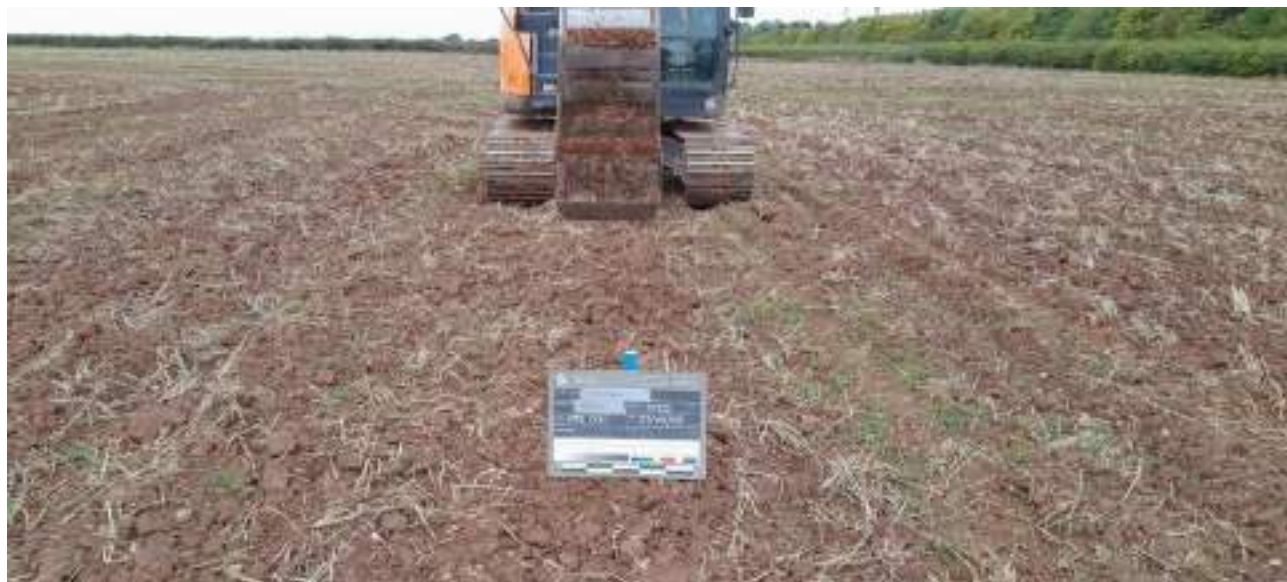
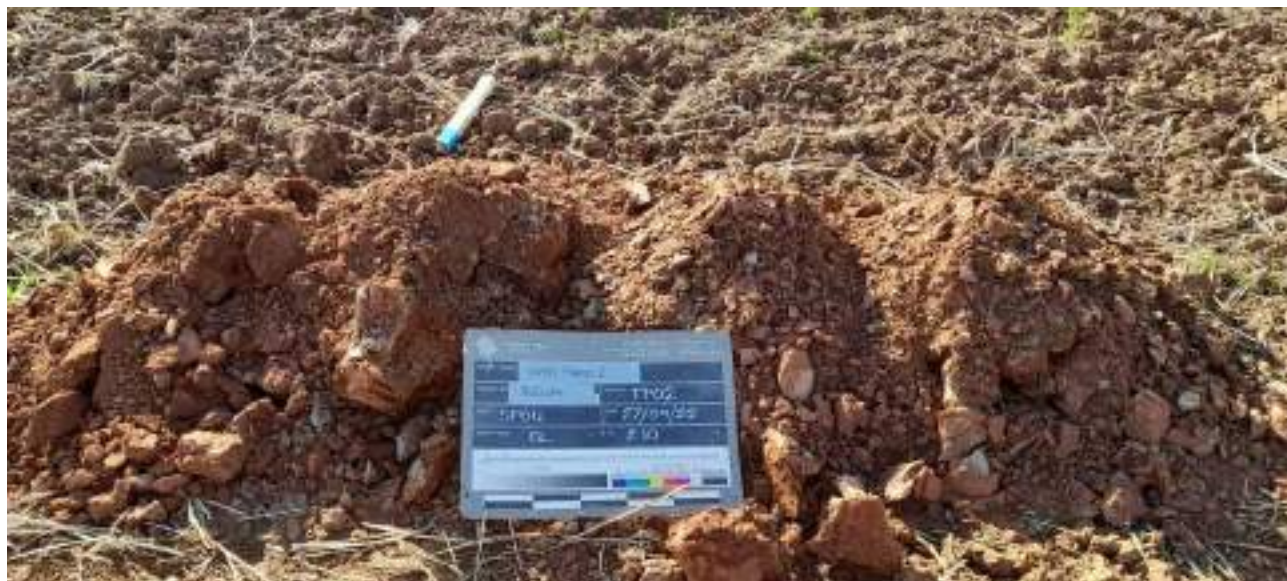
Contract: EMG Phase 2		Client: SEGRO		Trial Pit: TP02
Contract Ref: 765514	Start: 27.09.22 End: 27.09.22	Ground Level (m AOD): 87.34	National Grid Co-ordinate: E:446247.8 N:325352.0	Sheet: 2 of 3

Method Used: Machine dug	Plant Used: Tracked excavator	Logged By: GKalaher	Checked By: RL	
---------------------------------	--------------------------------------	----------------------------	-----------------------	--

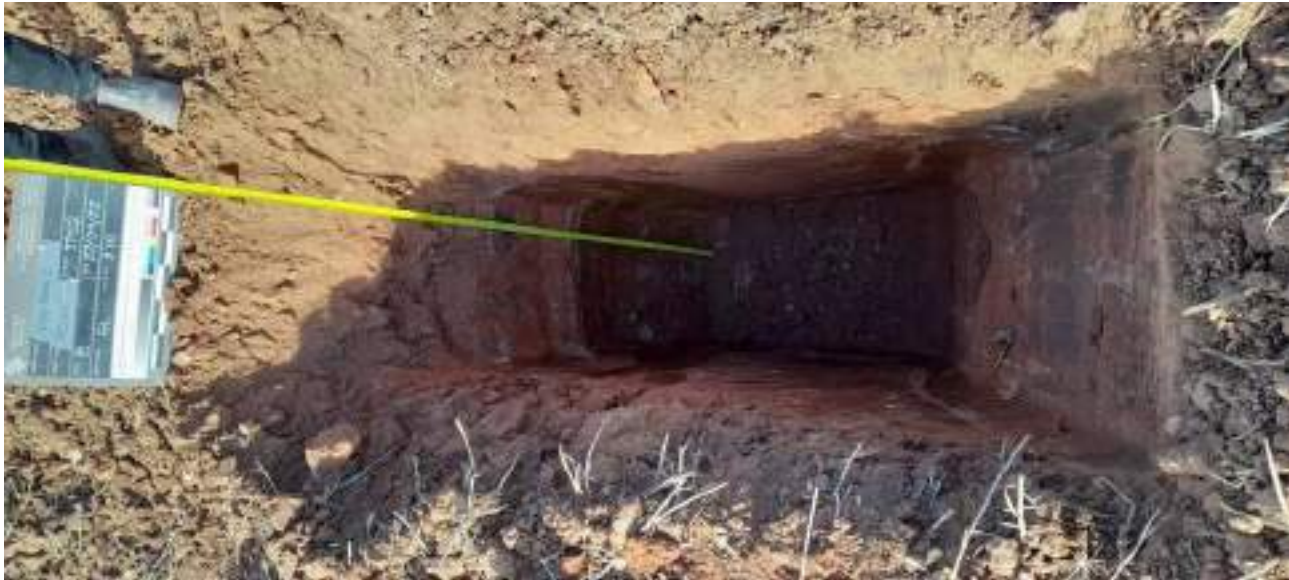
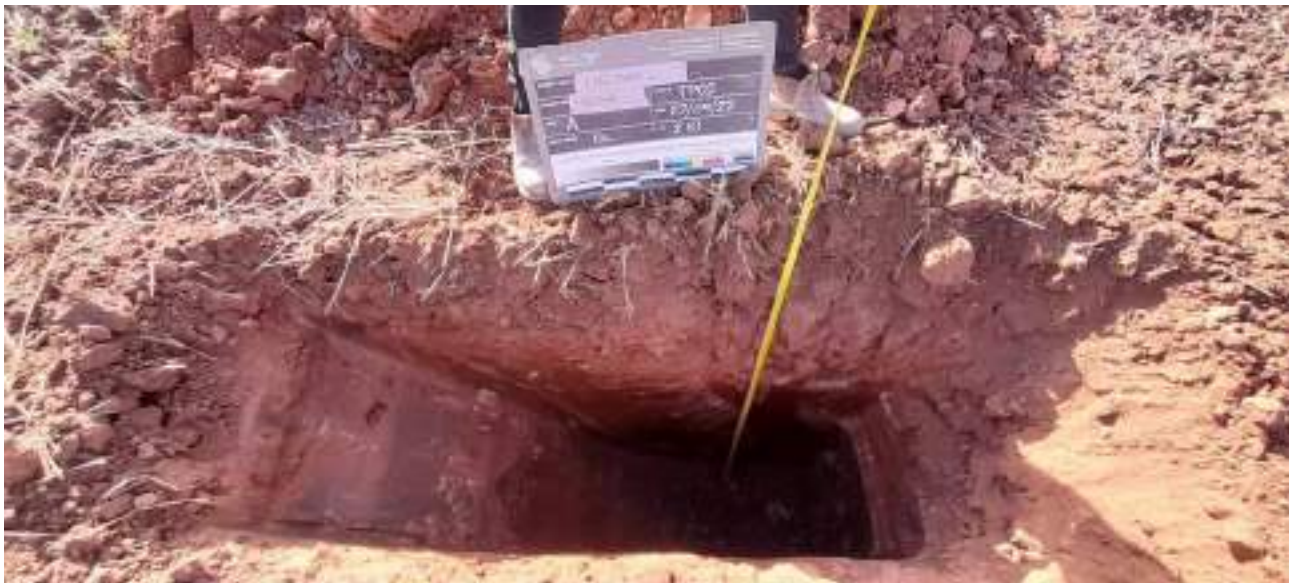
Contract: EMG Phase 2		Client: SEGRO		Trial Pit: TP02
Contract Ref: 765514	Start: 27.09.22 End: 27.09.22	Ground Level (m AOD): 87.34	National Grid Co-ordinate: E:446247.8 N:325352.0	Sheet: 3 of 3

Method Used: Machine dug	Plant Used: Tracked excavator	Logged By: GKalaher	Checked By: RL	
---------------------------------	--------------------------------------	----------------------------	-----------------------	--

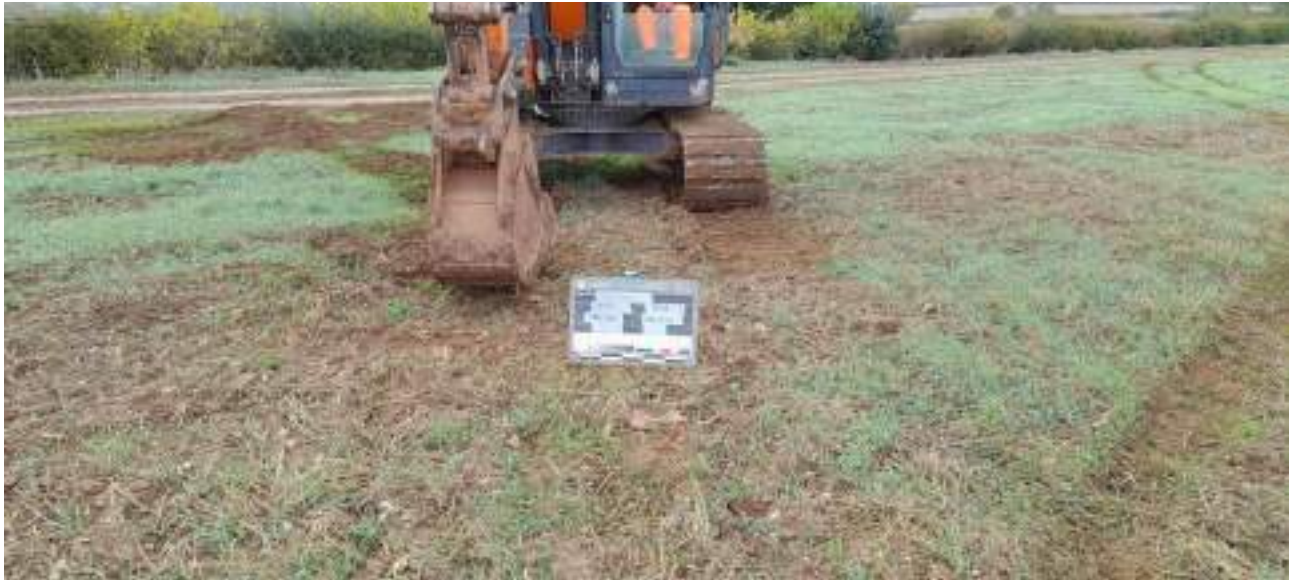
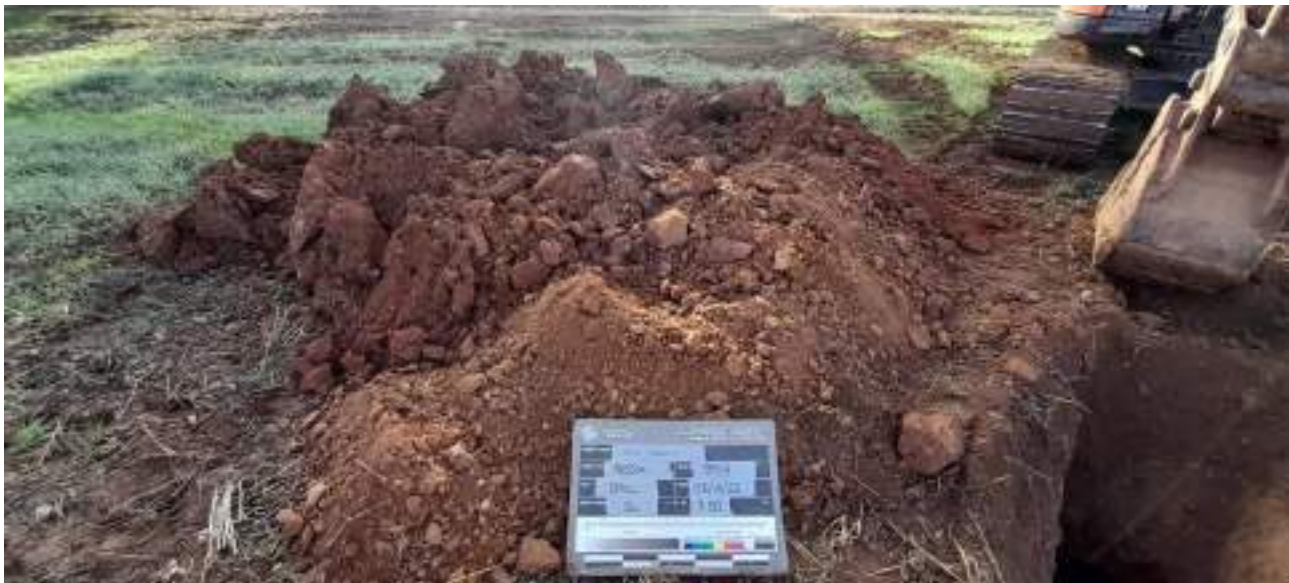
Contract: EMG Phase 2			Client: SEGRO		Trial Pit: TP03
Contract Ref: 765514	Start: 03.10.22 End: 03.10.22	Ground Level (m AOD): 90.59	National Grid Co-ordinate: E:446327.3 N:325173.4		Sheet: 2 of 5

Method Used: Machine dug	Plant Used: Tracked excavator	Logged By: GKalaher	Checked By: RL	
---------------------------------	--------------------------------------	----------------------------	-----------------------	--

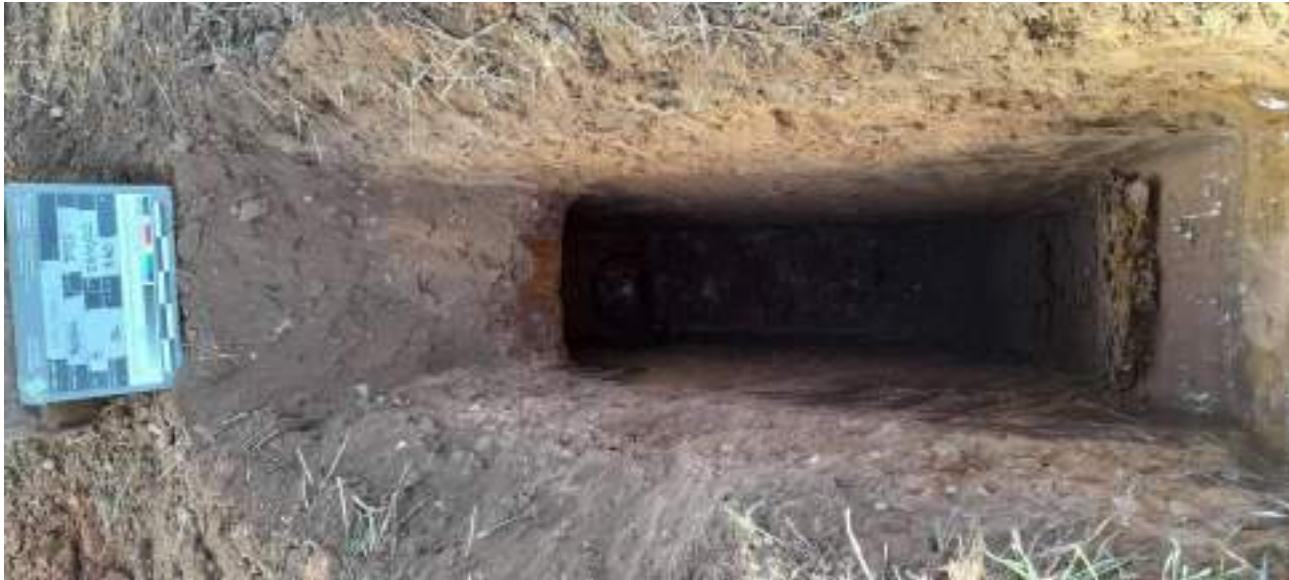
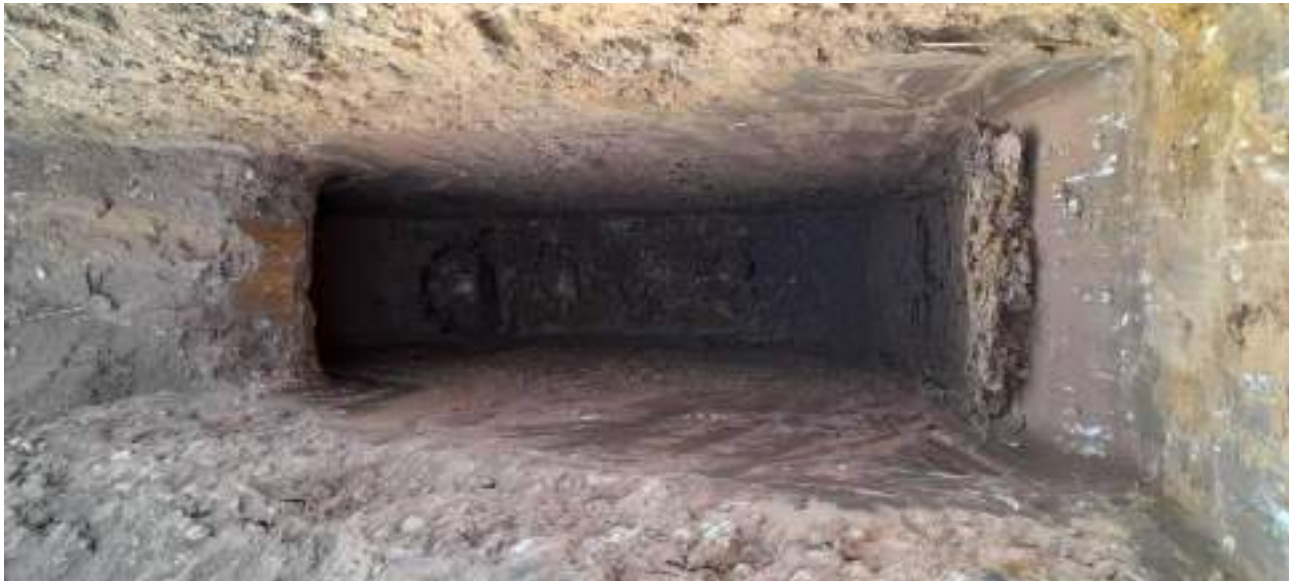
Contract: EMG Phase 2		Client: SEGRO		Trial Pit: TP03
Contract Ref: 765514	Start: 03.10.22 End: 03.10.22	Ground Level (m AOD): 90.59	National Grid Co-ordinate: E:446327.3 N:325173.4	Sheet: 3 of 5

Method Used: Machine dug	Plant Used: Tracked excavator	Logged By: GKalaher	Checked By: RL	
---------------------------------	--------------------------------------	----------------------------	-----------------------	--

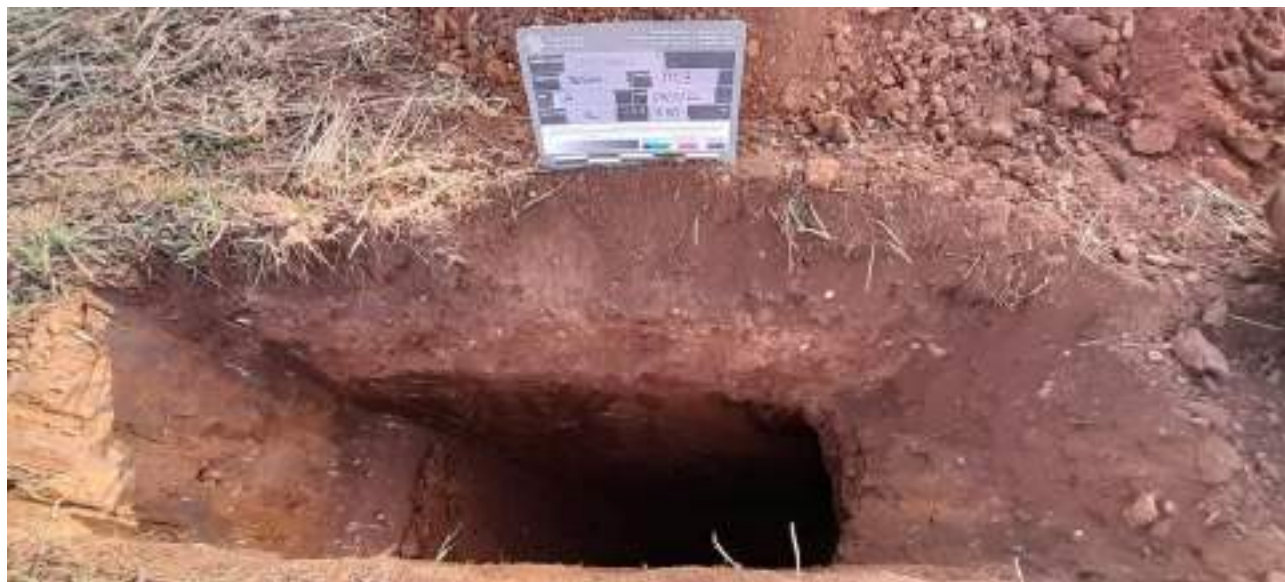
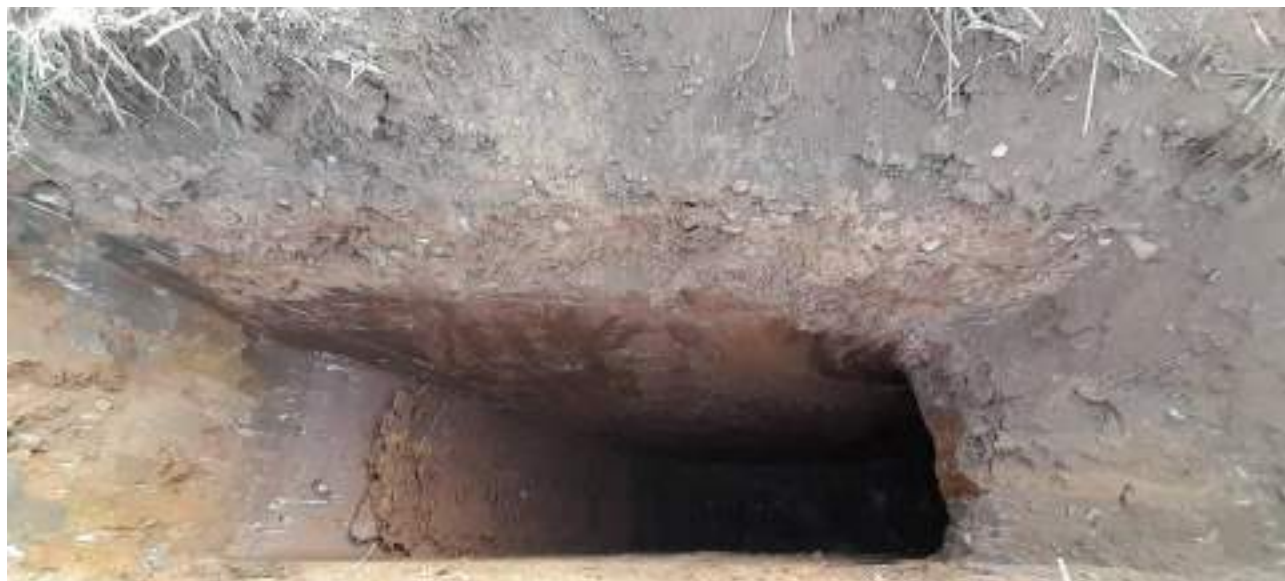
Contract: EMG Phase 2		Client: SEGRO		Trial Pit: TP03
Contract Ref: 765514	Start: 03.10.22 End: 03.10.22	Ground Level (m AOD): 90.59	National Grid Co-ordinate: E:446327.3 N:325173.4	Sheet: 4 of 5

Method Used: Machine dug	Plant Used: Tracked excavator	Logged By: GKalaher	Checked By: RL	
---------------------------------	--------------------------------------	----------------------------	-----------------------	--

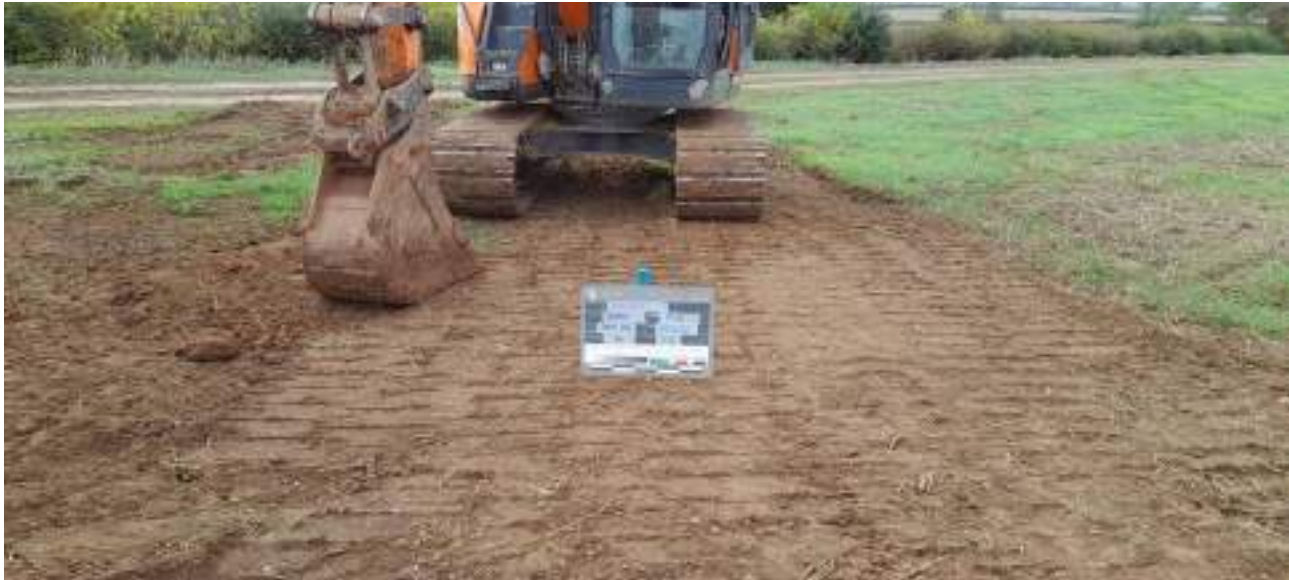
Contract: EMG Phase 2		Client: SEGRO		Trial Pit: TP03
Contract Ref: 765514	Start: 03.10.22 End: 03.10.22	Ground Level (m AOD): 90.59	National Grid Co-ordinate: E:446327.3 N:325173.4	Sheet: 5 of 5

Method Used: Machine dug	Plant Used: Tracked excavator	Logged By: GKalaher	Checked By: RL	
---------------------------------	--------------------------------------	----------------------------	-----------------------	--

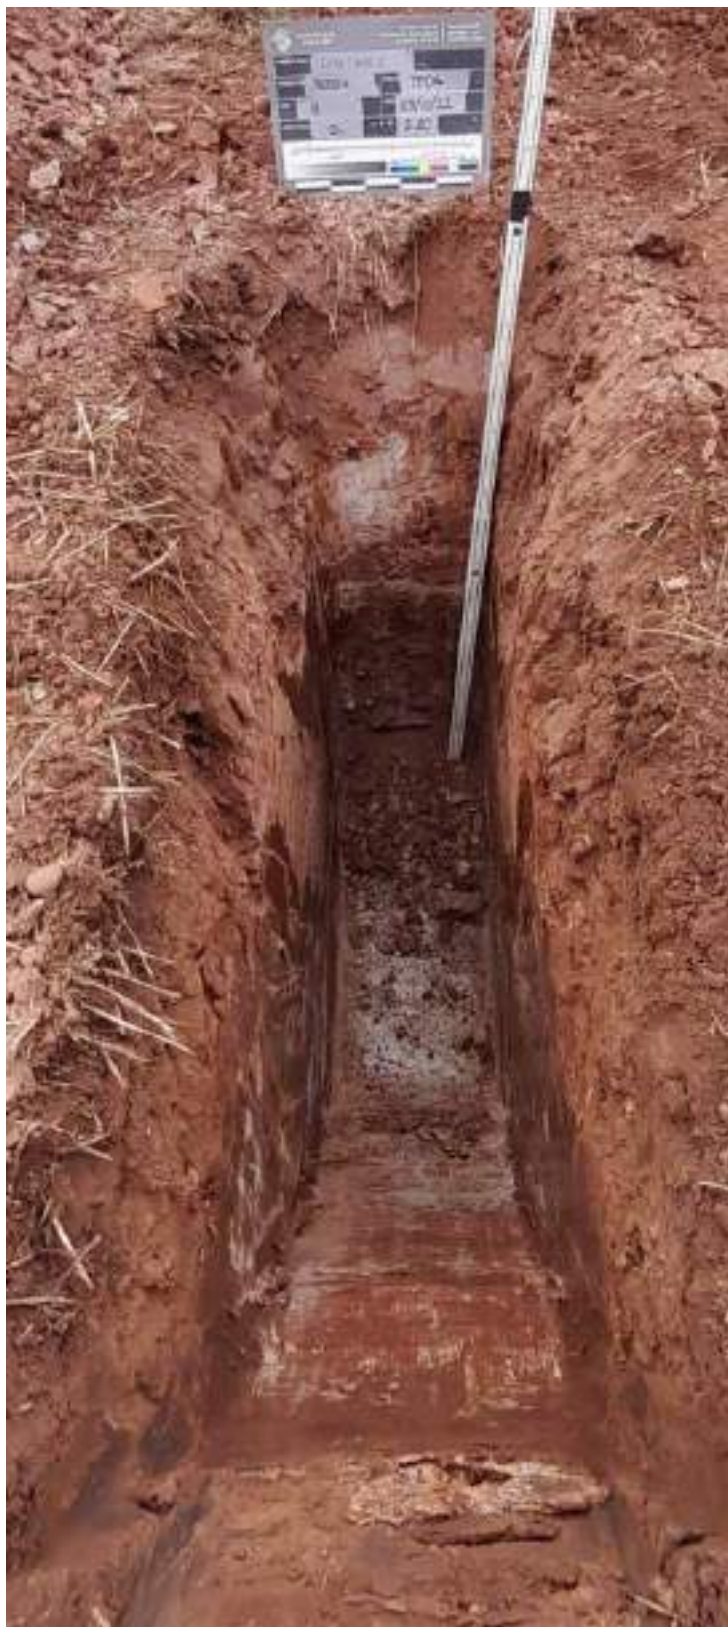
Contract: EMG Phase 2		Client: SEGRO		Trial Pit: TP04
Contract Ref: 765514	Start: 03.10.22 End: 03.10.22	Ground Level (m AOD): 88.71	National Grid Co-ordinate: E:446164.8 N:325278.9	Sheet: 2 of 4

Method Used: Machine dug	Plant Used: Tracked excavator	Logged By: GKalaher	Checked By: RL	
---------------------------------	--------------------------------------	----------------------------	-----------------------	--

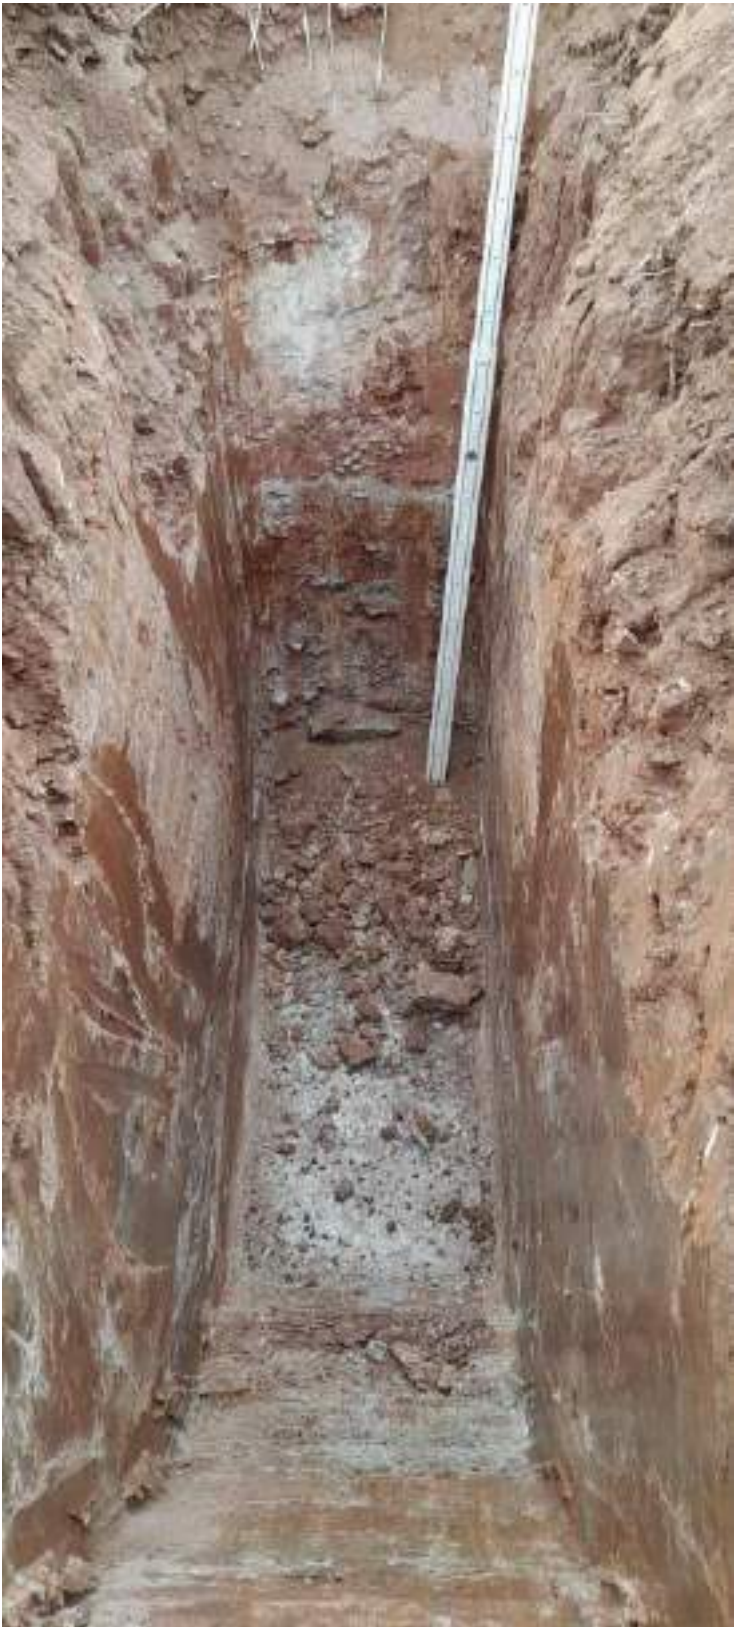
Contract: EMG Phase 2		Client: SEGRO		Trial Pit: TP04
Contract Ref: 765514	Start: 03.10.22 End: 03.10.22	Ground Level (m AOD): 88.71	National Grid Co-ordinate: E:446164.8 N:325278.9	Sheet: 3 of 4

Method Used: Machine dug	Plant Used: Tracked excavator	Logged By: GKalaher	Checked By: RL	
---------------------------------	--------------------------------------	----------------------------	-----------------------	--
