East Midlands Gateway Phase 2 (EMG2)

Appendix 13E

Lockington Brook Flood Assets

Job No.	Doc No.	Rev.	Page
220500	EMG2-BWB-ZZ-XX-T-W_0008	P02	Page 1
Project		Date Prepared	Prepared by
East Midlands Gateway Phase 2		19/03/25	Robin Green
Title			Authorised by
A Review of the Lockington Brook Flood Assets at the A50 and M1			Claire Gardner

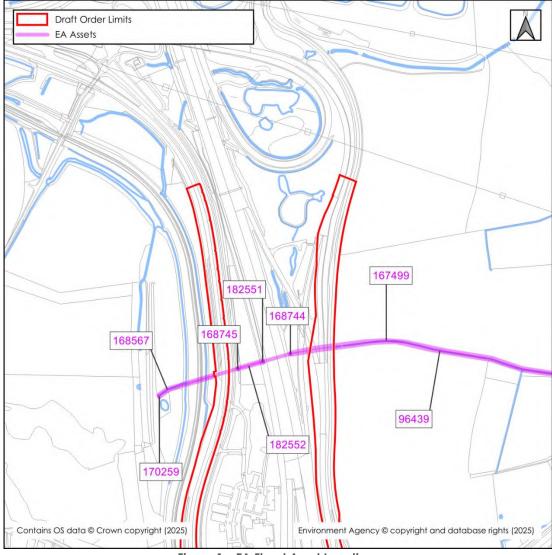
Figure 1 – EA Flood Asset Locations

The referenced assets are located within **Figure 1** below. Assets 168567, 170259, 182551, 182552, 167499 and 96439 are classified as 'natural high ground' – i.e.: river banks. Assets 168745 and 168744 are classified as 'simple culverts'.

In the returned scoping opinion, the EA state: "It is important to note that the northern section of the red line boundary intersects with flood assets for a main river. These assets should be scoped in for further assessment within the chapter on flood risk. We will require a pre-works and post works survey of these assets, with remediation of defects identified (e.g., assets: 168567, 170259, 168745, 182552, 167499, 96439)".

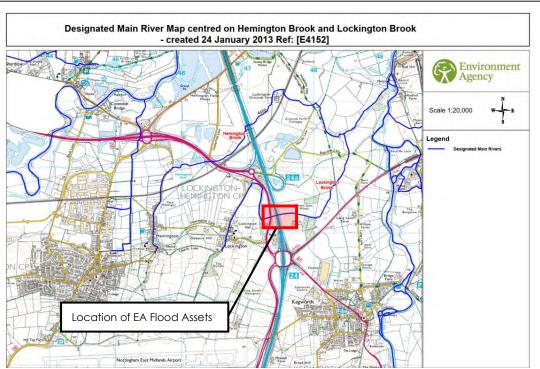
Figure 2 – EA Main River Map (2013) Illustrating the Assumed Connectivity of the Lockington Brook

The assets are understood to be associated with the Lockington Brook Main River – as illustrated with Figure 2.

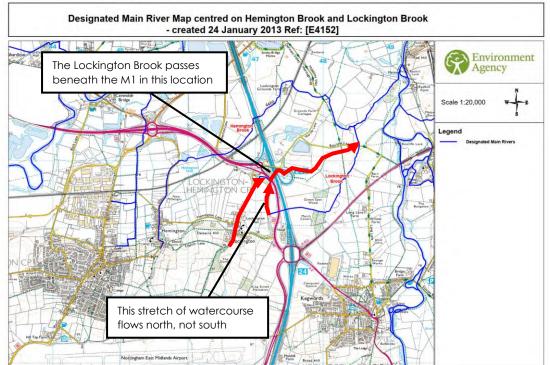
Figure 3 – EA Main River Map Mark-Up with Actual Connectivity of Lockington Brook confirmed in 2014

However, the route of the Lockington Brook was never through these assets. Inspection and dye tracing undertaken in 2014 for the first phase of EMG identified that the Brook passes beneath the M1 and A50 slip road 520m further to the north – as shown within **Figure 3** below. The dye testing plan accompanies this note (ref: NTH/209/W45).

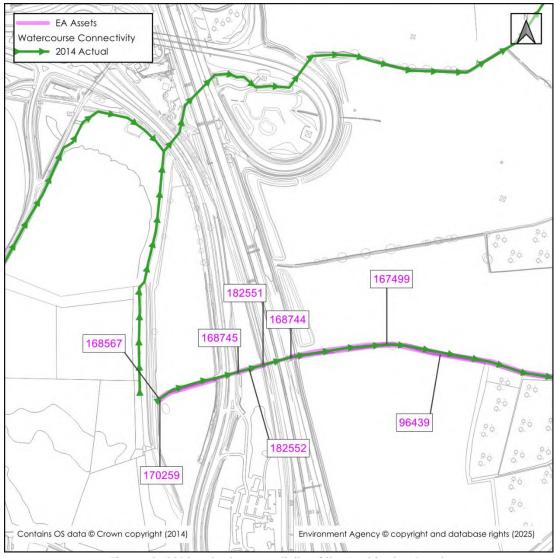
Figure 4 –2013 actual connectivity of the Lockington Brook

The actual watercourse connectivity from 2014, prior to construction of the EMG1 Rail Freight Terminal, is shown in **Figure 4**. Please note that this is overlain on historical Ordnance Survey data from 2014. No evidence of the channel "182551 | 182552" was ever observed, instead culvert "168745" was thought to extend to meet the inlet of culvert "168744".

As the Lockington Brook did not flow through this reach, it is believed that it was incorrectly identified as Main River and categorised as EA flood assets. The actual route of the Lockington Brook, located 520m to the north, should have been categorised as Main River.

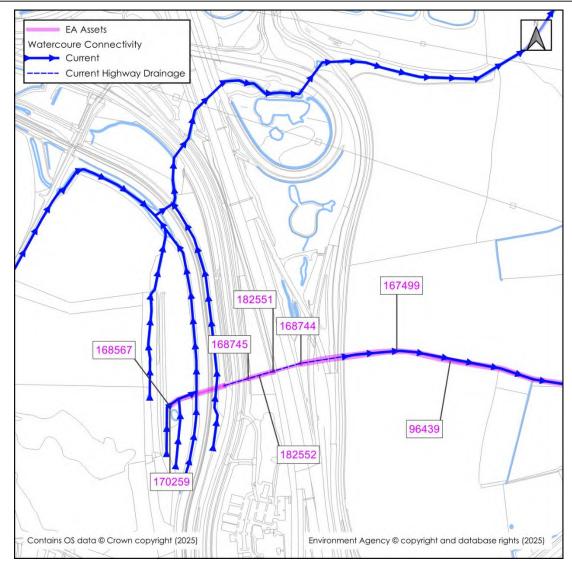
Figure 5 – Current Connectivity of the Lockington Brook

The present-day channel connectivity is illustrated within **Figure 5**, and this is reflected in the EA's own hydraulic model of the Lockington Brook, as shown in **Figure 6**.

- The minor channel associated with "168667 | 170259" was diverted to flow northwards towards the Lockington Brook.
- The inlet to culvert "168745" on the western side of the A50 was covered, an 'open' inlet to the culvert no longer exists.
- Culvert "168744" was extended downstream to allow the new slip road between the A50 and junction 24 of the M1 to be created above.
