**East Midlands Gateway
Phase 2 (EMG2)**

Geotechnical Preliminary Risk Assessment (EMG2)

East Midlands Gateway Phase 2, Land south of East Midlands Airport, Derby Geo-environmental and Geotechnical Preliminary Risk Assessment

REPORT TITLE: Phase I Geo-environmental and Geotechnical Preliminary Risk Assessment

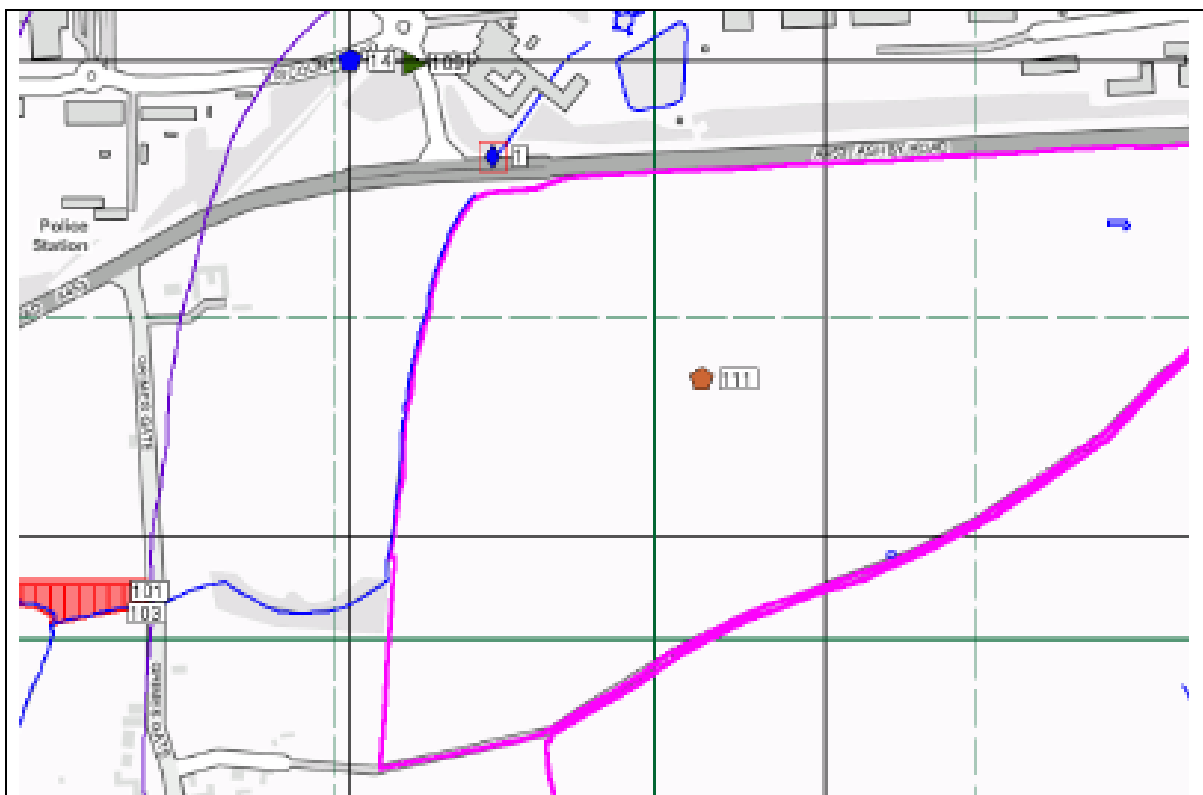
Plate 1 – Site Sensitivity Map Extract (Envirocheck Report – Appendix B)

Based on the information available it is considered that groundwater flow direction is likely to be in the south to south easterly flow direction. As such, surface water receptors are largely associated with the ponds identified on site, the drainage ditch in the south east and the associated tributaries of the Diseworth Brook. Ponds to the north and south west are not considered likely receptors.

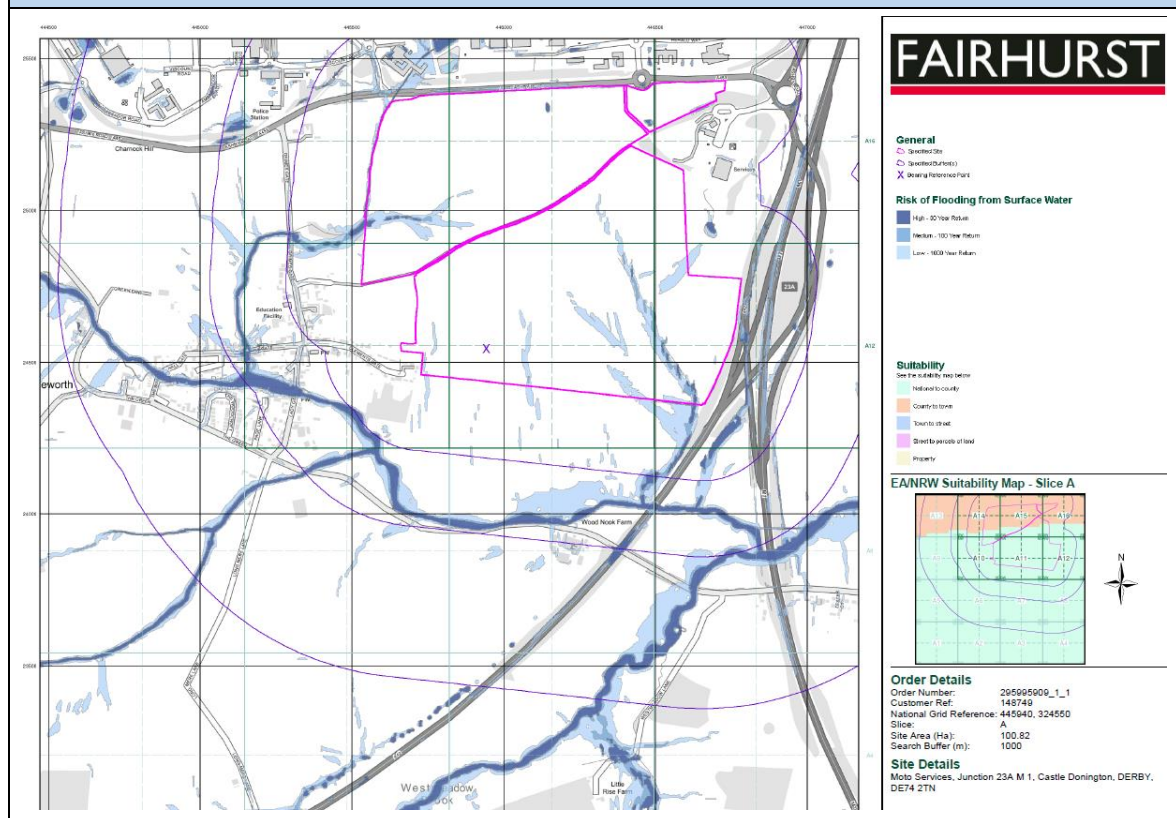
Plate 2 – Extent of Flooding Risk from Environment Agency

Although preliminary comment has been made in relation to flood risk base on the mapping this report does not provide formal advice on flood risk.

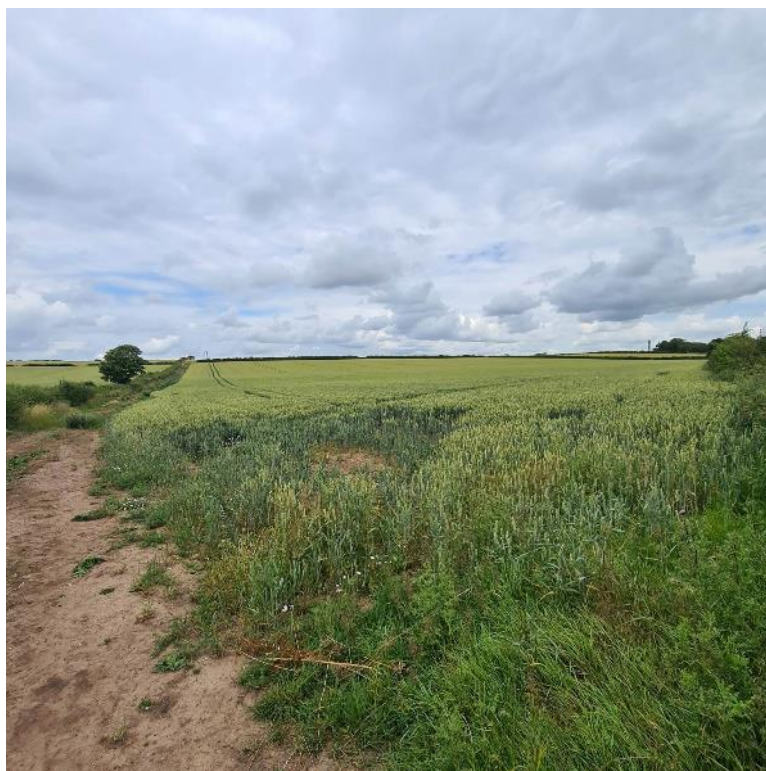
Photo 1 – View of the central field, to the north of Hyam's Lane, facing northwards. Wheat can be seen being grown in the background.

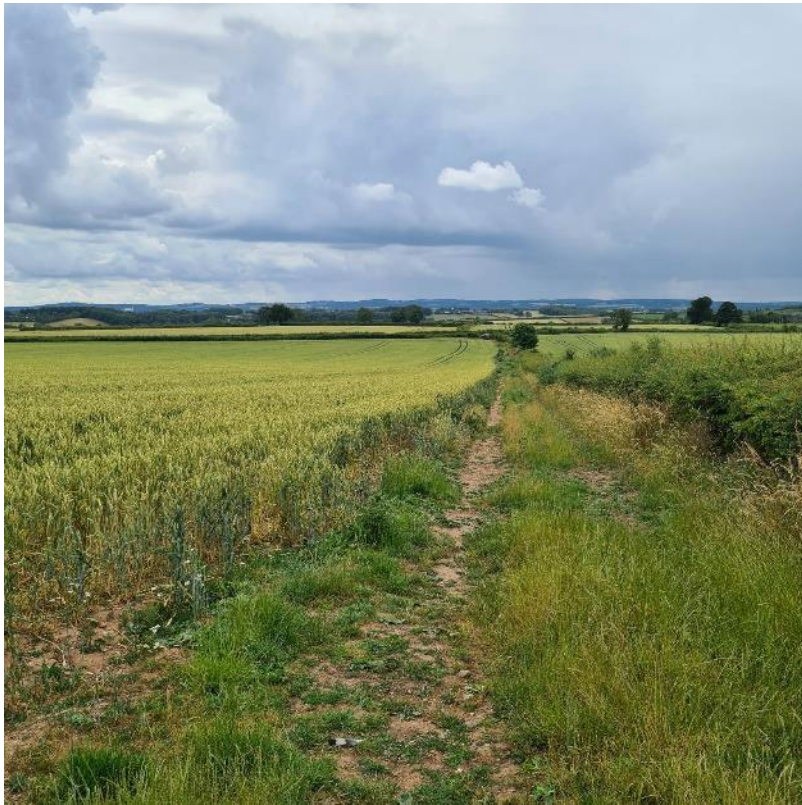
Photo 3 – View central field, to the north of Hyam's Lane, taken from the north of the site, facing southwards.

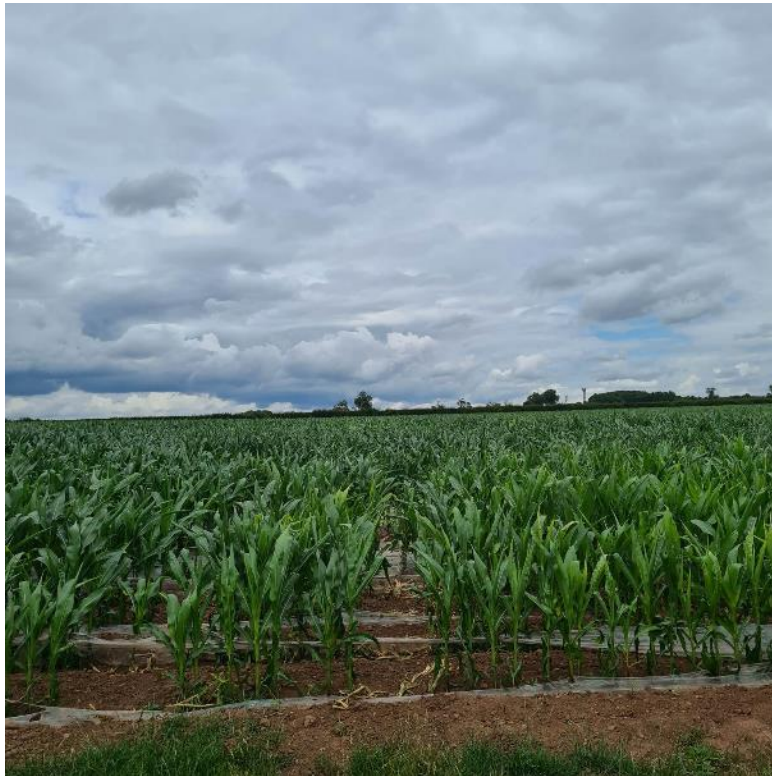
Ground cover to the south of Hyam's Lane comprises arable land in which the northern most fields were used to grow wheat and the southern and south-easternmost fields were used for growing maize. A field in the south-west was also observed to not be utilised for the growing of crops with wild flowers and grasses growing. Desiccated soils were observed in the wheat fields, albeit not as frequently, whilst the maize fields were observed to be surfaced with dried clumps of soil which was not seen elsewhere on-site. Liason with the farmer indicated that green manure had been spread on the maize fields only. Field boundaries were observed to be formed with hedges and mature trees.

Photo 9 – View of the central-southern field, facing westwards. Maize can be seen being grown.

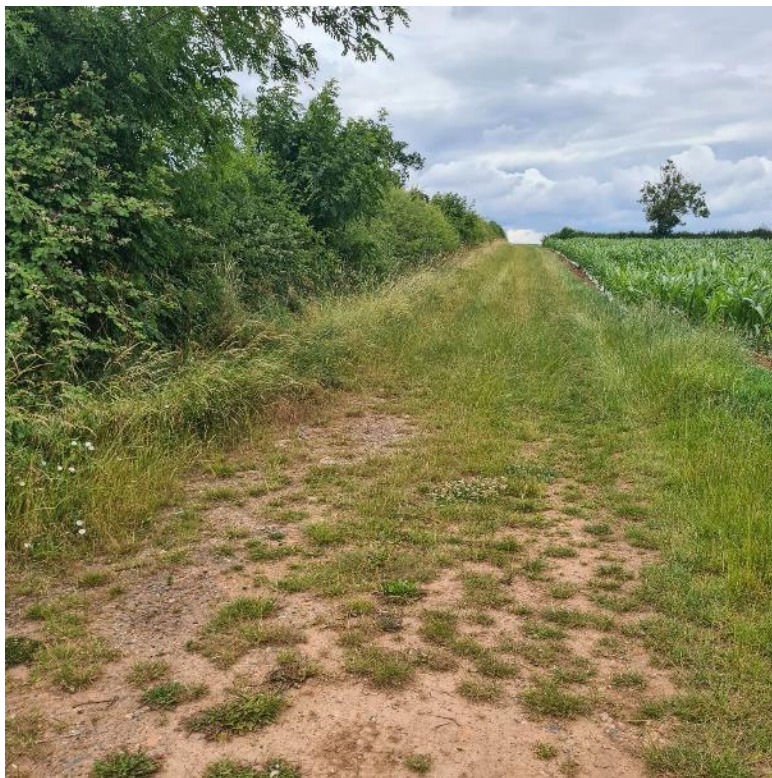
Photo 10 – View of an access track extending northwards from Long Holden, in the south-west of the site. Maize can be seen being grown on the right of the photo.

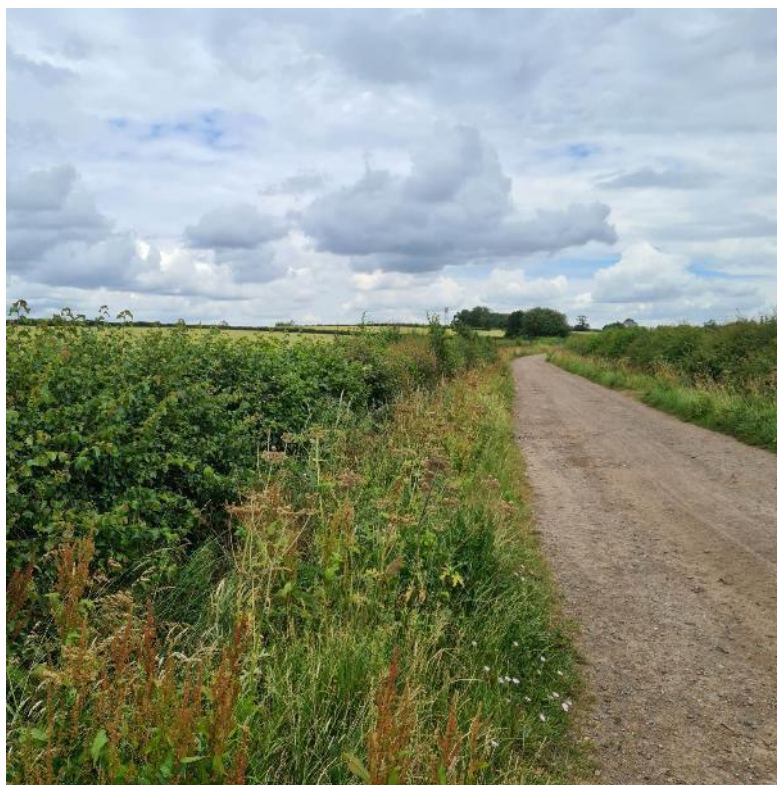
Photo 12 – View of Hyam's Lane facing westwards.
