**East Midlands Gateway
Phase 2 (EMG2)**

Flood Risk Assessment (EMG2 Works)

SEGRO (Properties) Ltd
East Midlands Gateway 2
Flood Risk Assessment – EMG2 Works

Document Number:	EMG2-BWB-ZZ-XX-T-W-0001_FRA
BWB Reference:	220500_FRA

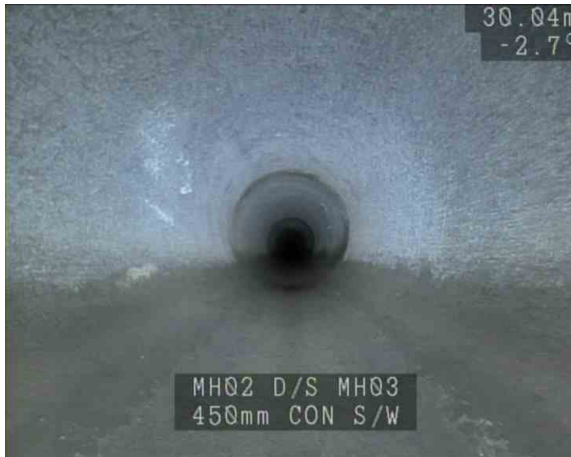
Section Pictures - 06/09/2022 - MH02X

m
Water level 0 % height/diameter

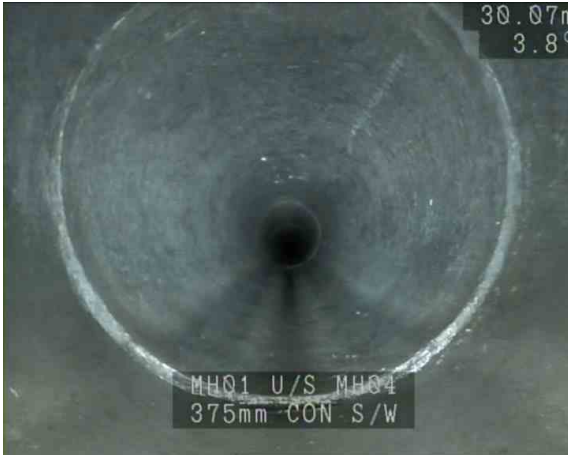
Section Pictures - 06/09/2022 - MH04X

_65dd77e6-3518-4ae3-b96e-6d0e2b6ca48d.jpg, 00:05:17,
30.07 m
General Condition photograph

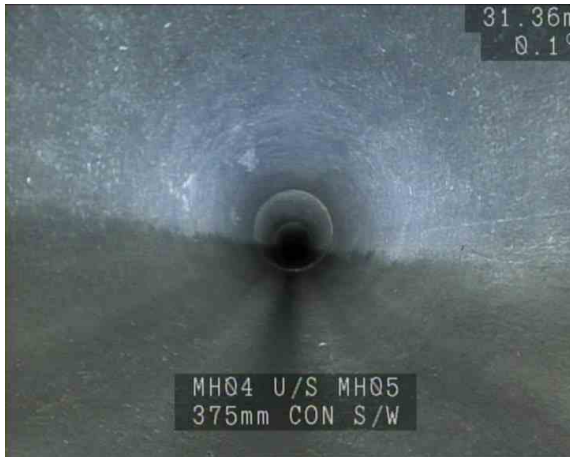
Section Pictures - 06/09/2022 - MH05X

_9bc4a412-f72a-40bc-90e6-bc7fab42619.jpg, 00:05:20,
31.36 m
General Condition photograph

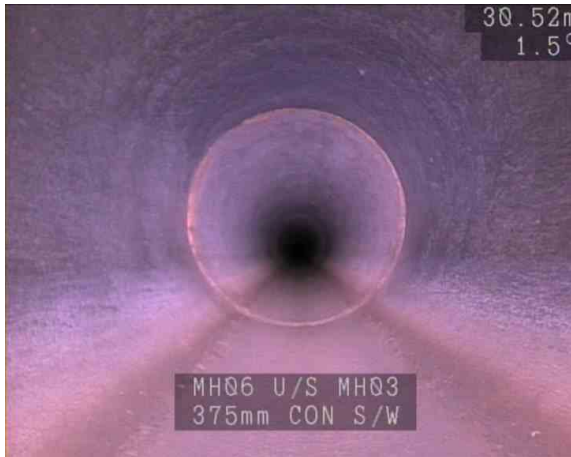
Section Pictures - 06/09/2022 - MH03X

_f72338c4-c7ce-444e-ab20-4d2f6b493fe3.jpg, 00:03:47, 30.52
m
General Condition photograph

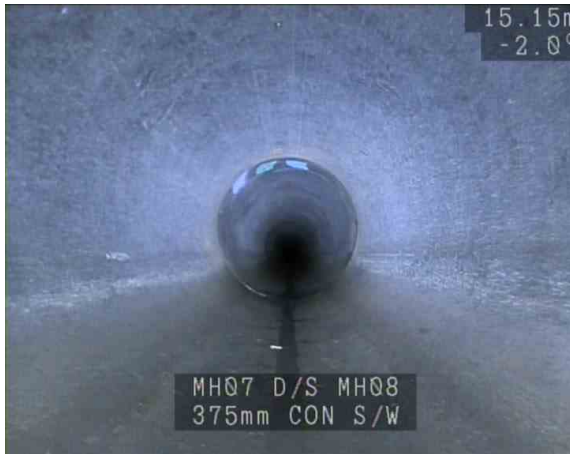
Section Pictures - 06/09/2022 - MH07X

_47d42bd8-e68a-4e2a-90c6-400fcb21c963.jpg, 00:02:51,
15.15 m
General Condition photograph

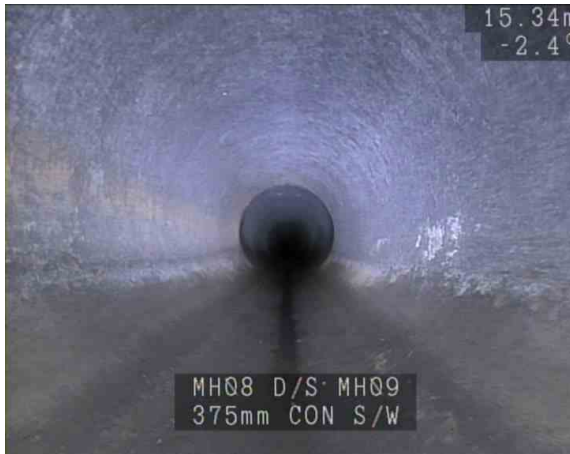
Section	Inspection Direction	PLR	Client's Job Ref	Contractor's Job Ref
8	Downstream	MH08X

Town or Village:		Inspection Direction: Downstream		Upstream Node NAMS Re MH08	
Road: Long Holden (Off)		Inspected Length: 33.60 m		Upstream Pipe Depth:	
Location:		Total Length: 33.60 m		Downstream Node NAMS Ref: MH09	
Surface Type:		Joint Length: 2.50 m		Downstream Pipe Depth:	
Use: Surface water		Pipe Shape: C			
Type of Pipe:		Dia/Height: 375 mm			
Flow Control:		Pipe Material: Concrete			
Year Constructed: Not Specified		Lining Type: No Lining			
Inspection Purpose: Routine inspection of condition		Lining Material: No Lining

_e4bb61a4-ab0a-467d-93a4-65bbdad6d939.jpg, 00:02:21,
15.33 m

General Condition photograph

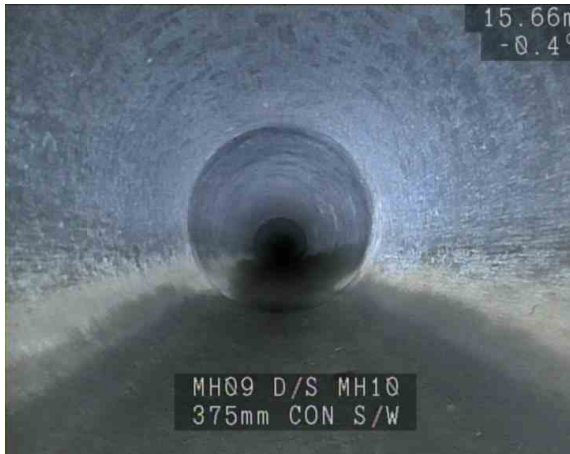
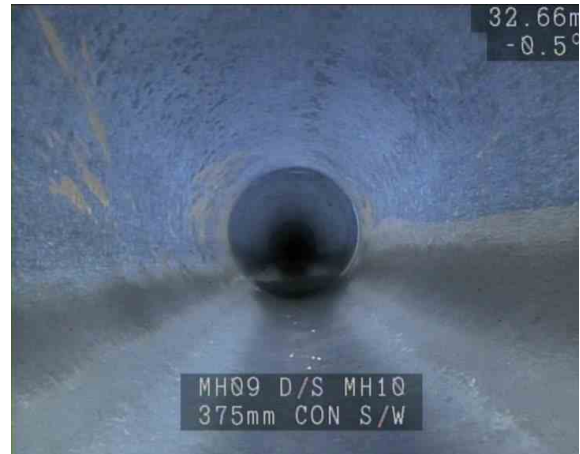
Section	Inspection Direction	PLR	Client's Job Ref	Contractor's Job Ref
9	Downstream	MH09X

Town or Village:		Inspection Direction: Downstream		Upstream Node NAMS Re MH09	
Road: Long Holden (Off)		Inspected Length: 90.25 m		Upstream Pipe Depth:	
Location:		Total Length: 90.25 m		Downstream Node NAMS Ref: MH10	
Surface Type:		Joint Length: 2.50 m		Downstream Pipe Depth:	
Use: Surface water		Pipe Shape: C			
Type of Pipe:		Dia/Height: 375 mm			
Flow Control:		Pipe Material: Concrete			
Year Constructed: Not Specified		Lining Type: No Lining			
Inspection Purpose: Routine inspection of condition		Lining Material: No Lining

_390ca381-15d0-418f-a45c-e2b560419aa3.jpg, 00:03:03,
15.66 m
General Condition photograph

_96ce8c79-5e2d-478d-bf0e-58d48171529f.jpg, 00:05:45,
32.66 m
General Condition photograph

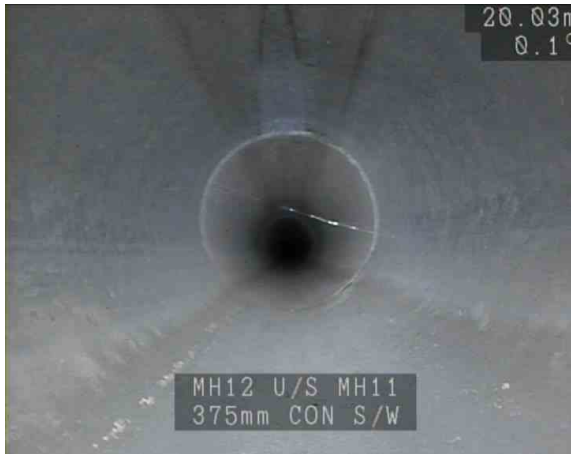
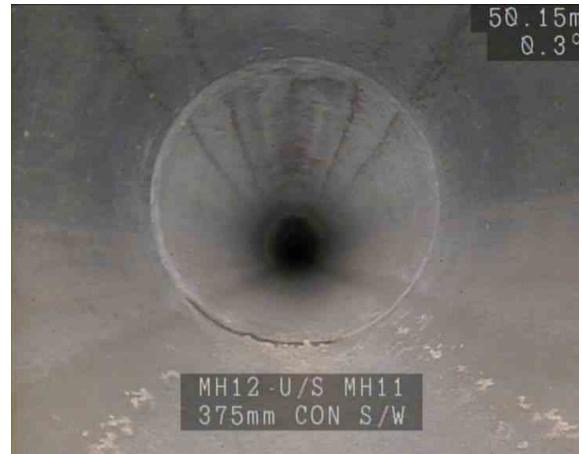
Section	Inspection Direction	PLR	Client's Job Ref	Contractor's Job Ref
10	Upstream	MH11X

Town or Village:		Inspection Direction: Upstream		Upstream Node NAMS Re MH11	
Road: Long Holden (Off)		Inspected Length: 89.59 m		Upstream Pipe Depth:	
Location:		Total Length: 89.59 m		Downstream Node NAMS Ref: MH12	
Surface Type:		Joint Length: 2.50 m		Downstream Pipe Depth:	
Use: Surface water		Pipe Shape: C			
Type of Pipe:		Dia/Height: 375 mm			
Flow Control:		Pipe Material: Concrete			
Year Constructed: Not Specified		Lining Type: No Lining			
Inspection Purpose: Routine inspection of condition		Lining Material: No Lining

_c52f416b-4ec1-4efa-af89-8528181f16d6.jpg, 00:02:44, 20.03
m
General Condition photograph

_612b8f39-a50e-4149-ade1-68436daa23fc.jpg, 00:05:17,
50.15 m
General Condition photograph

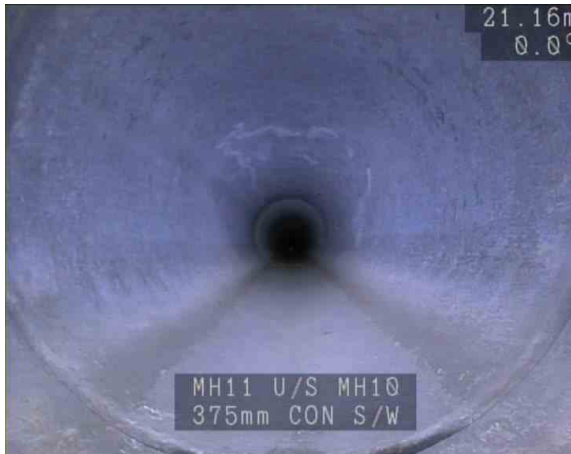
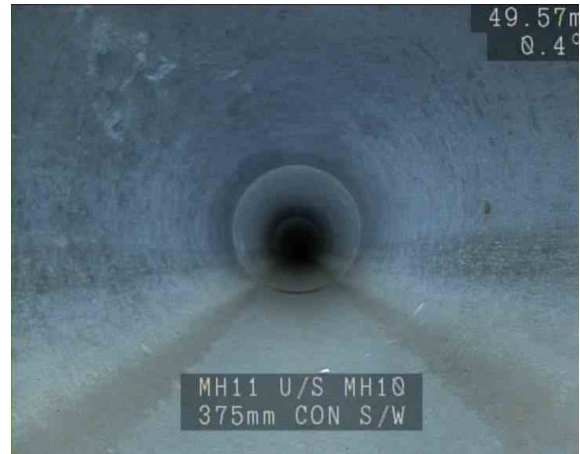
Section	Inspection Direction	PLR	Client's Job Ref	Contractor's Job Ref
11	Upstream	MH10X

Town or Village:		Inspection Direction: Upstream		Upstream Node NAMS Re MH10	
Road: Long Holden (Off)		Inspected Length: 89.68 m		Upstream Pipe Depth:	
Location:		Total Length: 89.68 m		Downstream Node NAMS Ref: MH11	
Surface Type:		Joint Length: 2.50 m		Downstream Pipe Depth:	
Use: Surface water		Pipe Shape: C			
Type of Pipe:		Dia/Height: 375 mm			
Flow Control:		Pipe Material: Concrete			
Year Constructed: Not Specified		Lining Type: No Lining			
Inspection Purpose: Routine inspection of condition		Lining Material: No Lining

_b9f9db0a-aa81-41f0-8fe2-300d445328ad.jpg, 00:02:40,
21.16 m
General Condition photograph

_6d3894c7-fb04-44b7-aa8c-0f877416d629.jpg, 00:05:13,
49.57 m
General Condition photograph

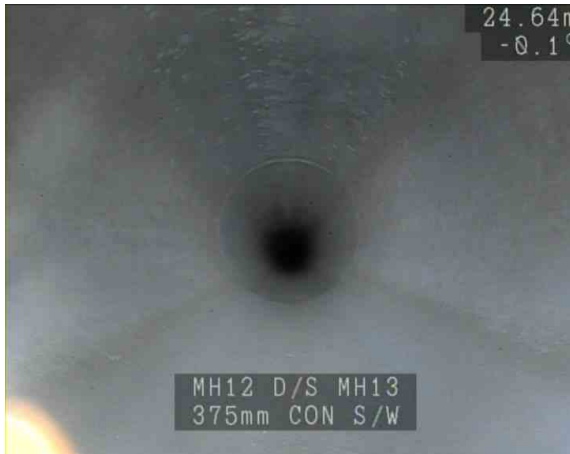
Section	Inspection Direction	PLR	Client's Job Ref	Contractor's Job Ref
12	Downstream	MH12X

Town or Village:		Inspection Direction: Downstream		Upstream Node NAMS Re MH12	
Road: Long Holden (Off)		Inspected Length: 86.73 m		Upstream Pipe Depth:	
Location:		Total Length: 86.73 m		Downstream Node NAMS Ref: MH13	
Surface Type:		Joint Length: 2.50 m		Downstream Pipe Depth:	
Use: Surface water		Pipe Shape: C			
Type of Pipe:		Dia/Height: 375 mm			
Flow Control:		Pipe Material: Concrete			
Year Constructed: Not Specified		Lining Type: No Lining			
Inspection Purpose: Routine inspection of condition		Lining Material: No Lining

_03a2ace7-3884-44ee-9bcc-249d12e54f09.jpg, 00:02:50,
24.64 m
General Condition photograph

_f22a16c7-2dd7-4872-a5fb-448f33d4f7f3.jpg, 00:05:21, 60.31
m
General Condition photograph

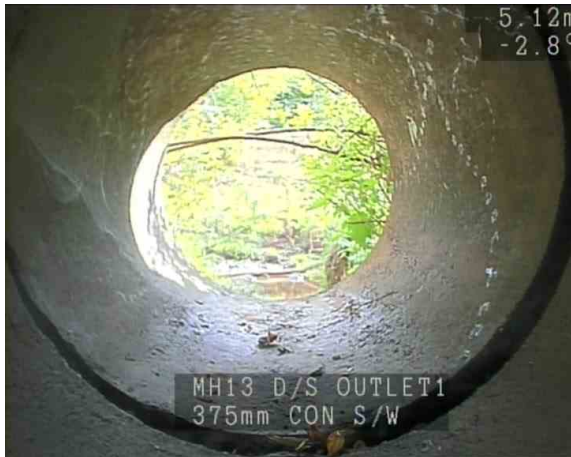
Town or Village:		Inspection Direction: Downstream		Upstream Node NAMS Re MH13	
Road: Long Holden (Off)		Inspected Length: 5.60 m		Upstream Pipe Depth:	
Location:		Total Length: 5.60 m		Downstream Node NAMS Ref: OUTLET1	
Surface Type:		Joint Length: 2.50 m		Downstream Pipe Depth:	
Use: Surface water		Pipe Shape: C			
Type of Pipe:		Dia/Height: 375 mm			
Flow Control:		Pipe Material: Concrete			
Year Constructed: Not Specified		Lining Type: No Lining			
Inspection Purpose: Routine inspection of condition		Lining Material: No Lining

_59d4ae3c-aae6-4fce-aa25-b87ad489547b.jpg, 00:03:01, 5.12
m
Joint displaced medium
