**East Midlands Gateway  
Phase 2 (EMG2)**

**Document DCO 6.13G/MCO 6.13G**

Appendix 13G

# **Flood Risk Assessment – EMG2 Main Site**

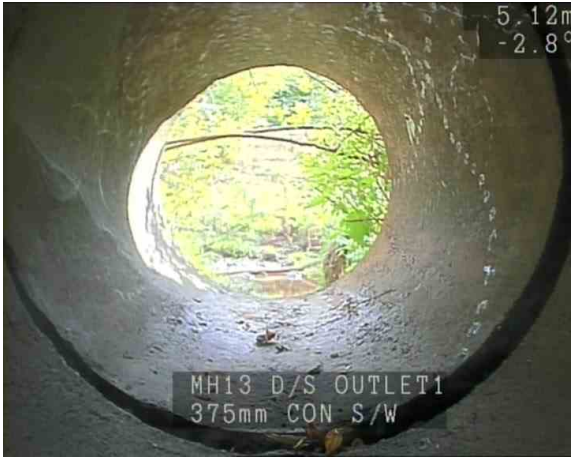
\_59d4ae3c-aae6-4fce-aa25-b87ad489547b.jpg, 00:03:01, 5.12  
m

Joint displaced medium

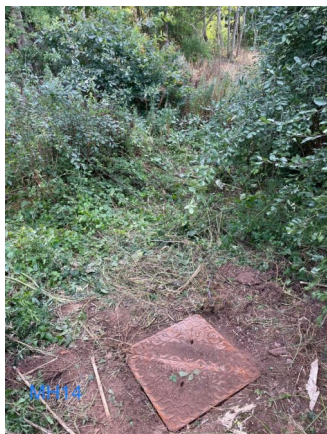
Remarks: Catchpit overall depth 2.20
