**East Midlands Gateway  
Phase 2 (EMG2)**

# EMG1 Preliminary Ground Investigation Interpretative Report

# **East Midlands Gateway Strategic Rail Freight Interchange**

Preliminary Ground Investigation Interpretive Report

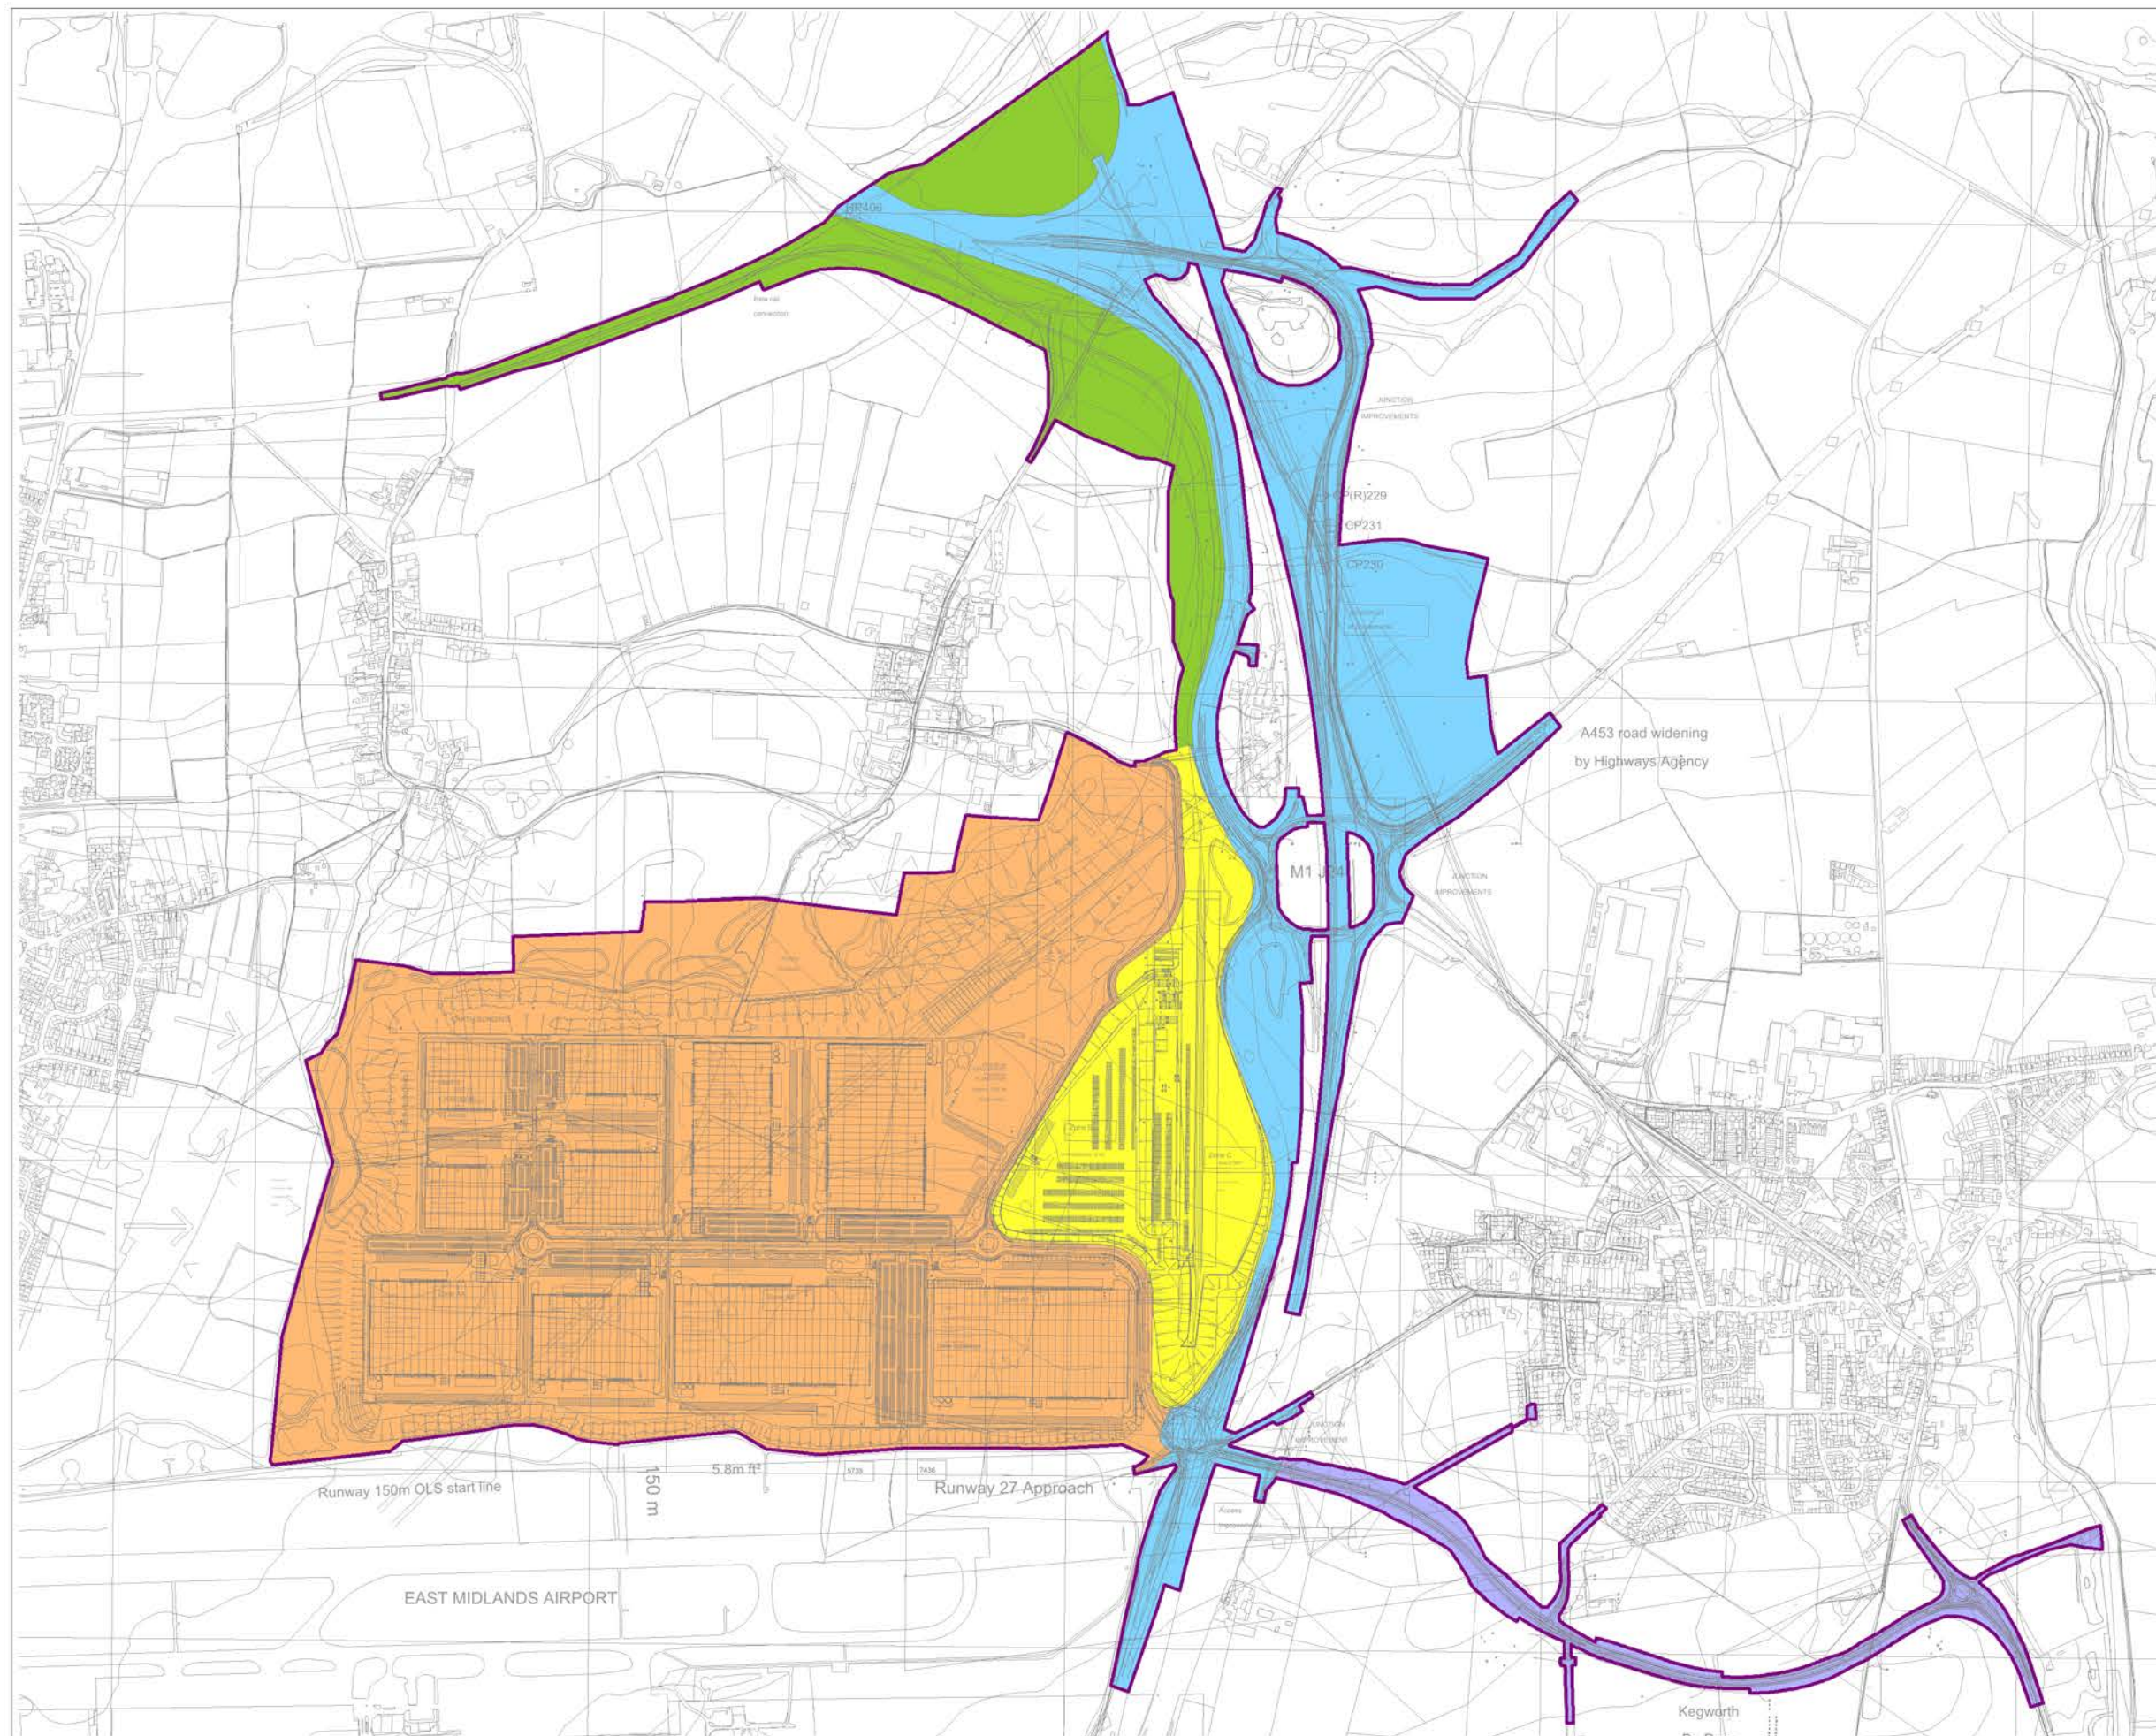
Figure 2  
Proposed Development Plan and Zones  
For Reporting

- Boundary
- Zone 1A - Main Development Plateau - Distribution
- Zone 1B - Main Development Plateau - Rail Freight Terminal
- Zone 2 - New Rail Branch Line
- Zone 3 - Major Trunk Road Improvements (Highways Agency)
- Zone 4 - Kegworth Bypass (Local Authority Highways)
